Appendix A: Photographs of the Areas Impacted by the Enbridge Line 6B Oil  
Discharges and of Response Actions  
from U.S. EPA presentations in 2010 and 2015

# Enbridge Line 6B Incident

## Public Update and Availability Session

October 14, 2010  
(Day 81)

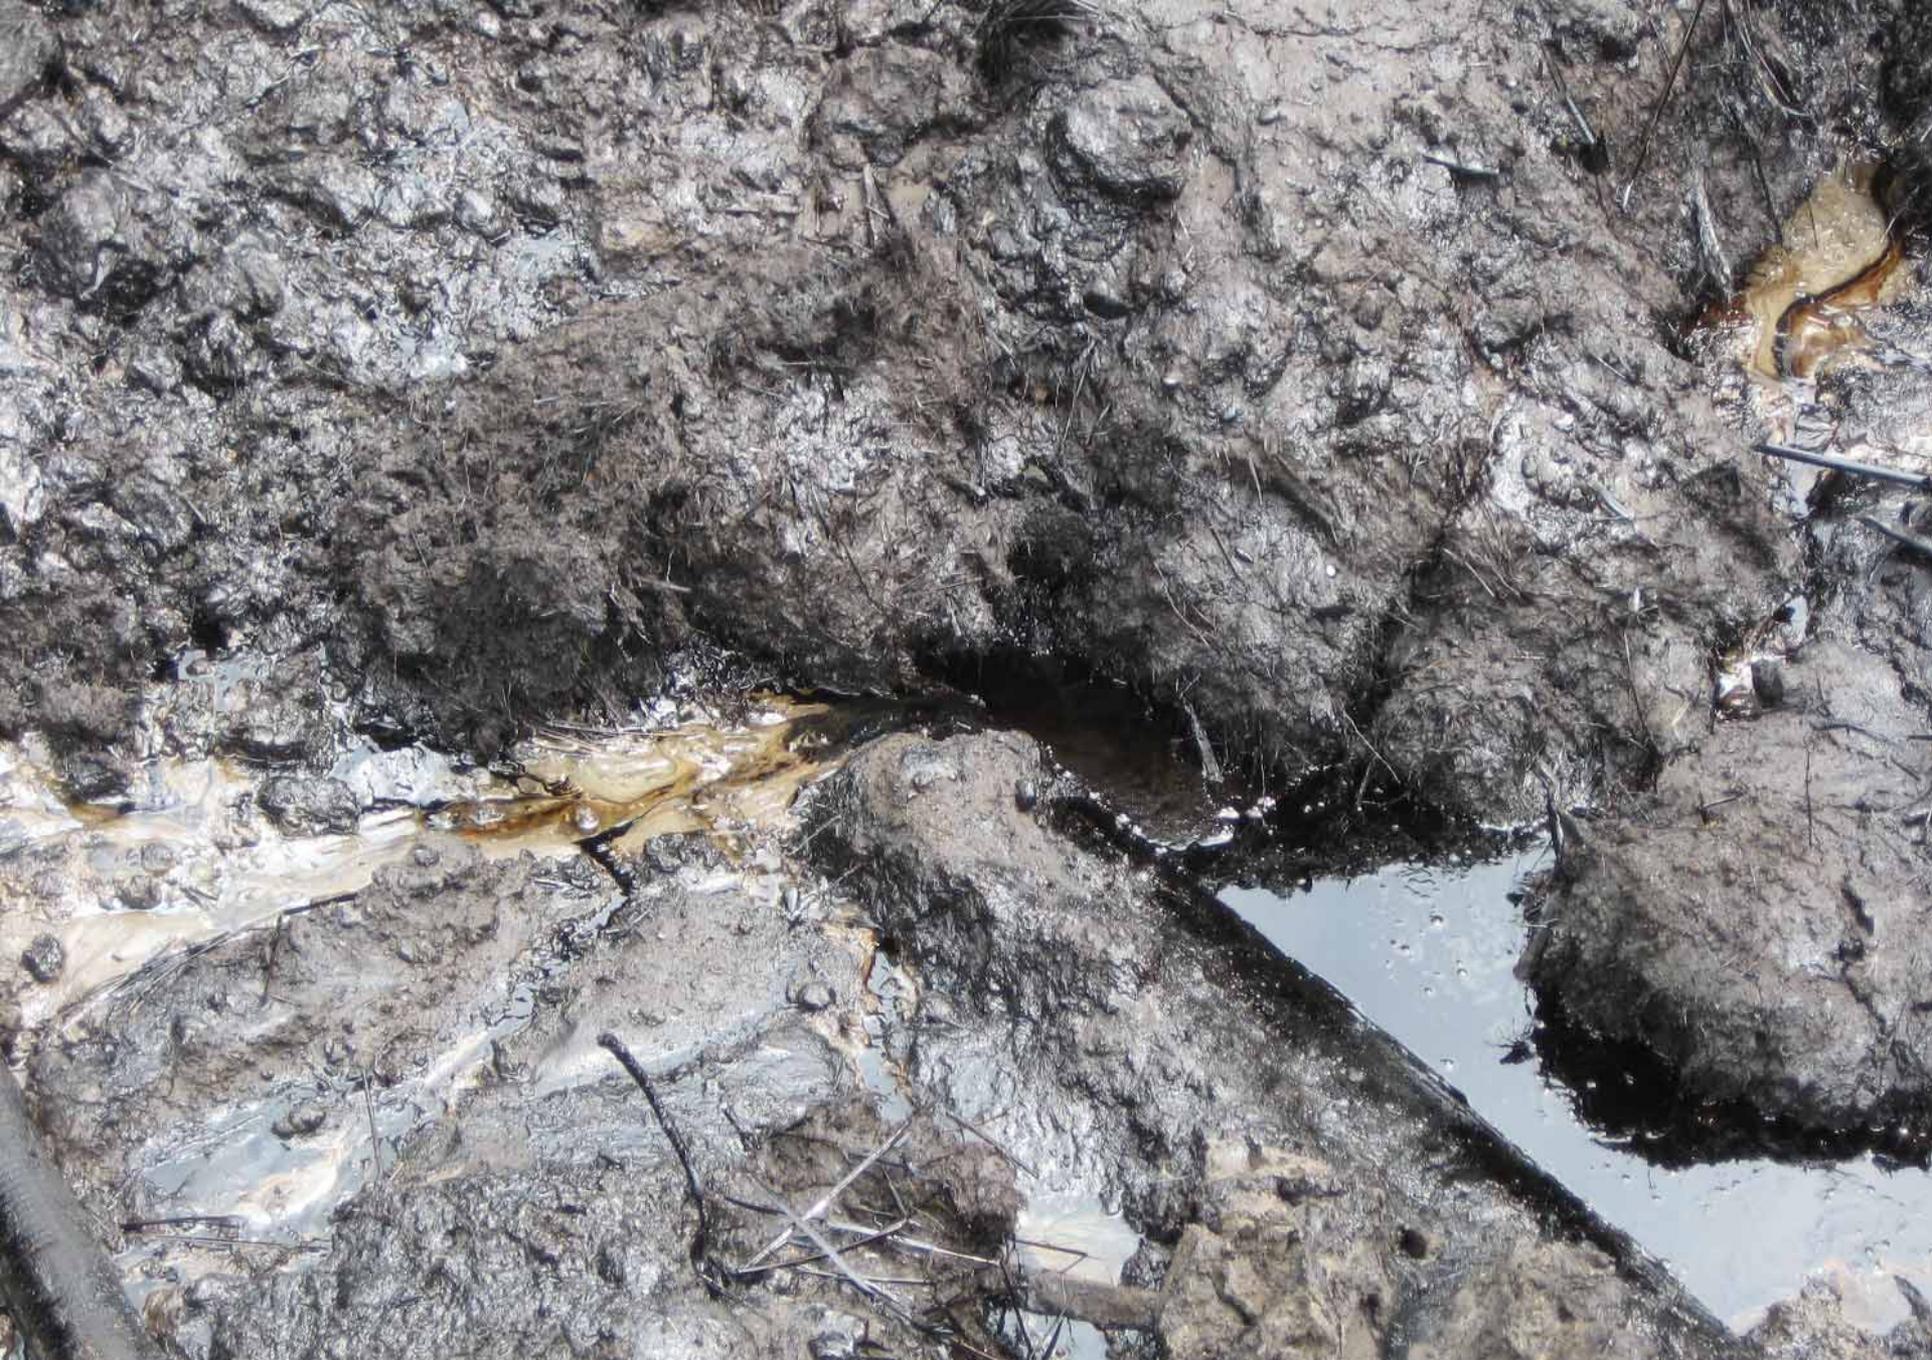
**Exposed pipeline during the first week of the oil spill response.**

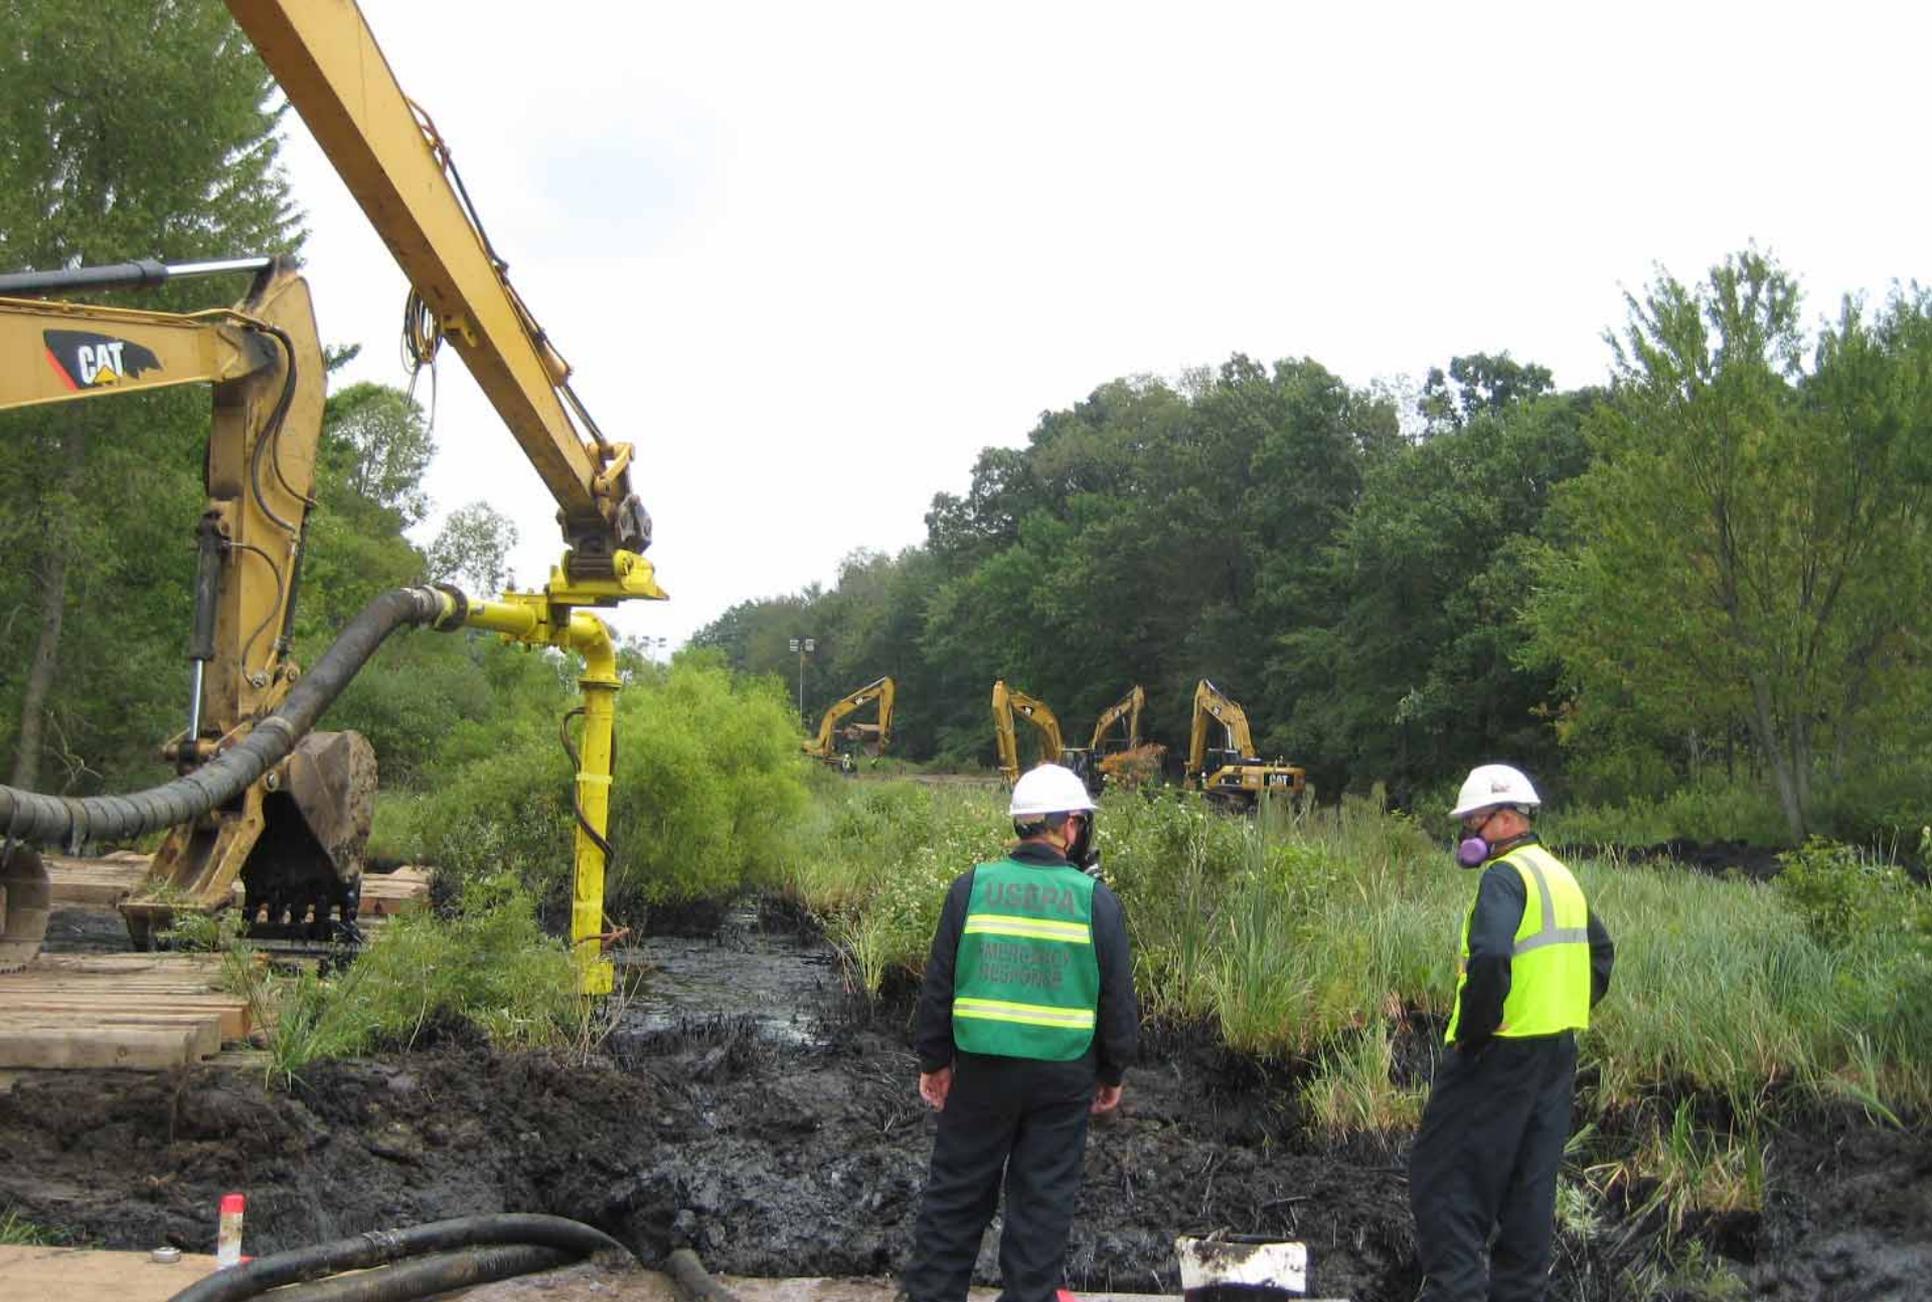
**Initial cleanup of a 5-acre contaminated zone in the pipeline break area. Photo shows a dewatering operation.**

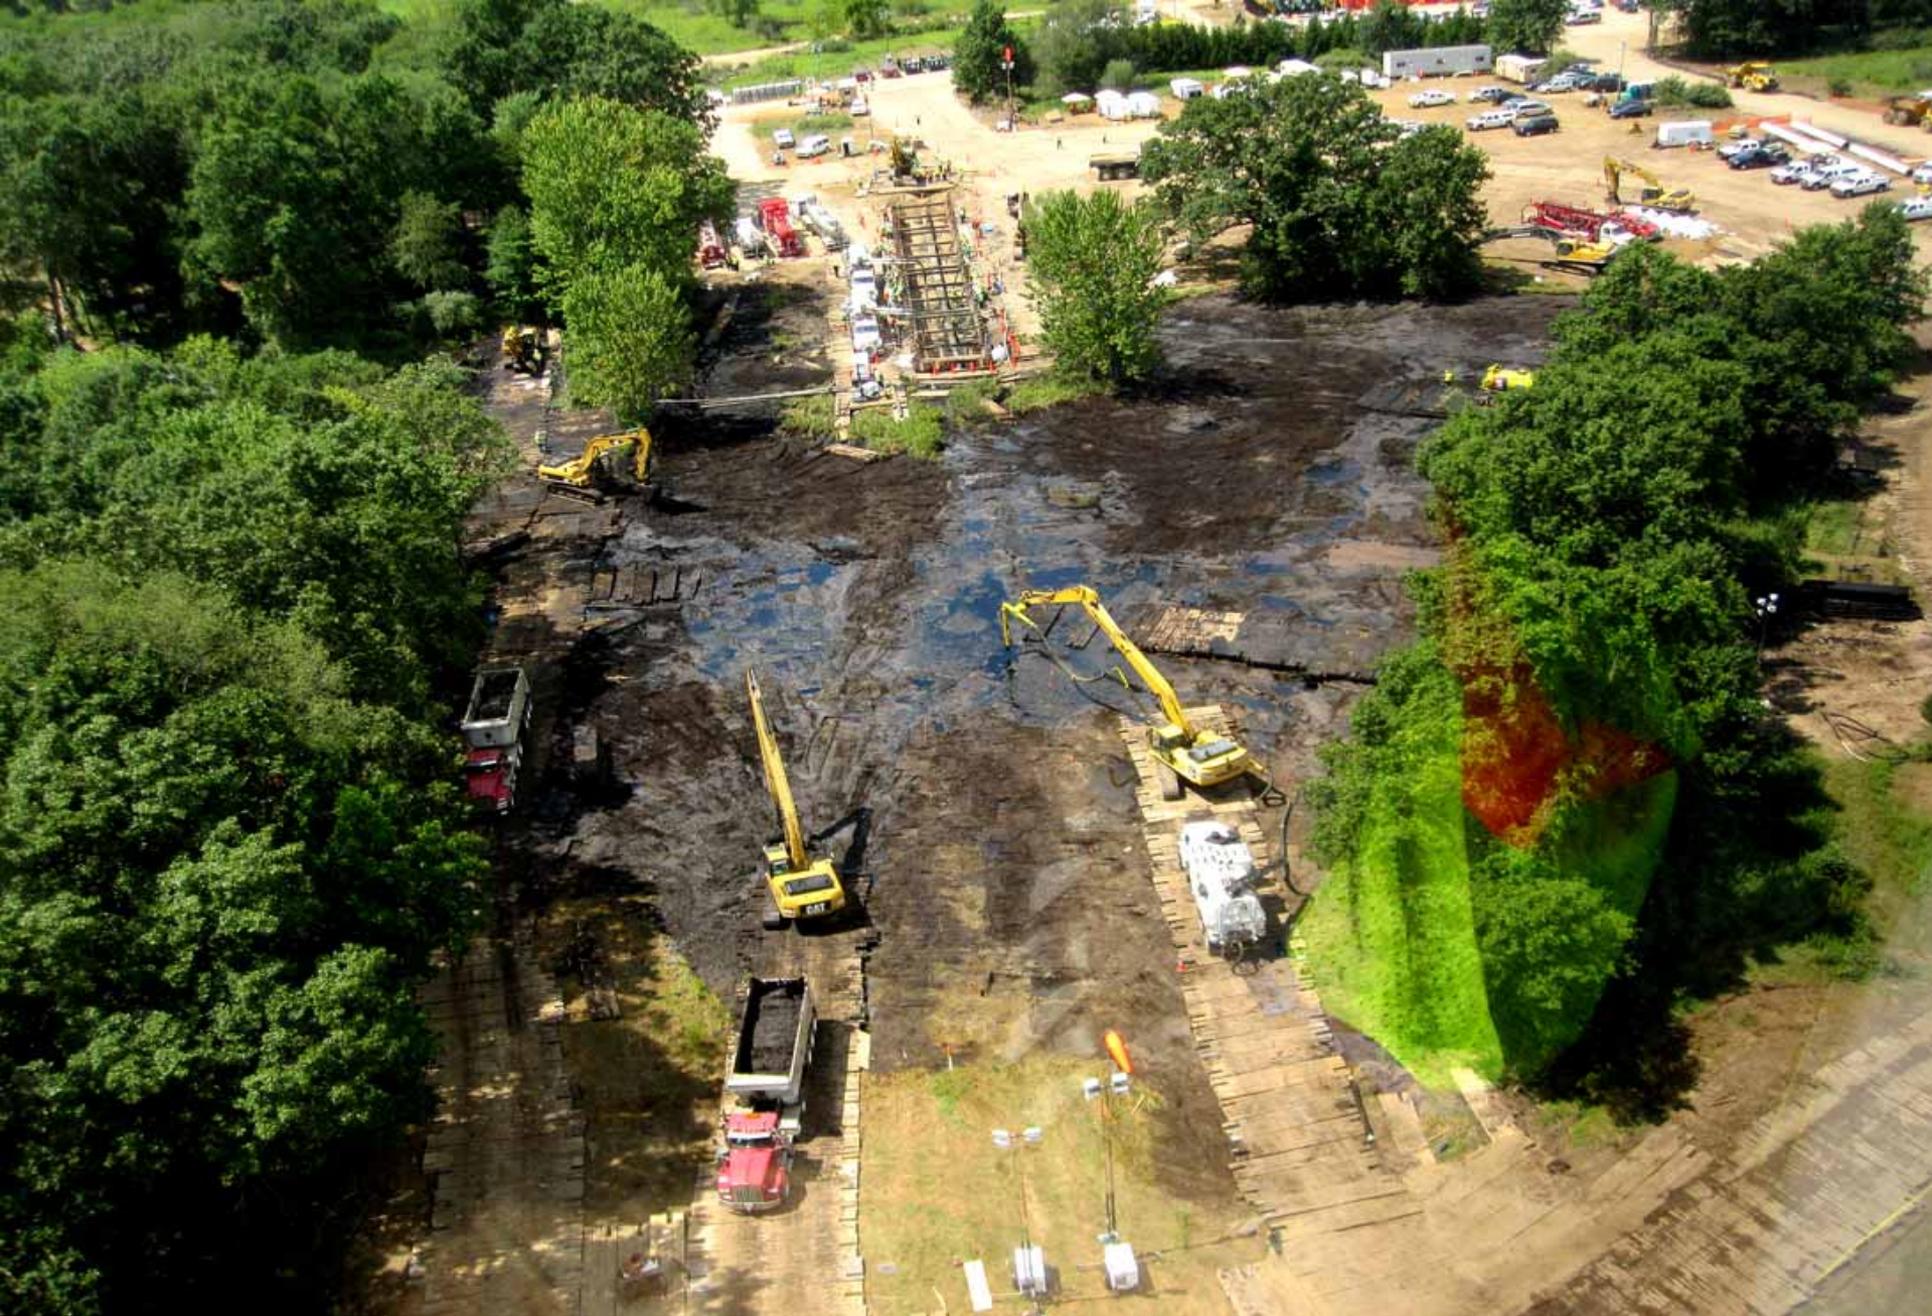
**Second week of contaminated soil cleanup near the pipeline break.**

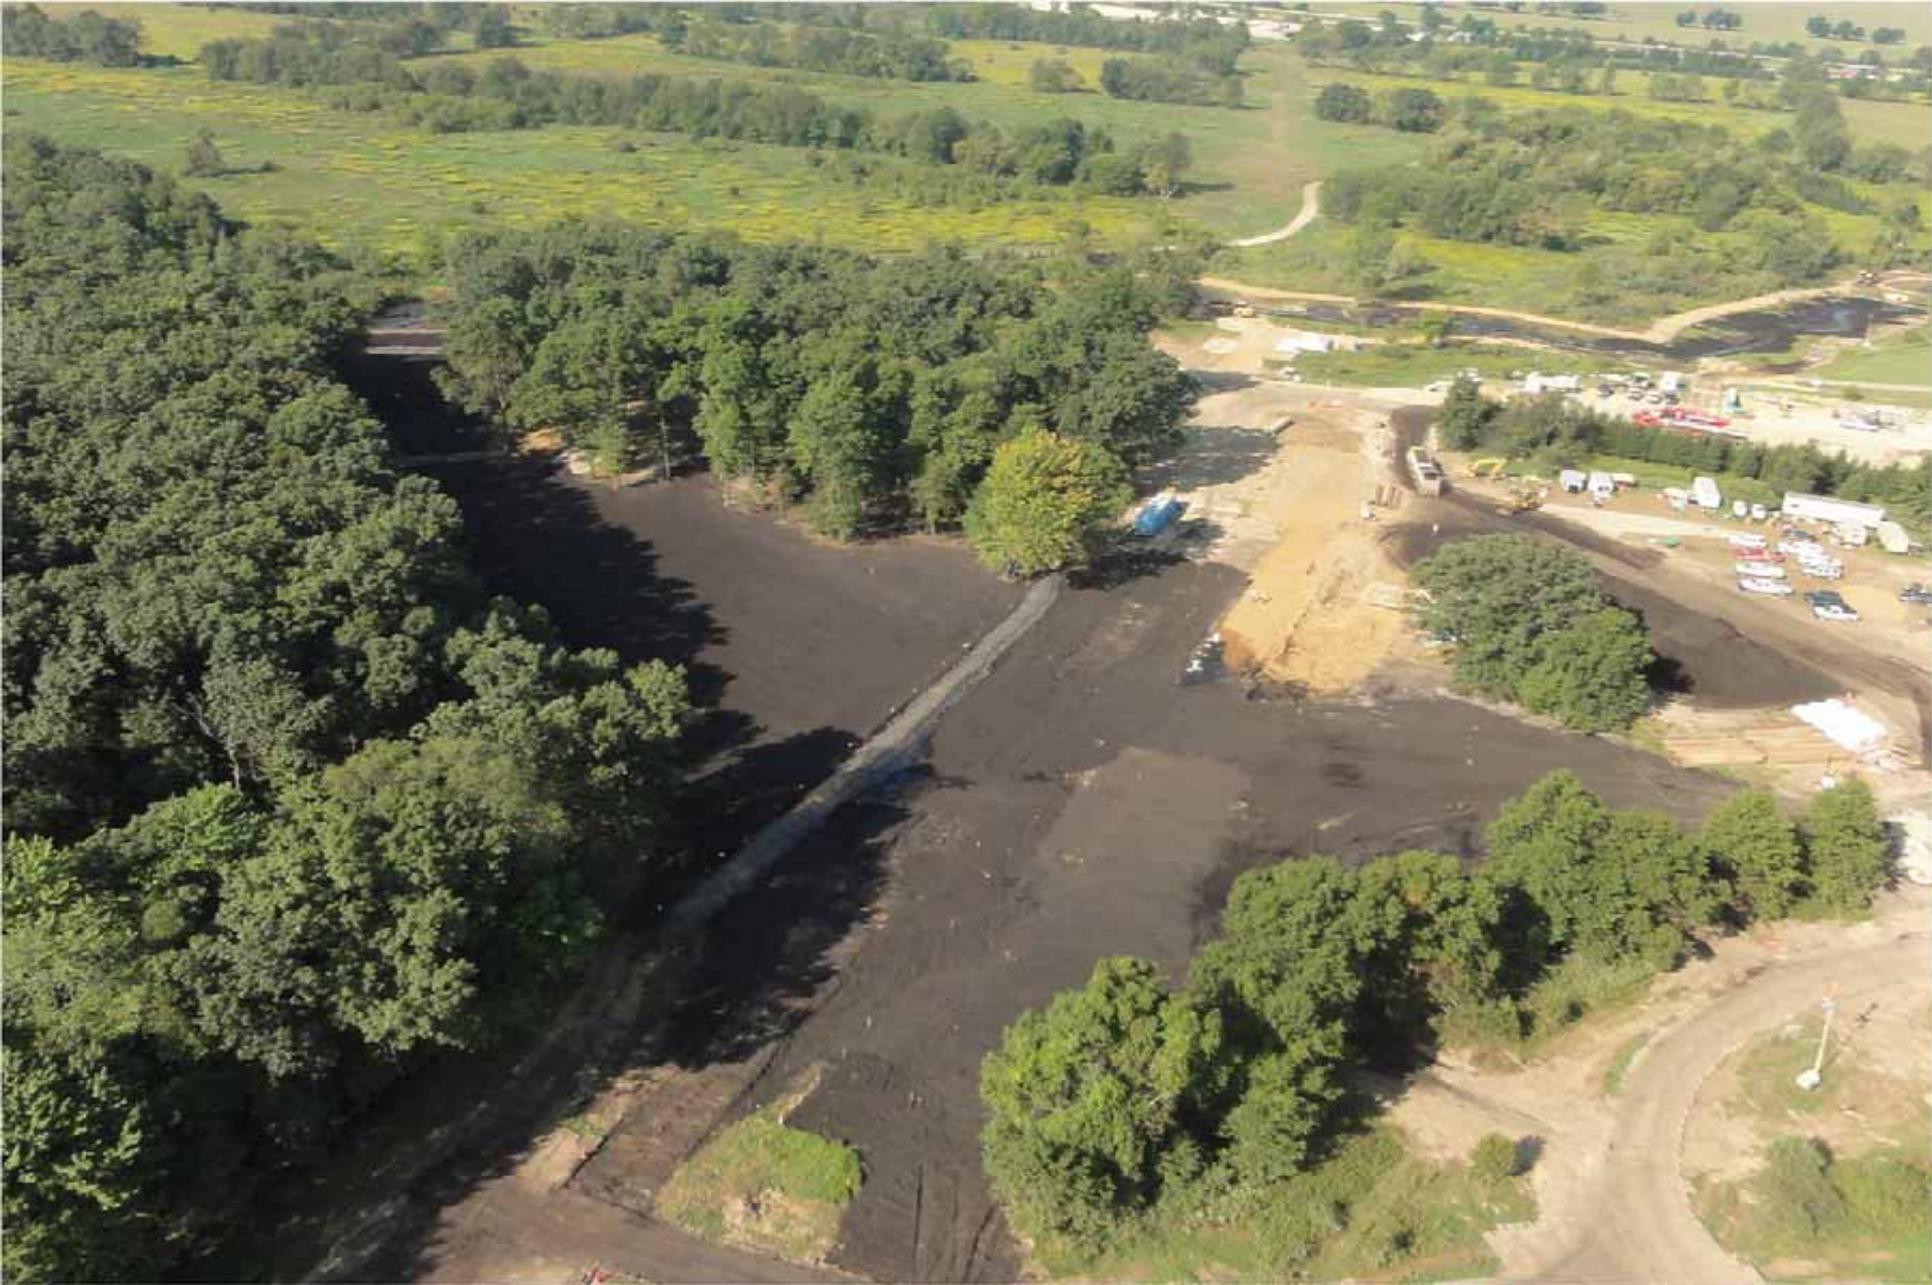
**After four weeks, contaminated land located by the pipeline break was backfilled with clean soil.**

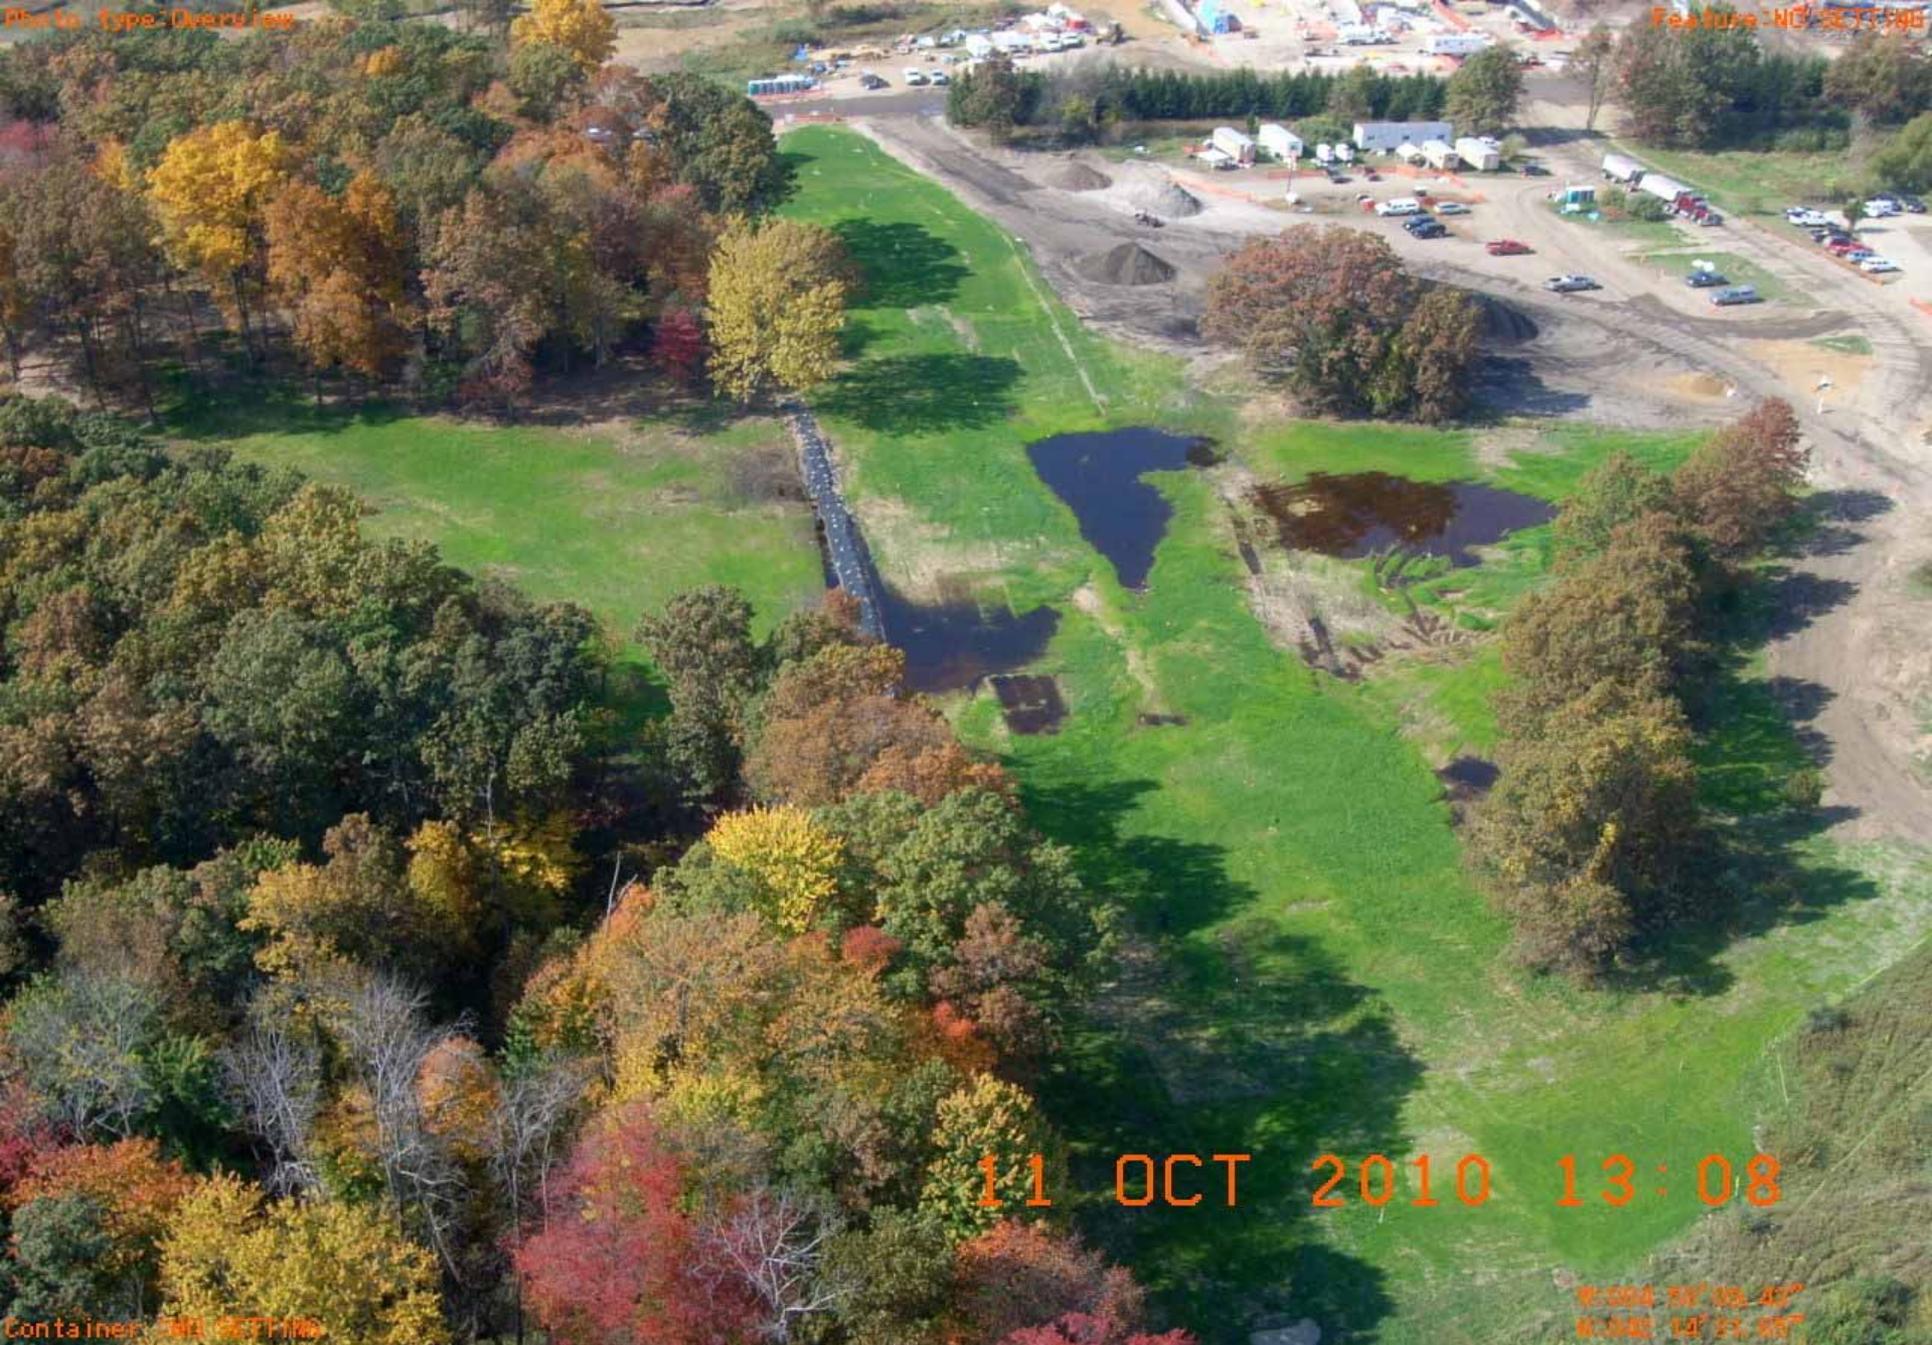
**Restored and re-vegetated pipeline break area on Oct. 11, 2010.**

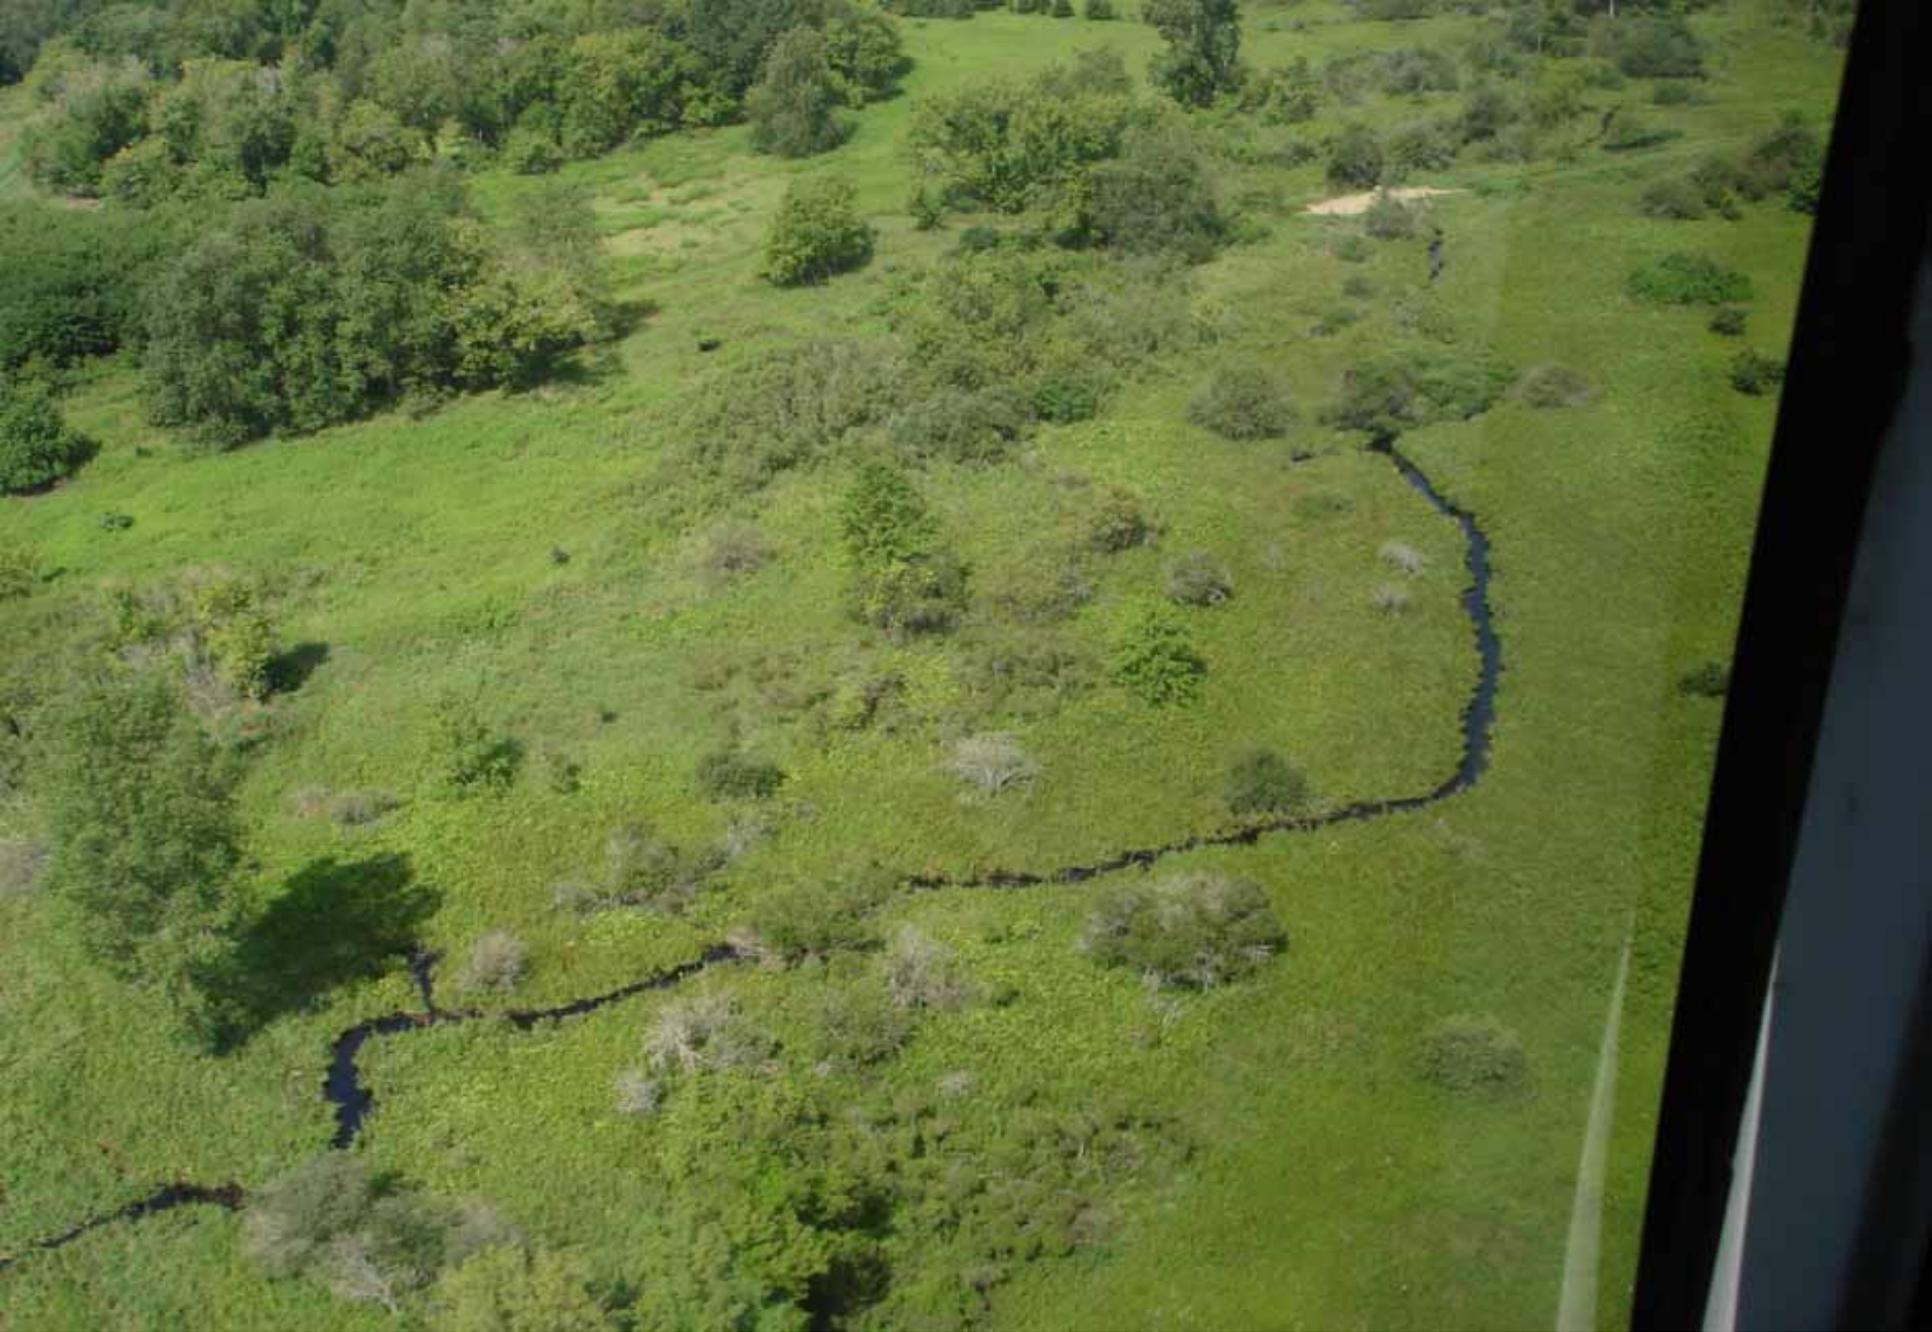
**Talmadge Creek day one: creek and floodplain completely oil-covered.**

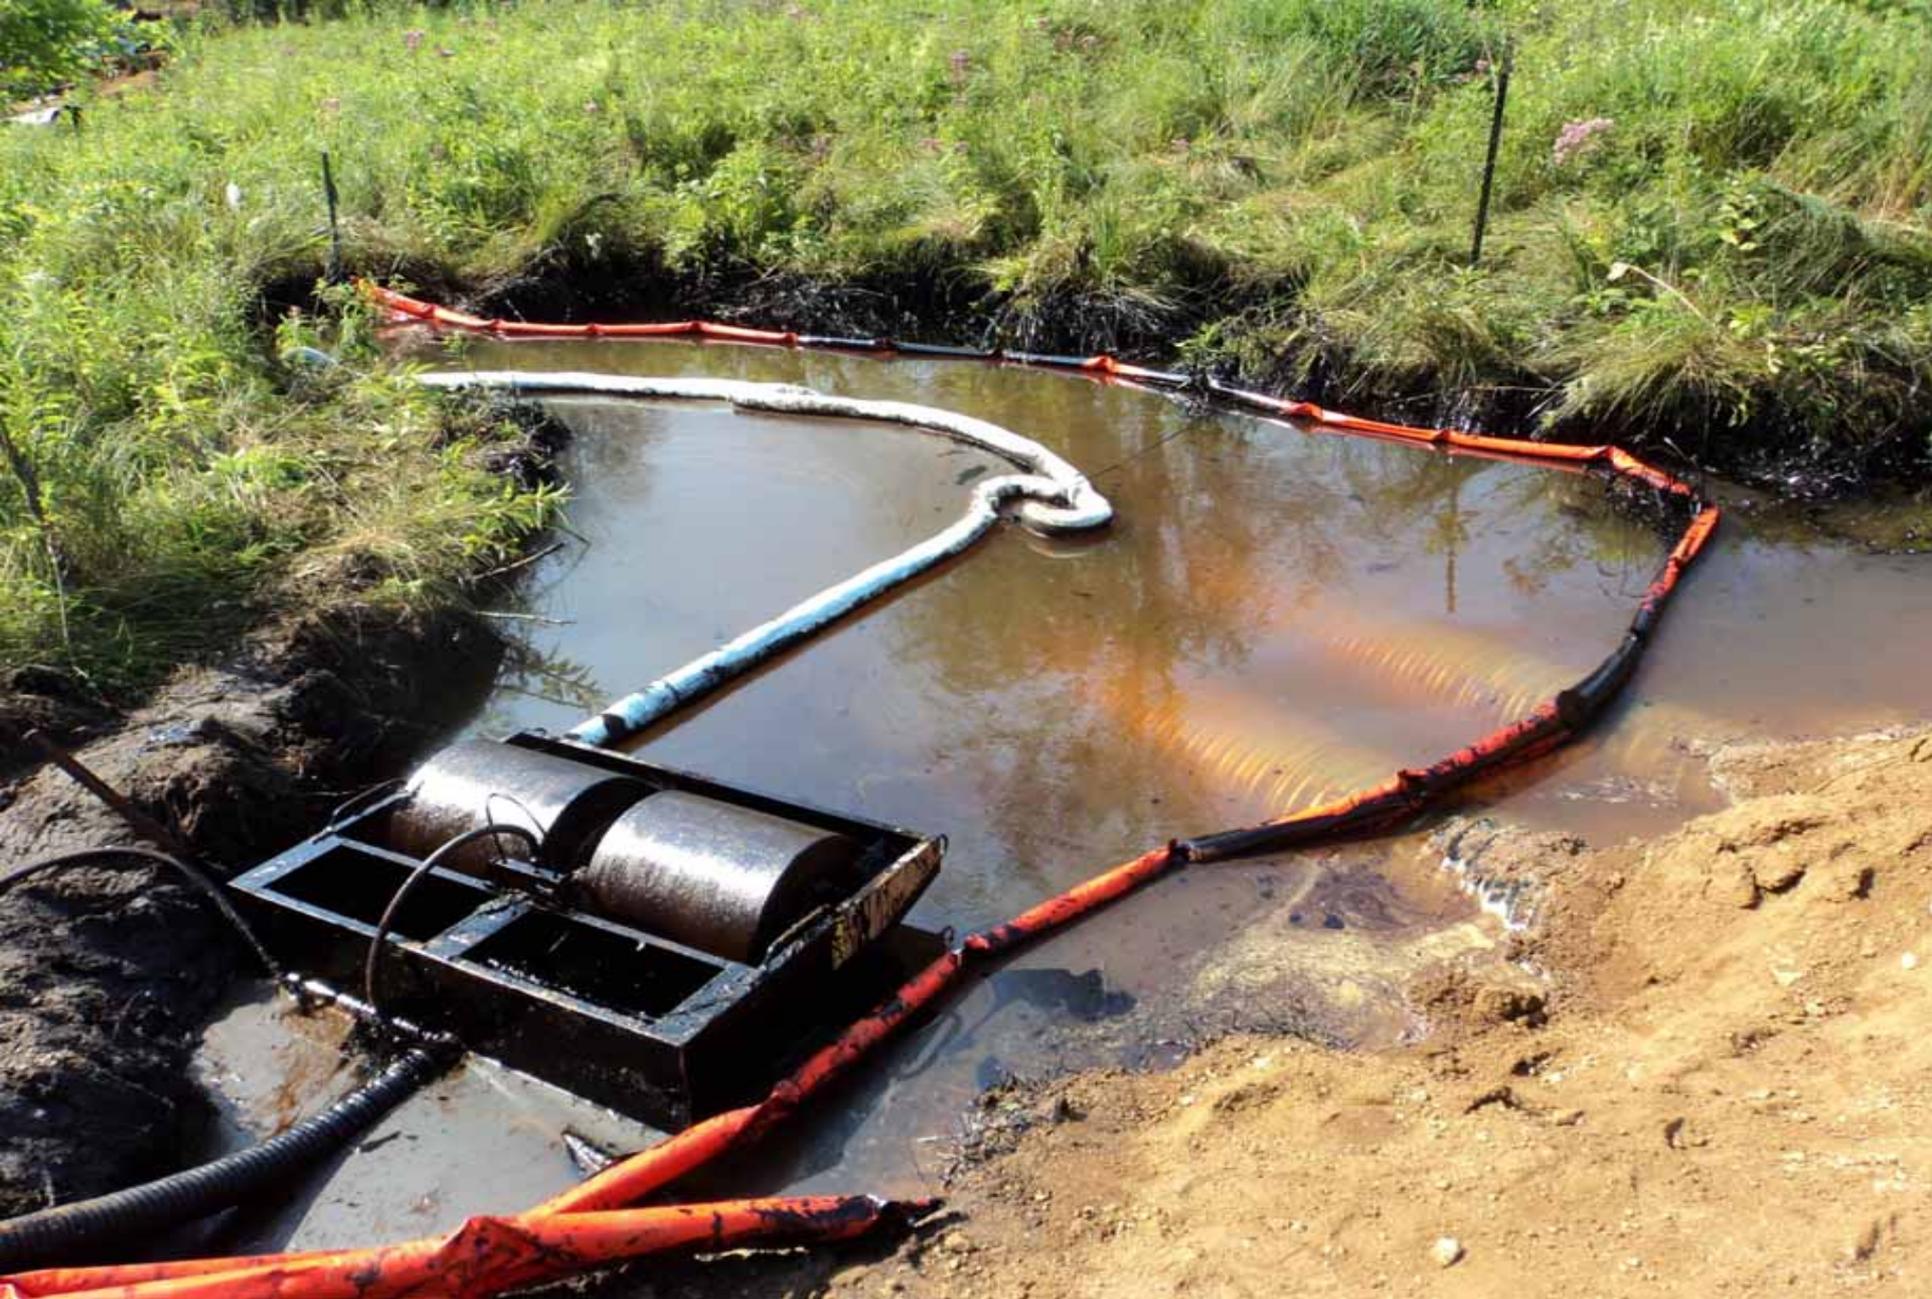
**Initial containment measure in the creek includes skimmers, containment booms, and siphon dams.**

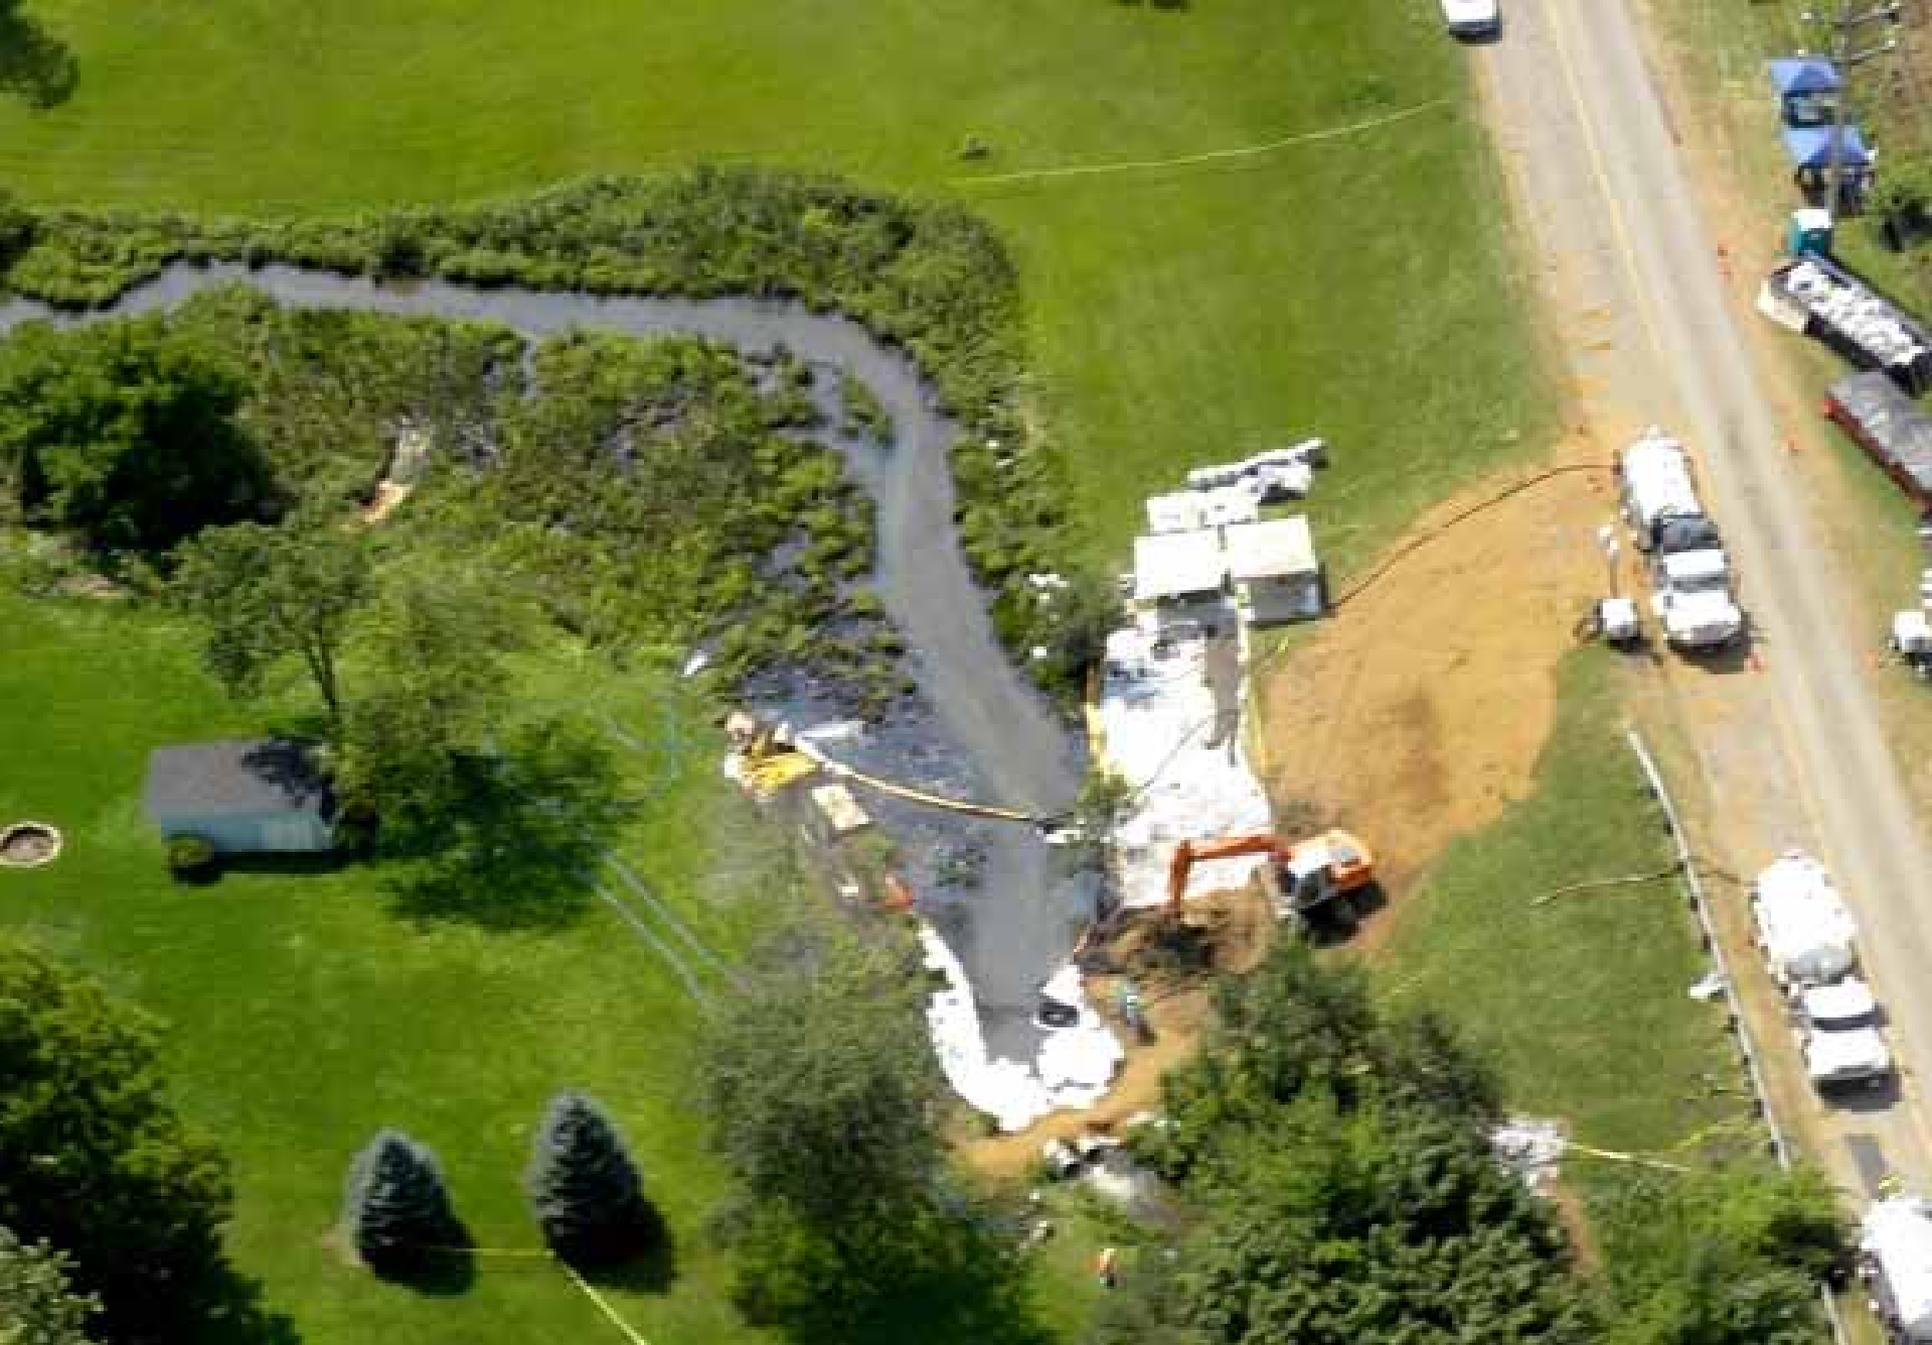
**Surface water was reduced to heavy sheen by the end of the response's first week.**

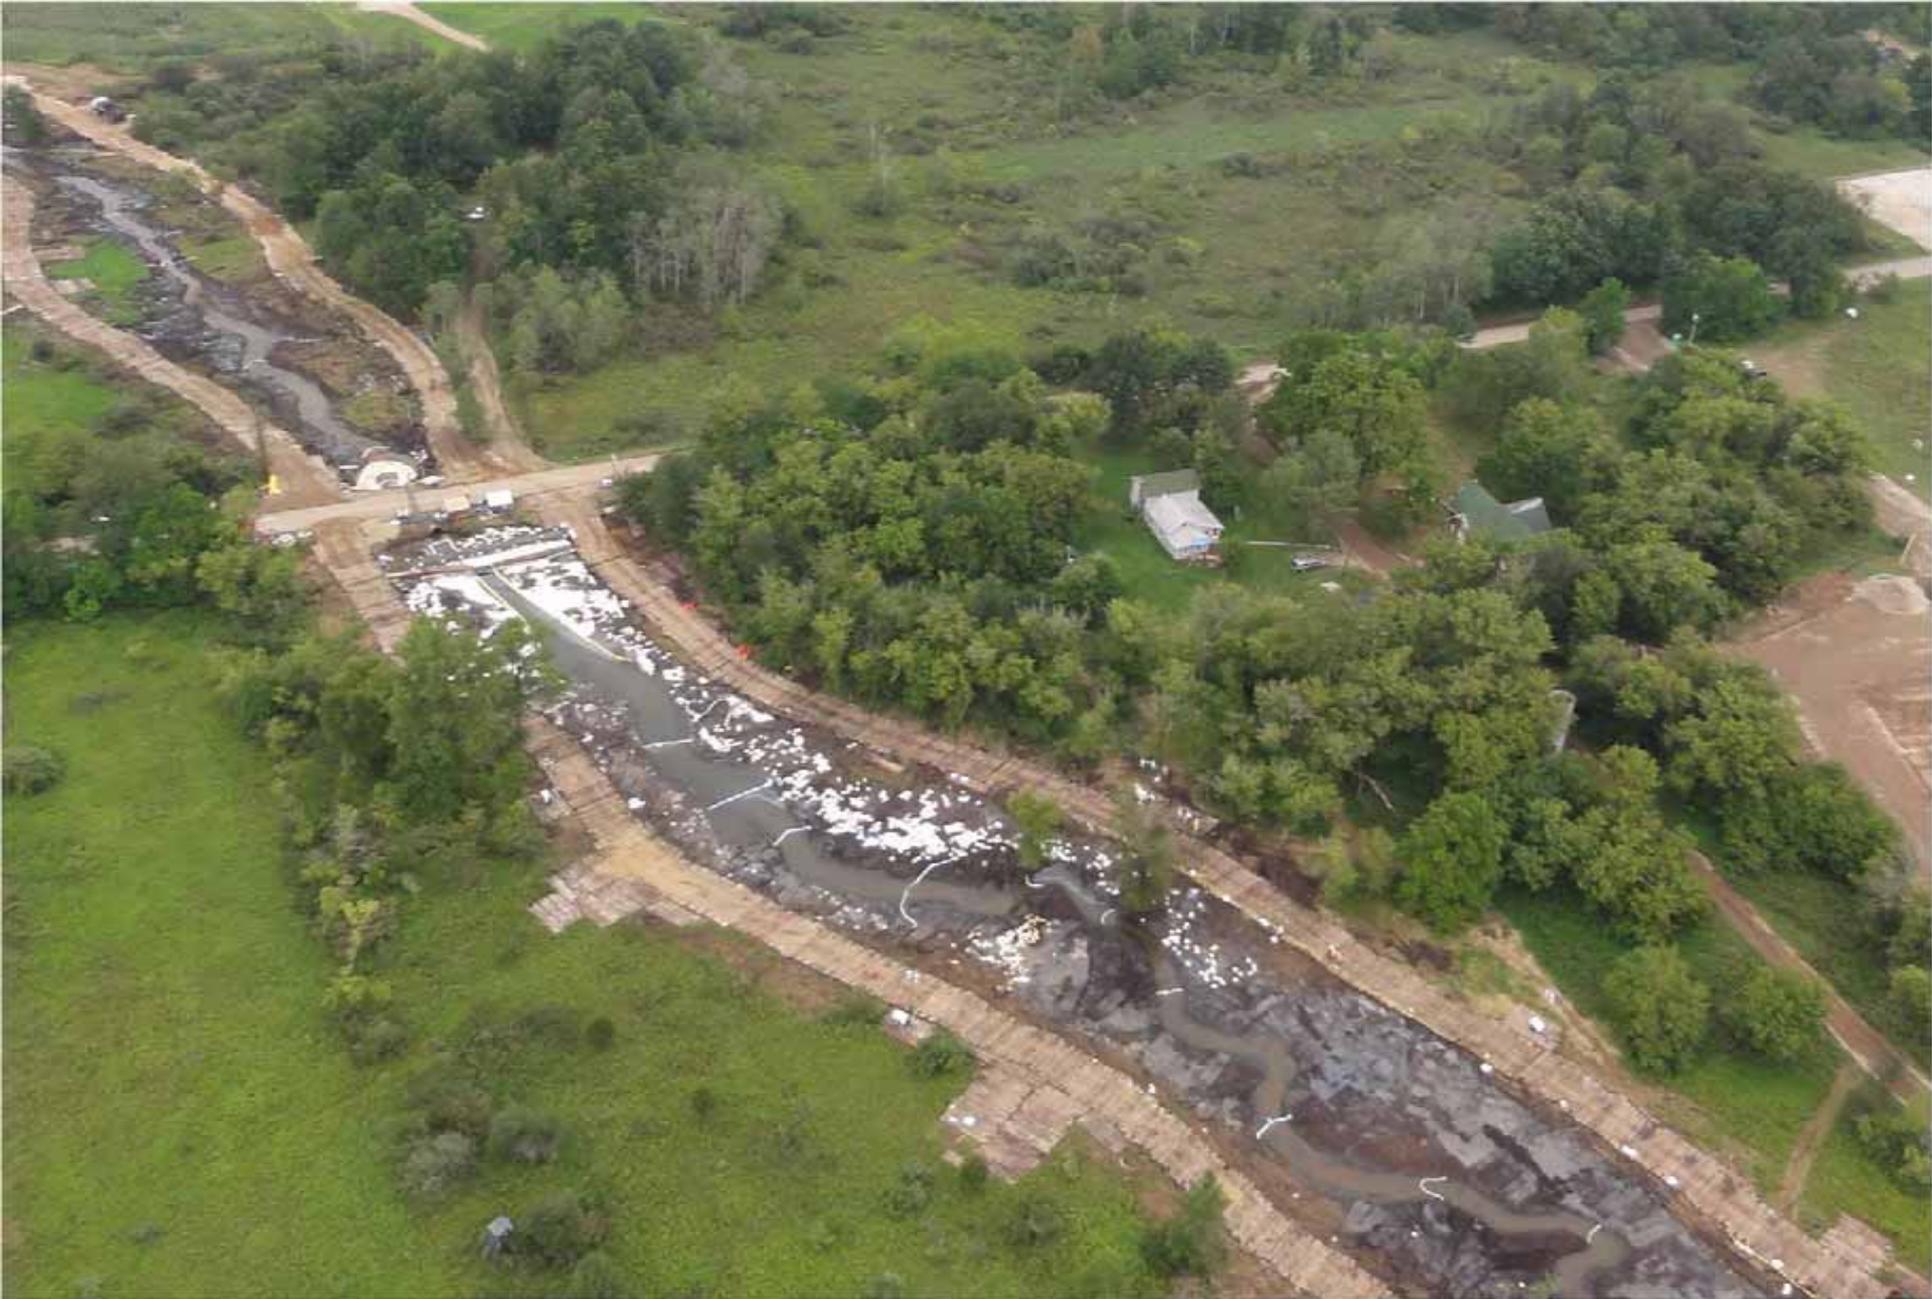
**To access the creek in order to remove contaminated soil, swamp mat roads were established. Note white oil pads placed to absorb oil.**
