Appendix A: Photographs of the Areas Impacted by the Enbridge Line 6B Oil  
Discharges and of Response Actions  
from U.S. EPA presentations in 2010 and 2015

# Enbridge Line 6B Incident

## Public Update and Availability Session

October 14, 2010  
(Day 81)

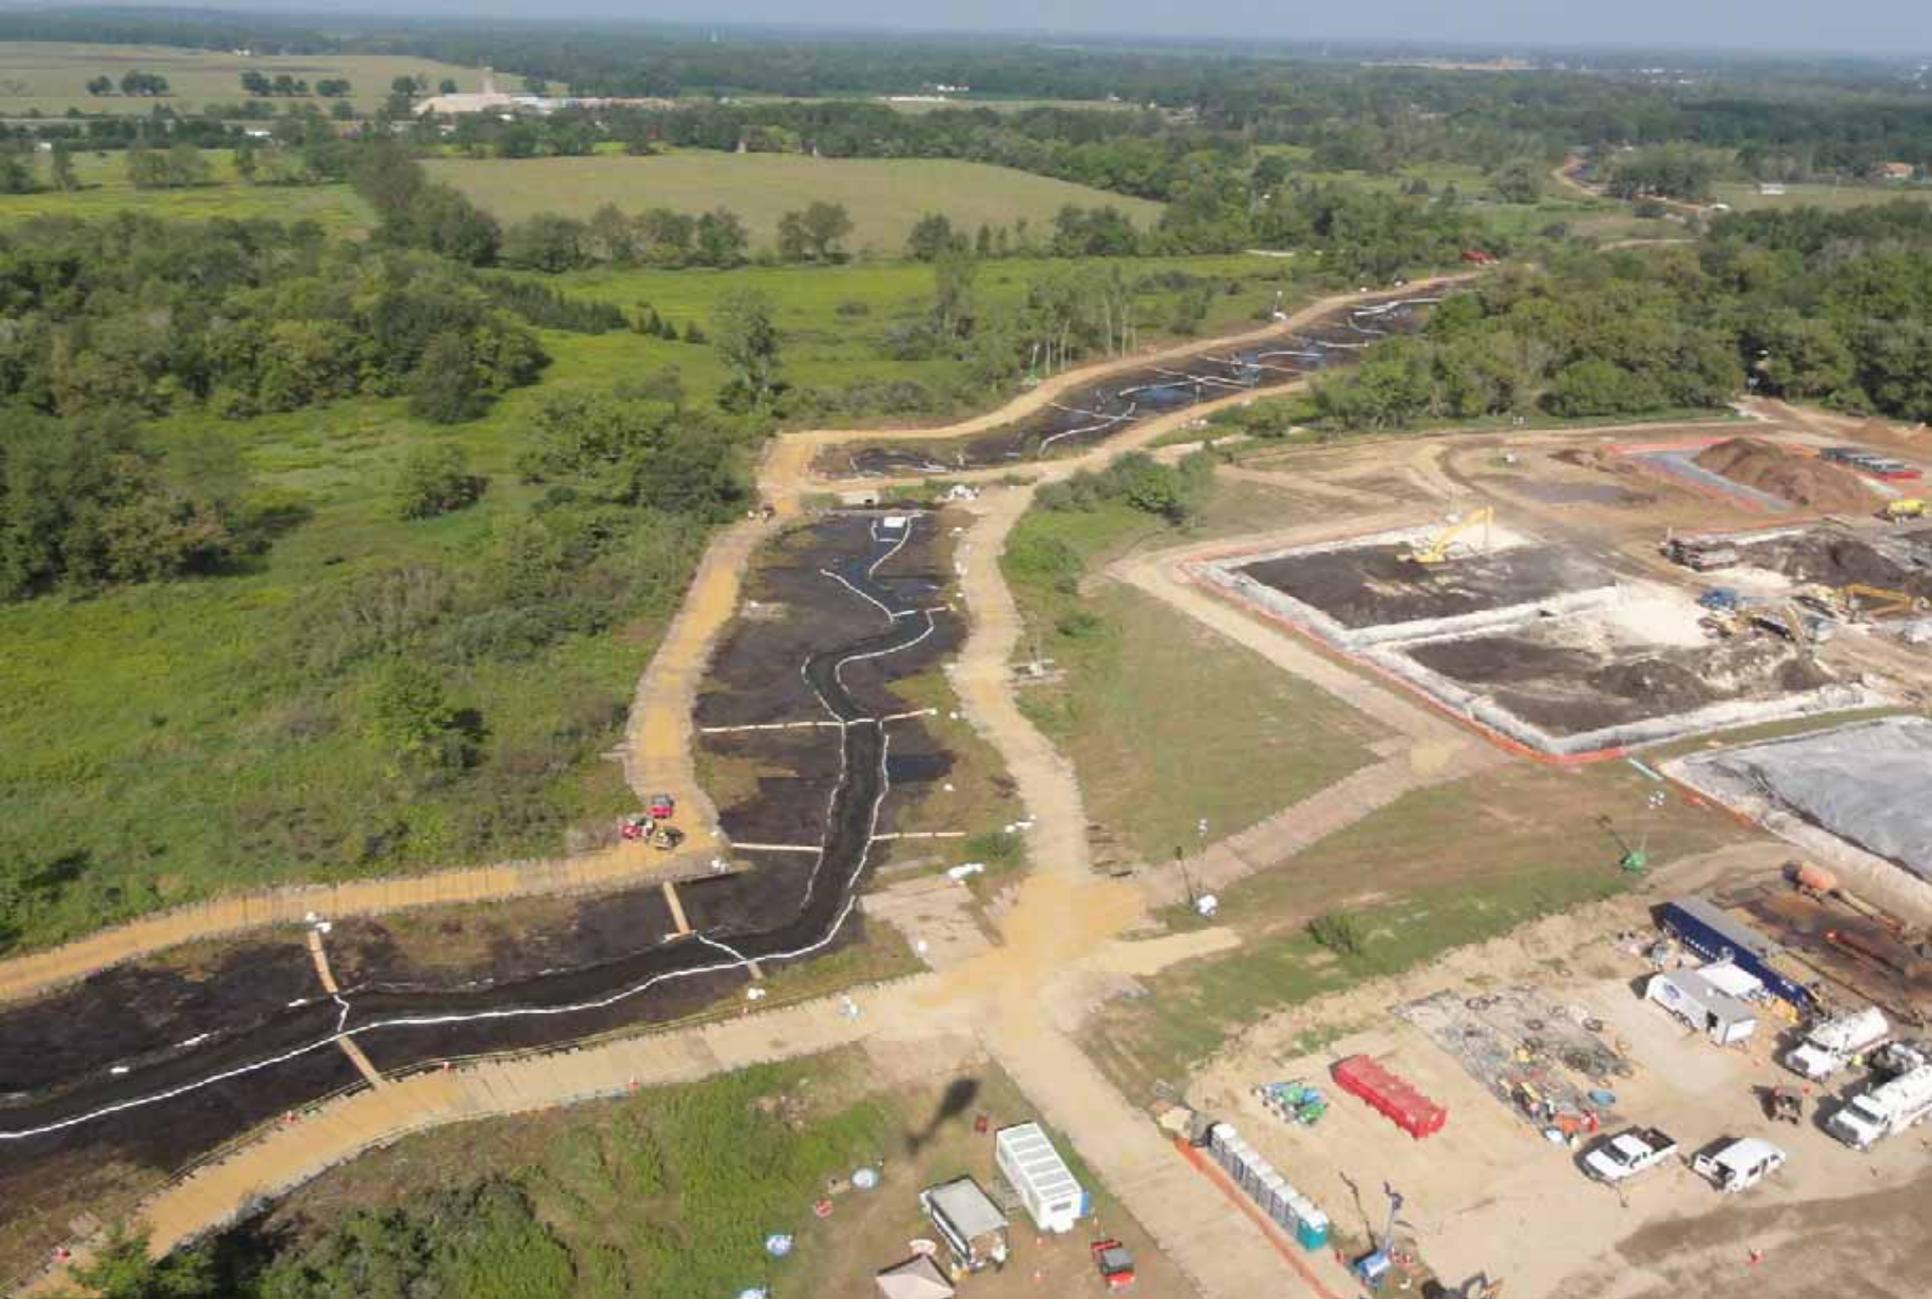
**Talmadge Creek after soil scrapping was completed. Contaminated soil staging pads visible on the right side of the picture.**

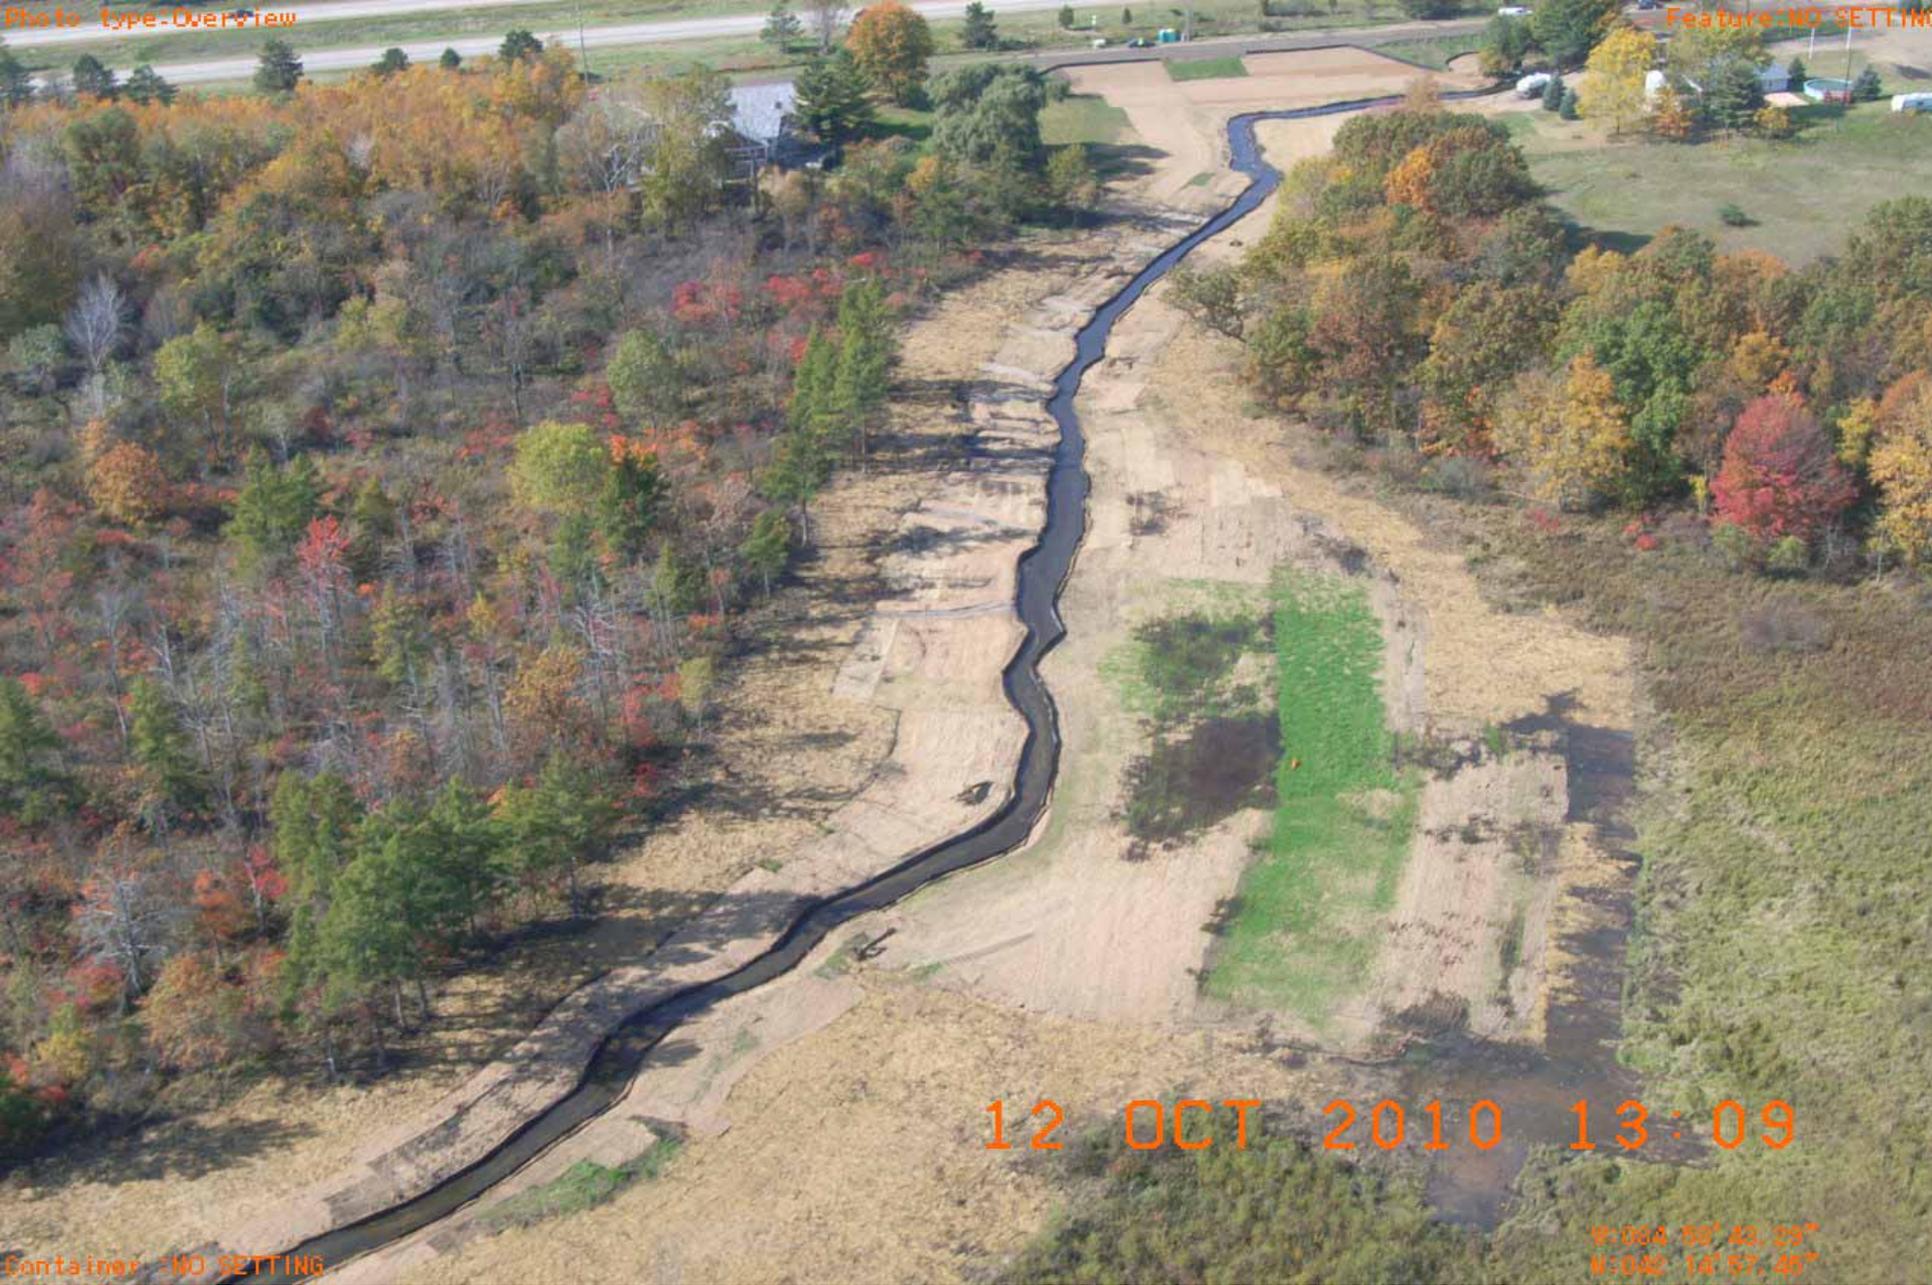
**Talmadge Creek following restoration, which included soil backfilling, coconut matting, vegetation seeding, and silt fencing.**

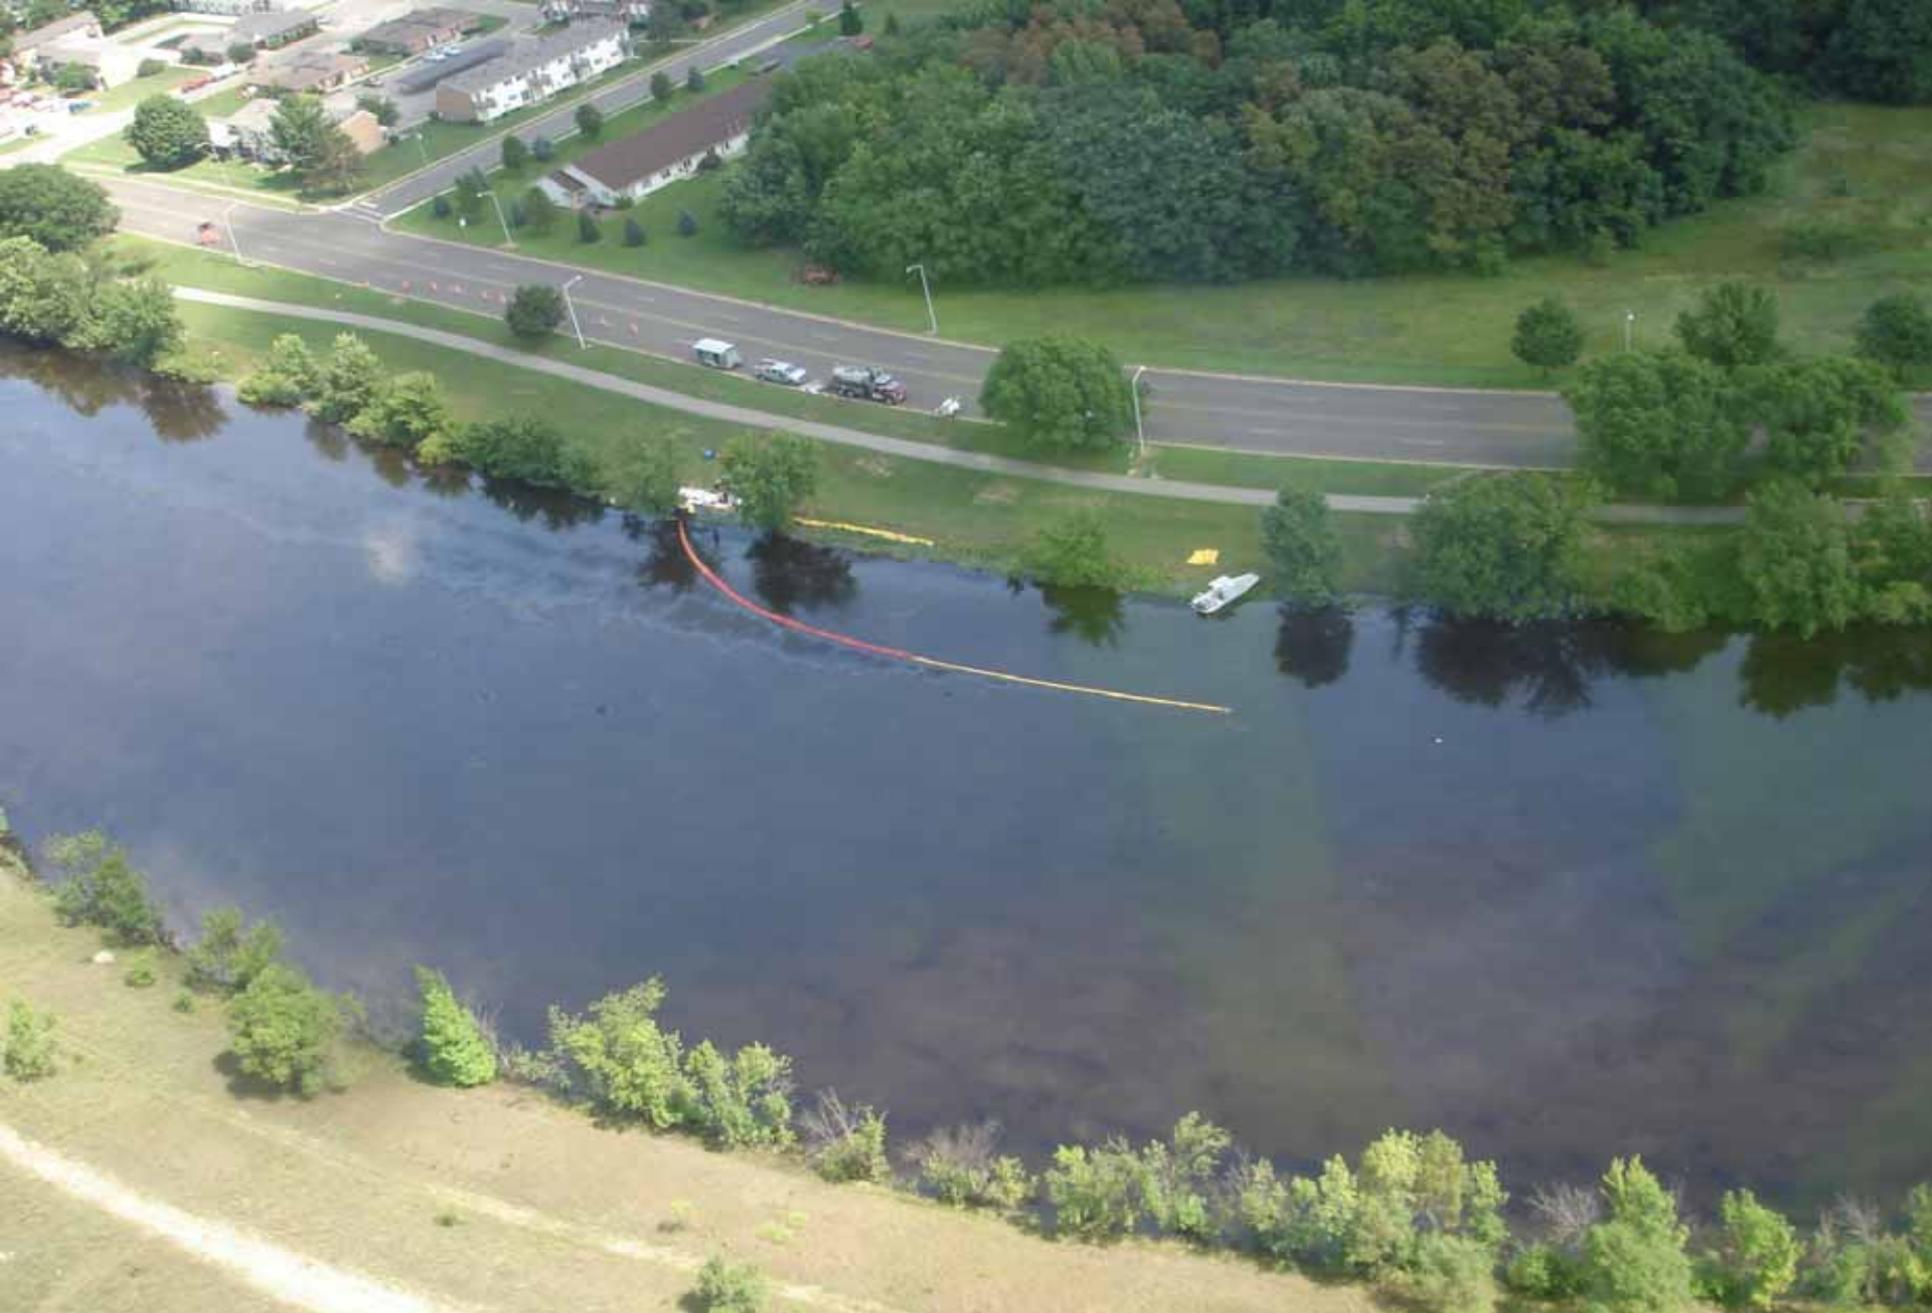
**Kalamazoo River on July 26, 2010, day one of the response: oil covered the river from bank to bank.**

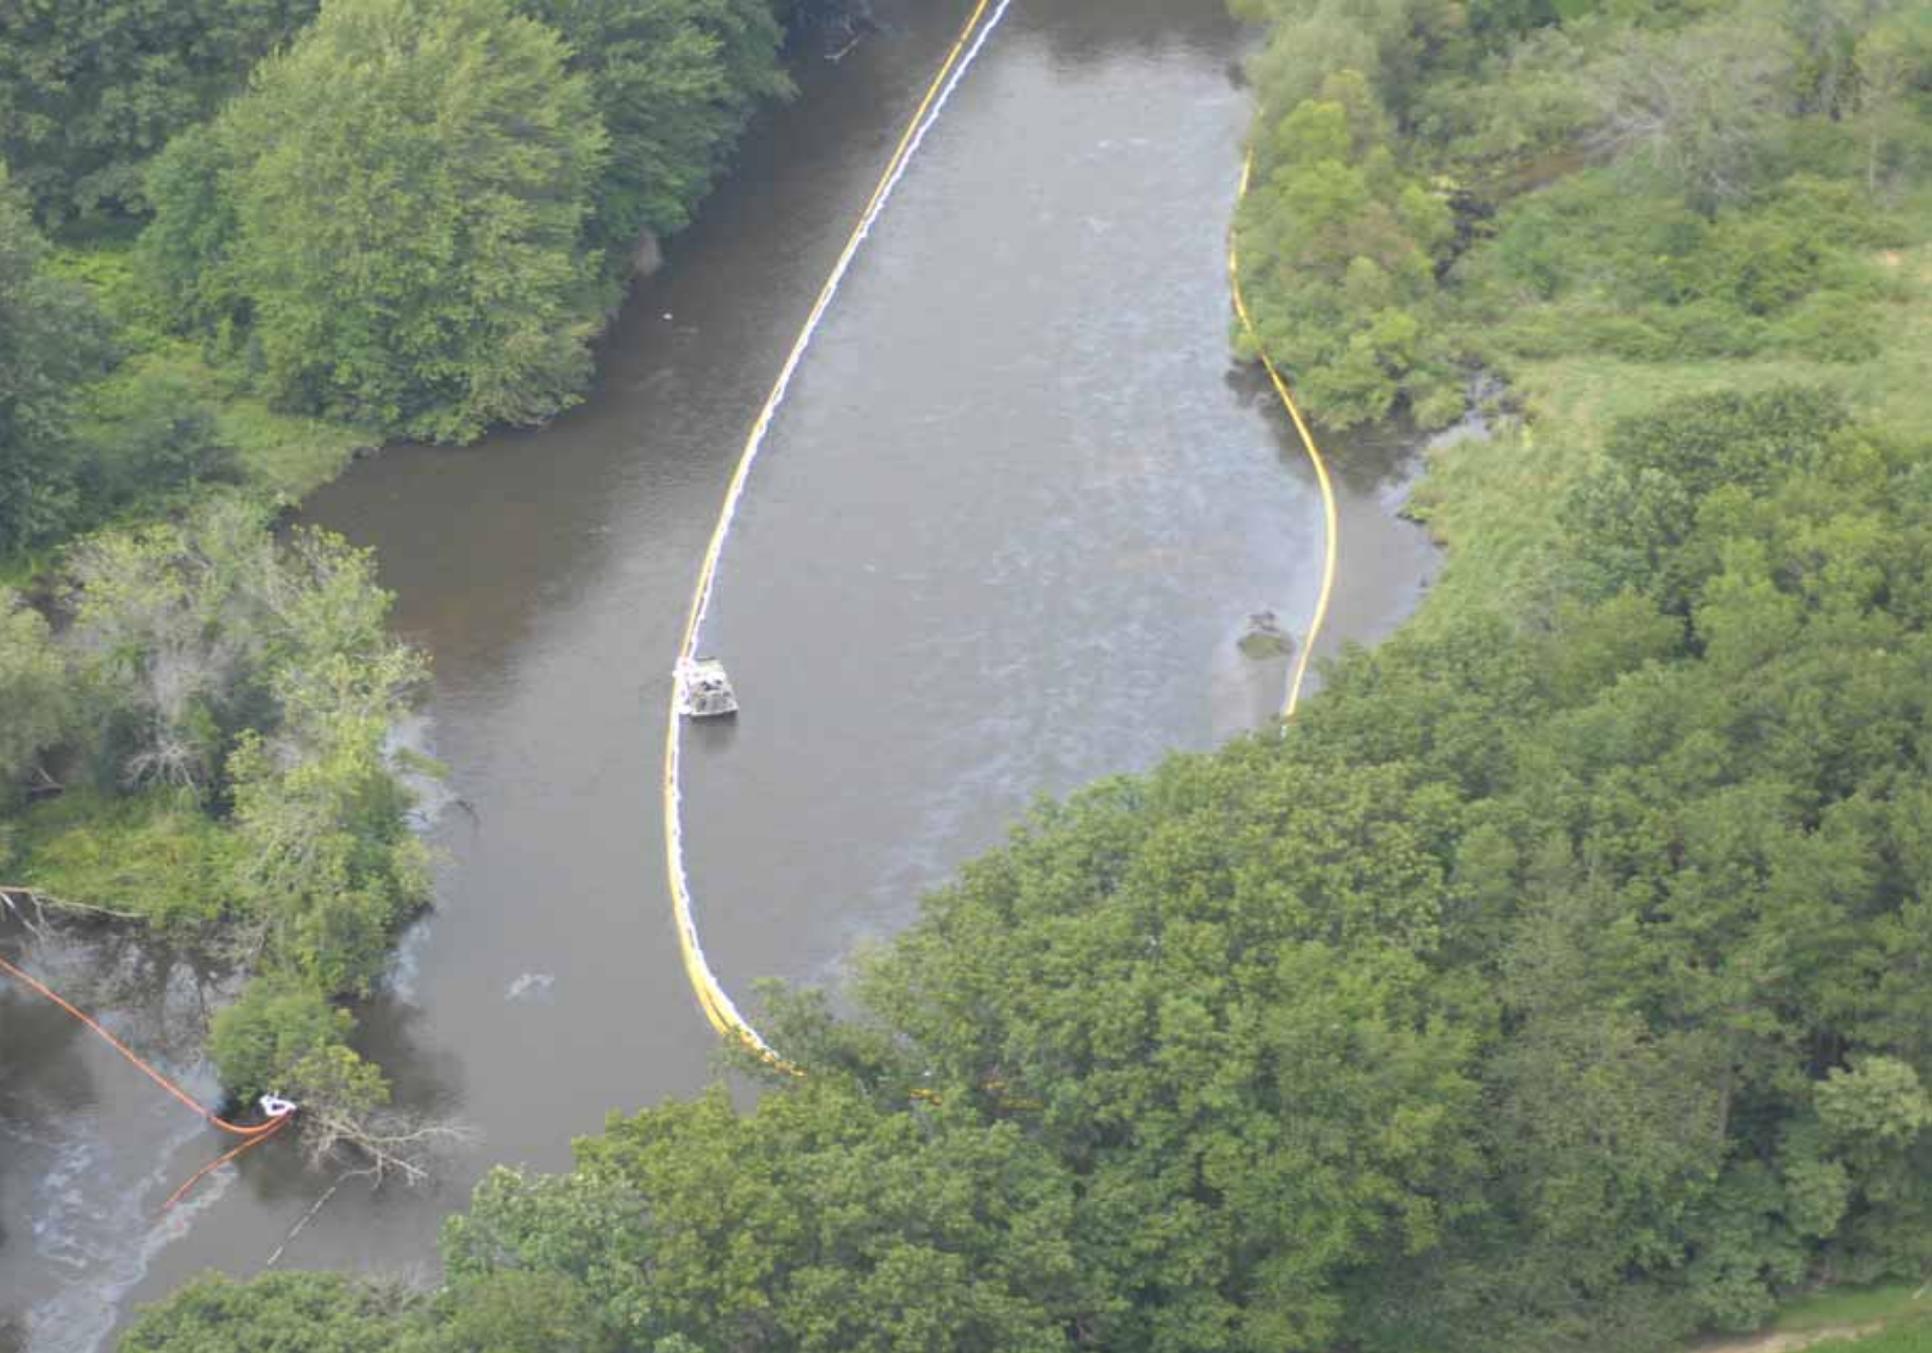
**Within one week, presence of heavy oil reduced to a sheen.**

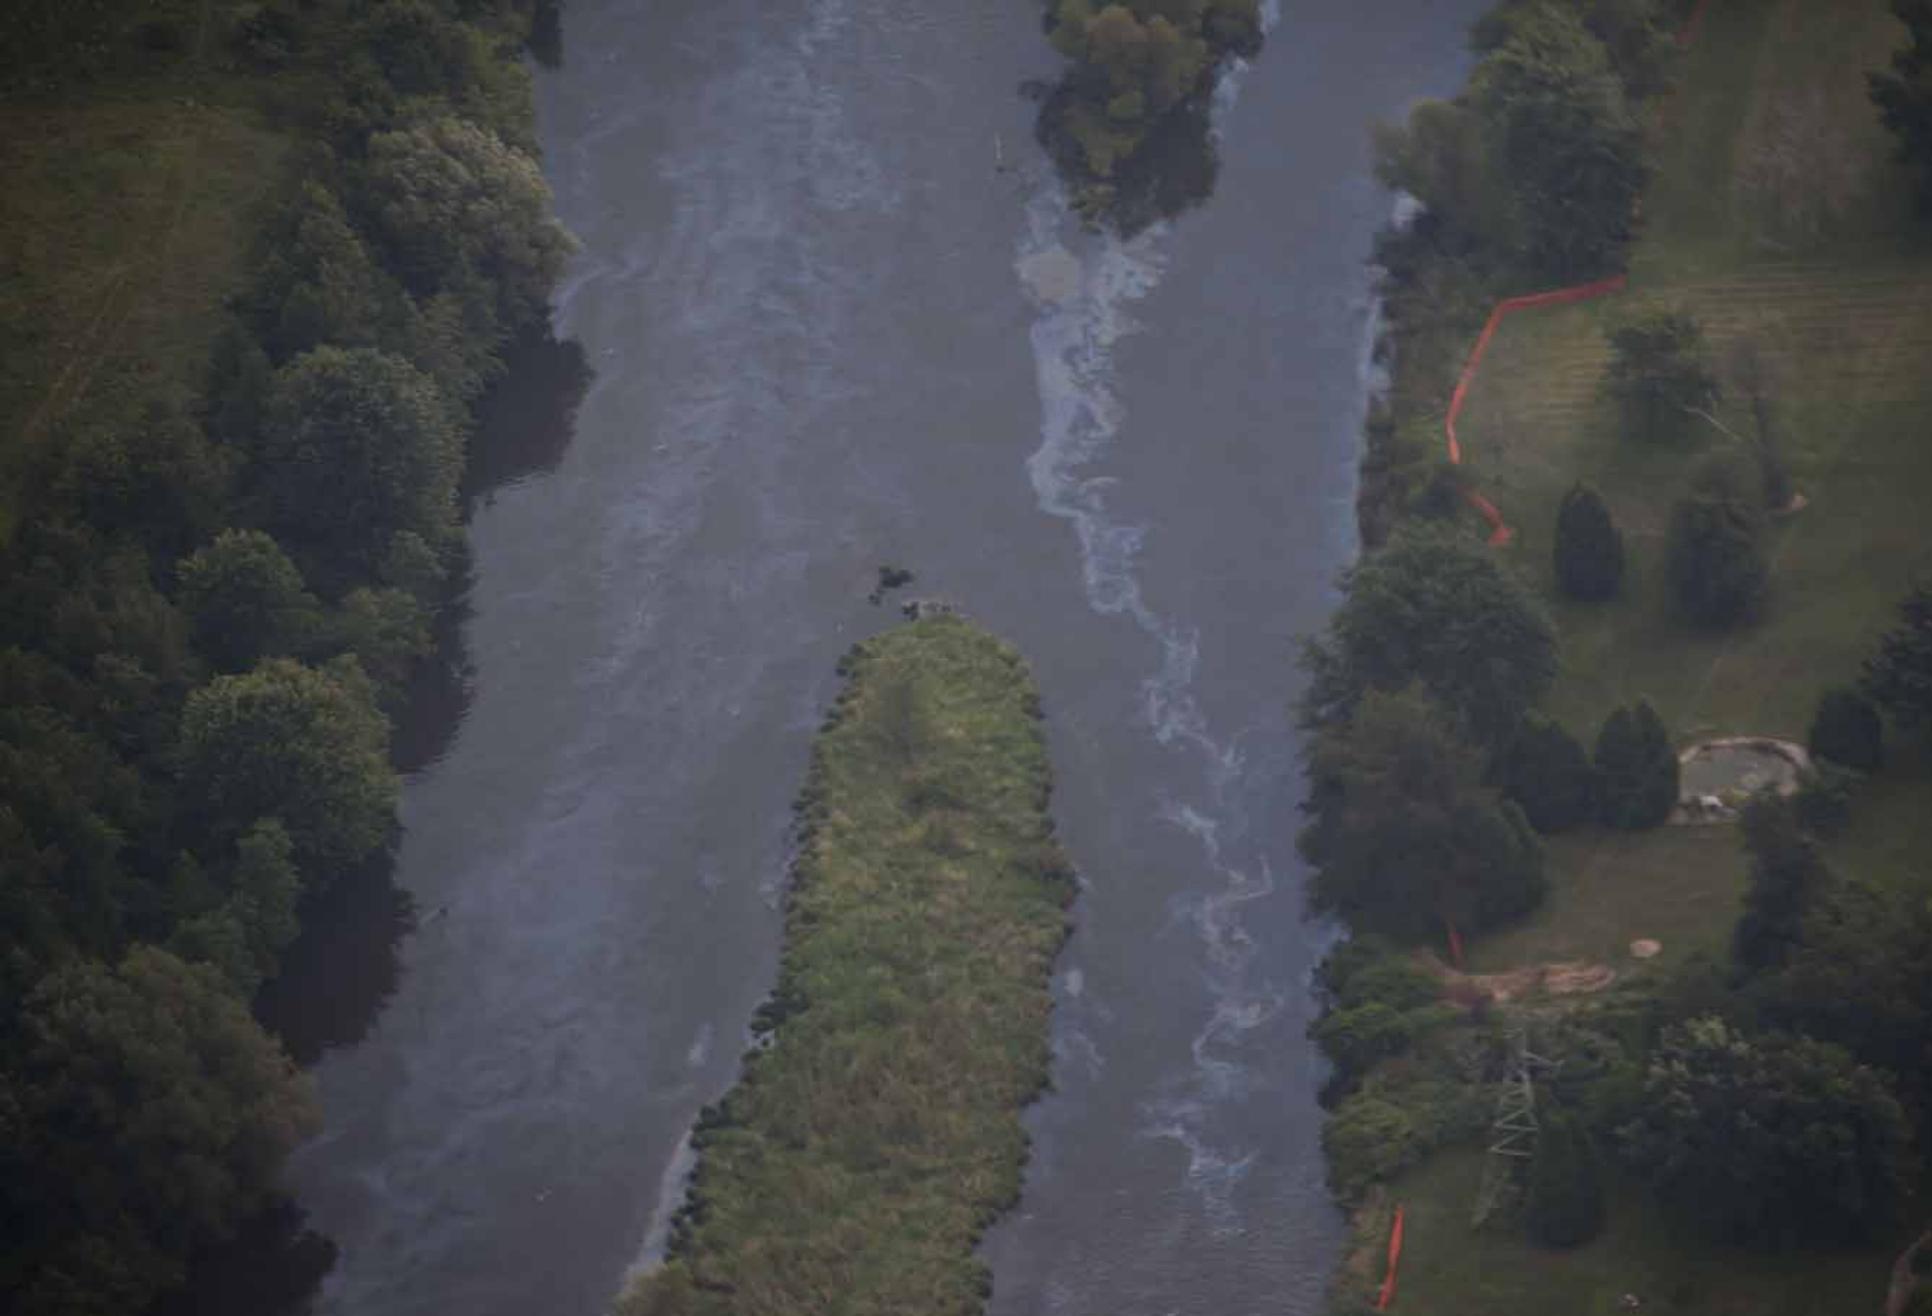
**In August 2010, most sheen production came from contaminated vegetation on the riverbanks and islands.**

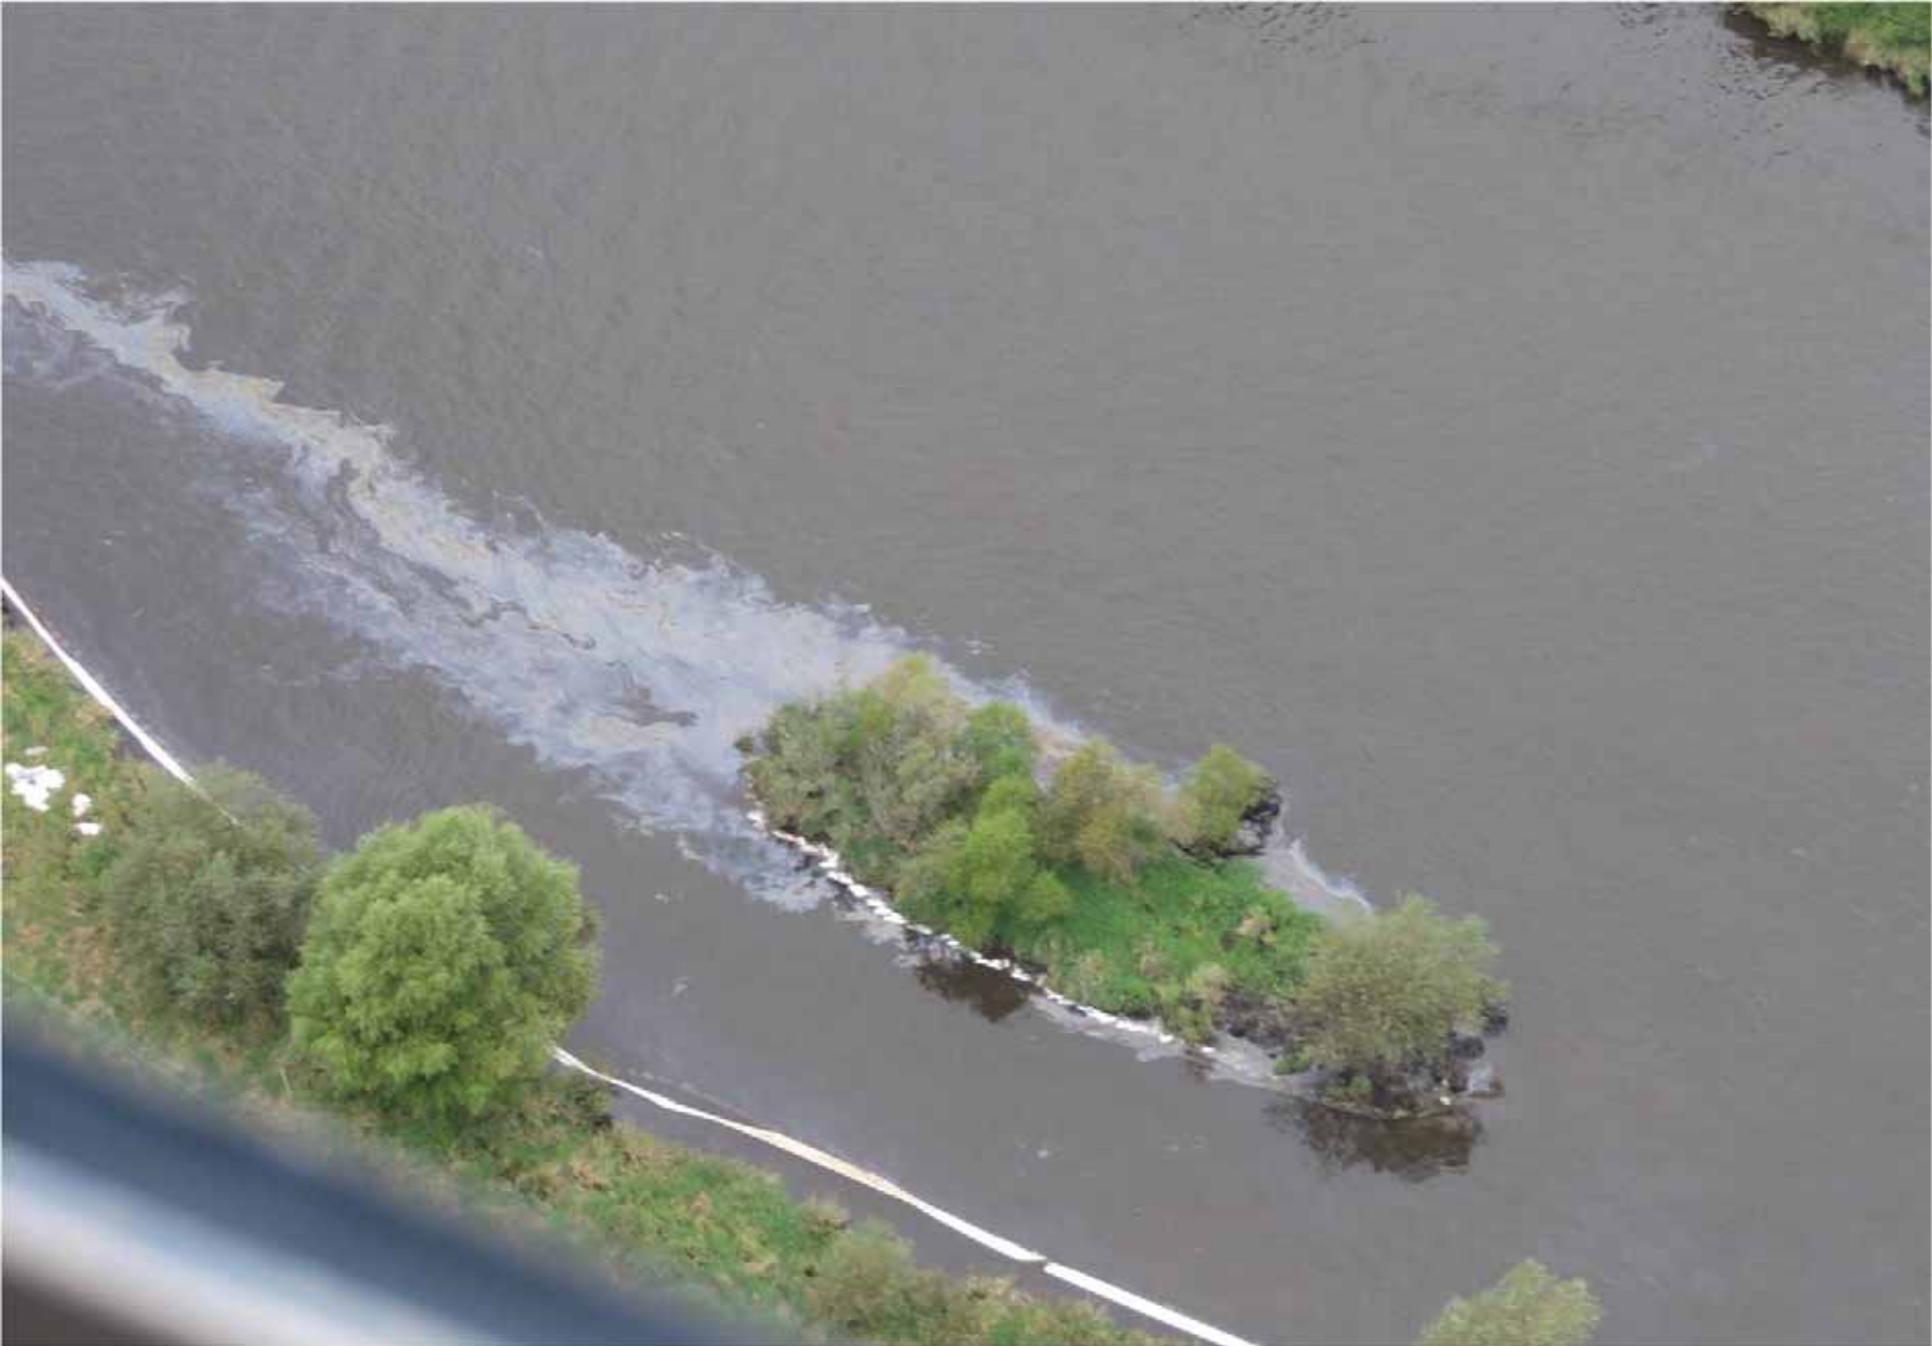
**Example of sheening during week two and three of the response.**

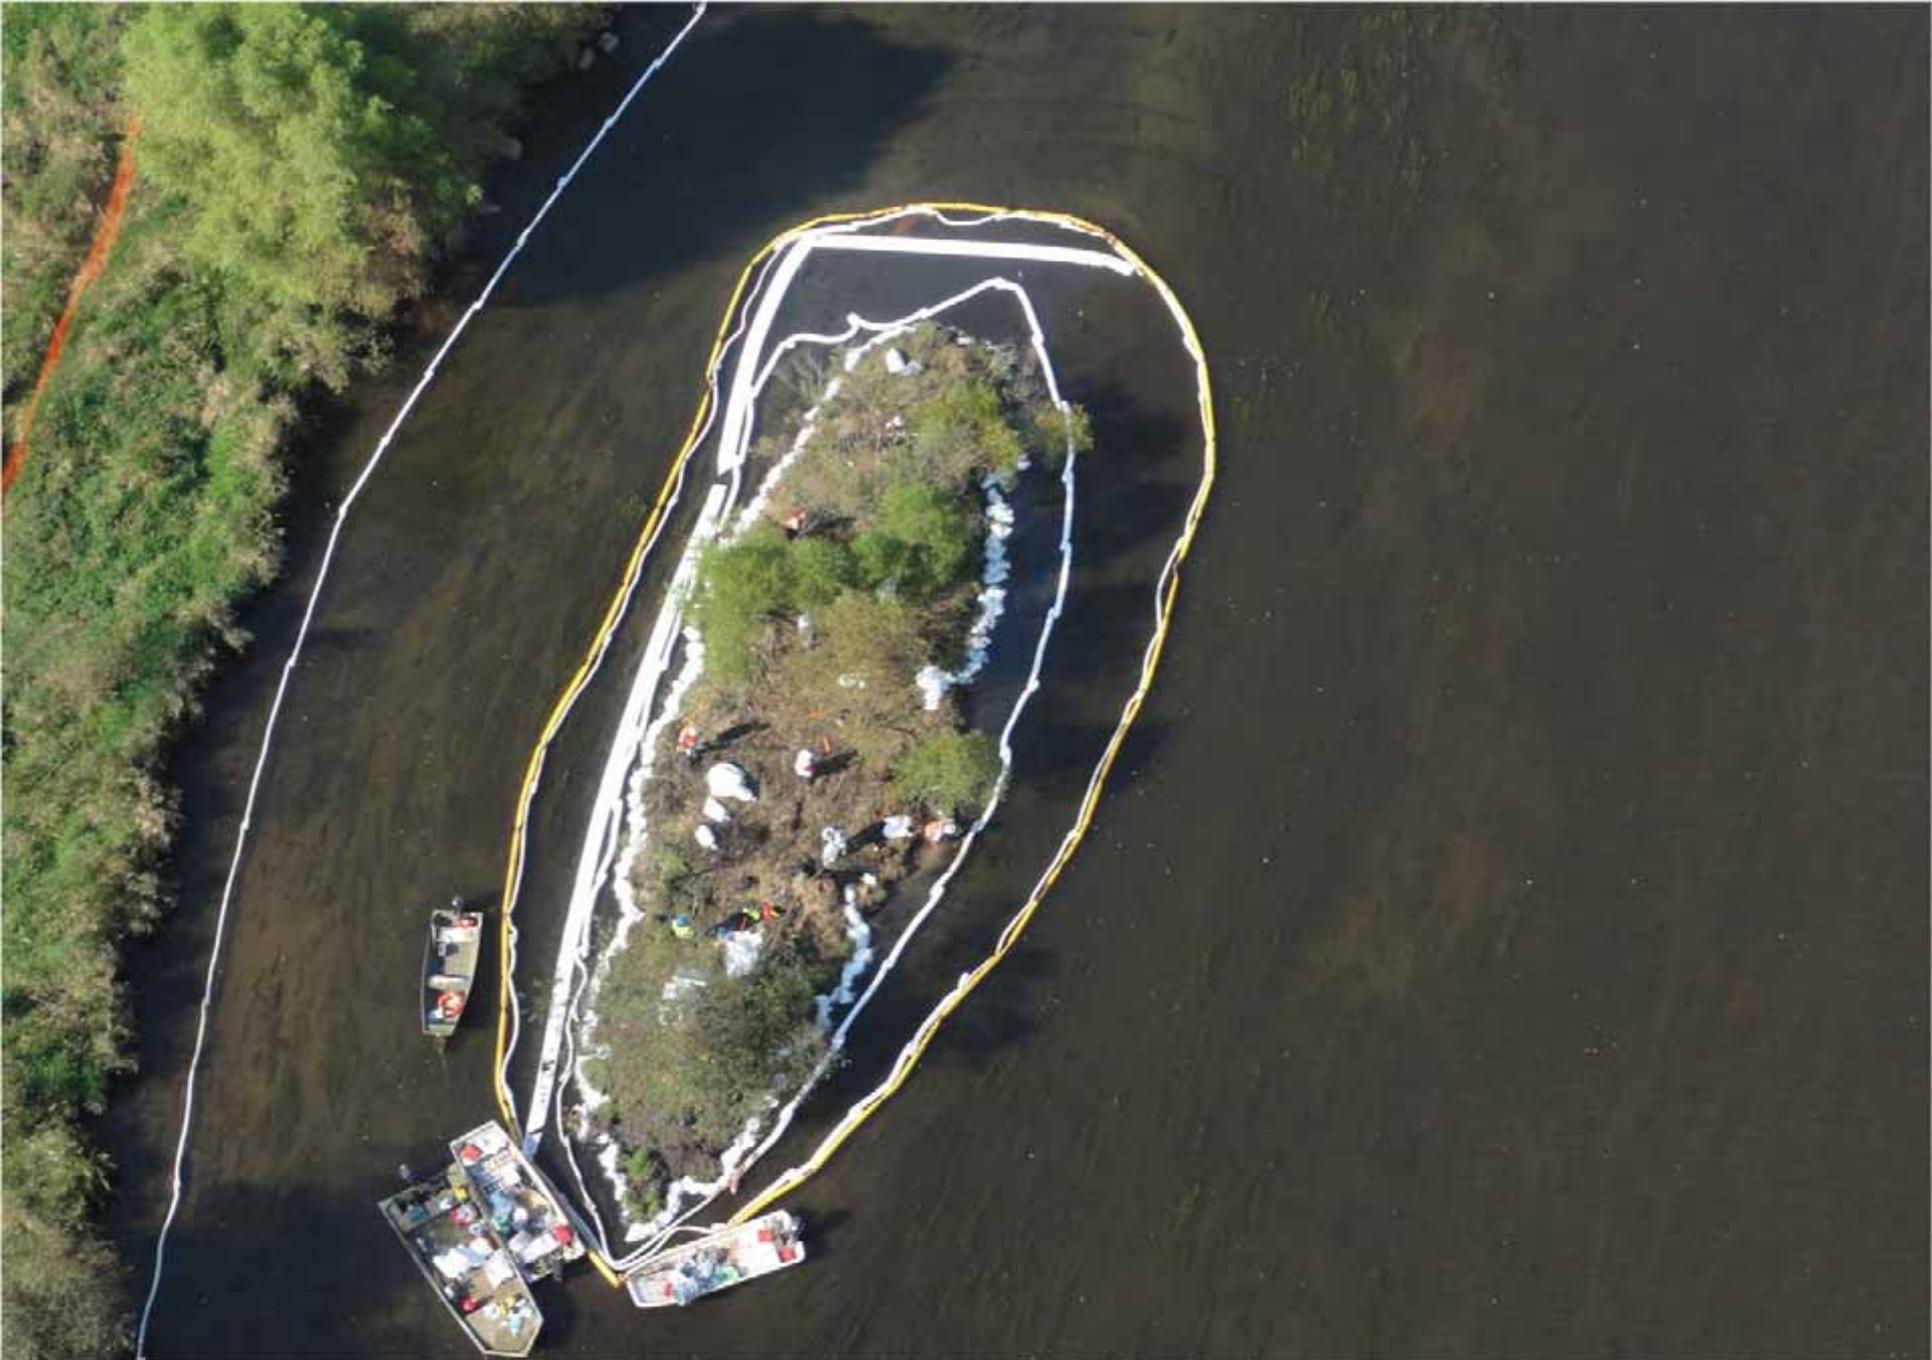
**By mid-August, all contaminated islands were contained.**

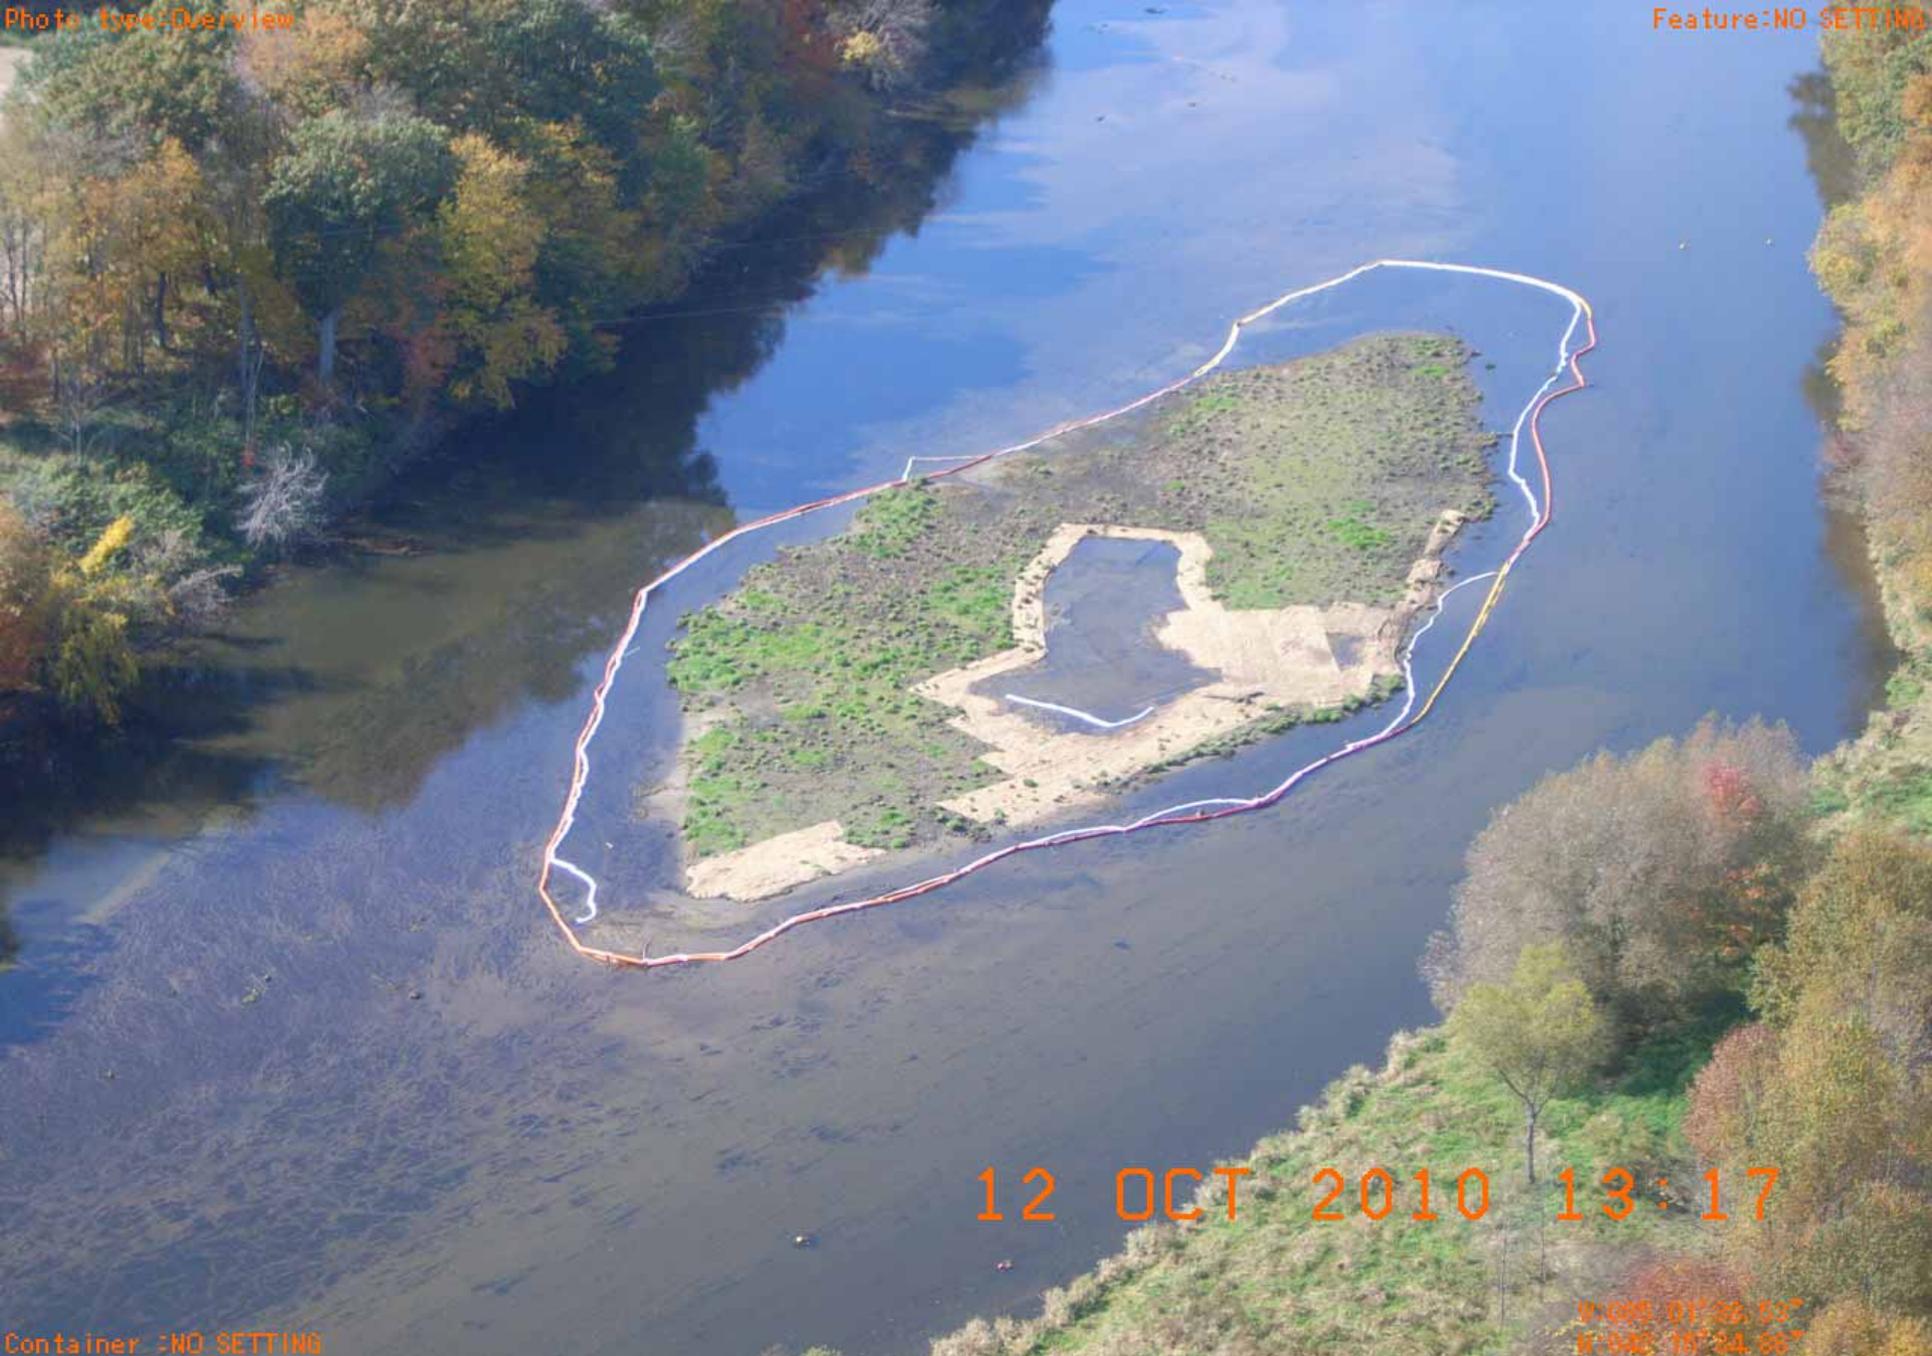
**Some islands required soil removal.**

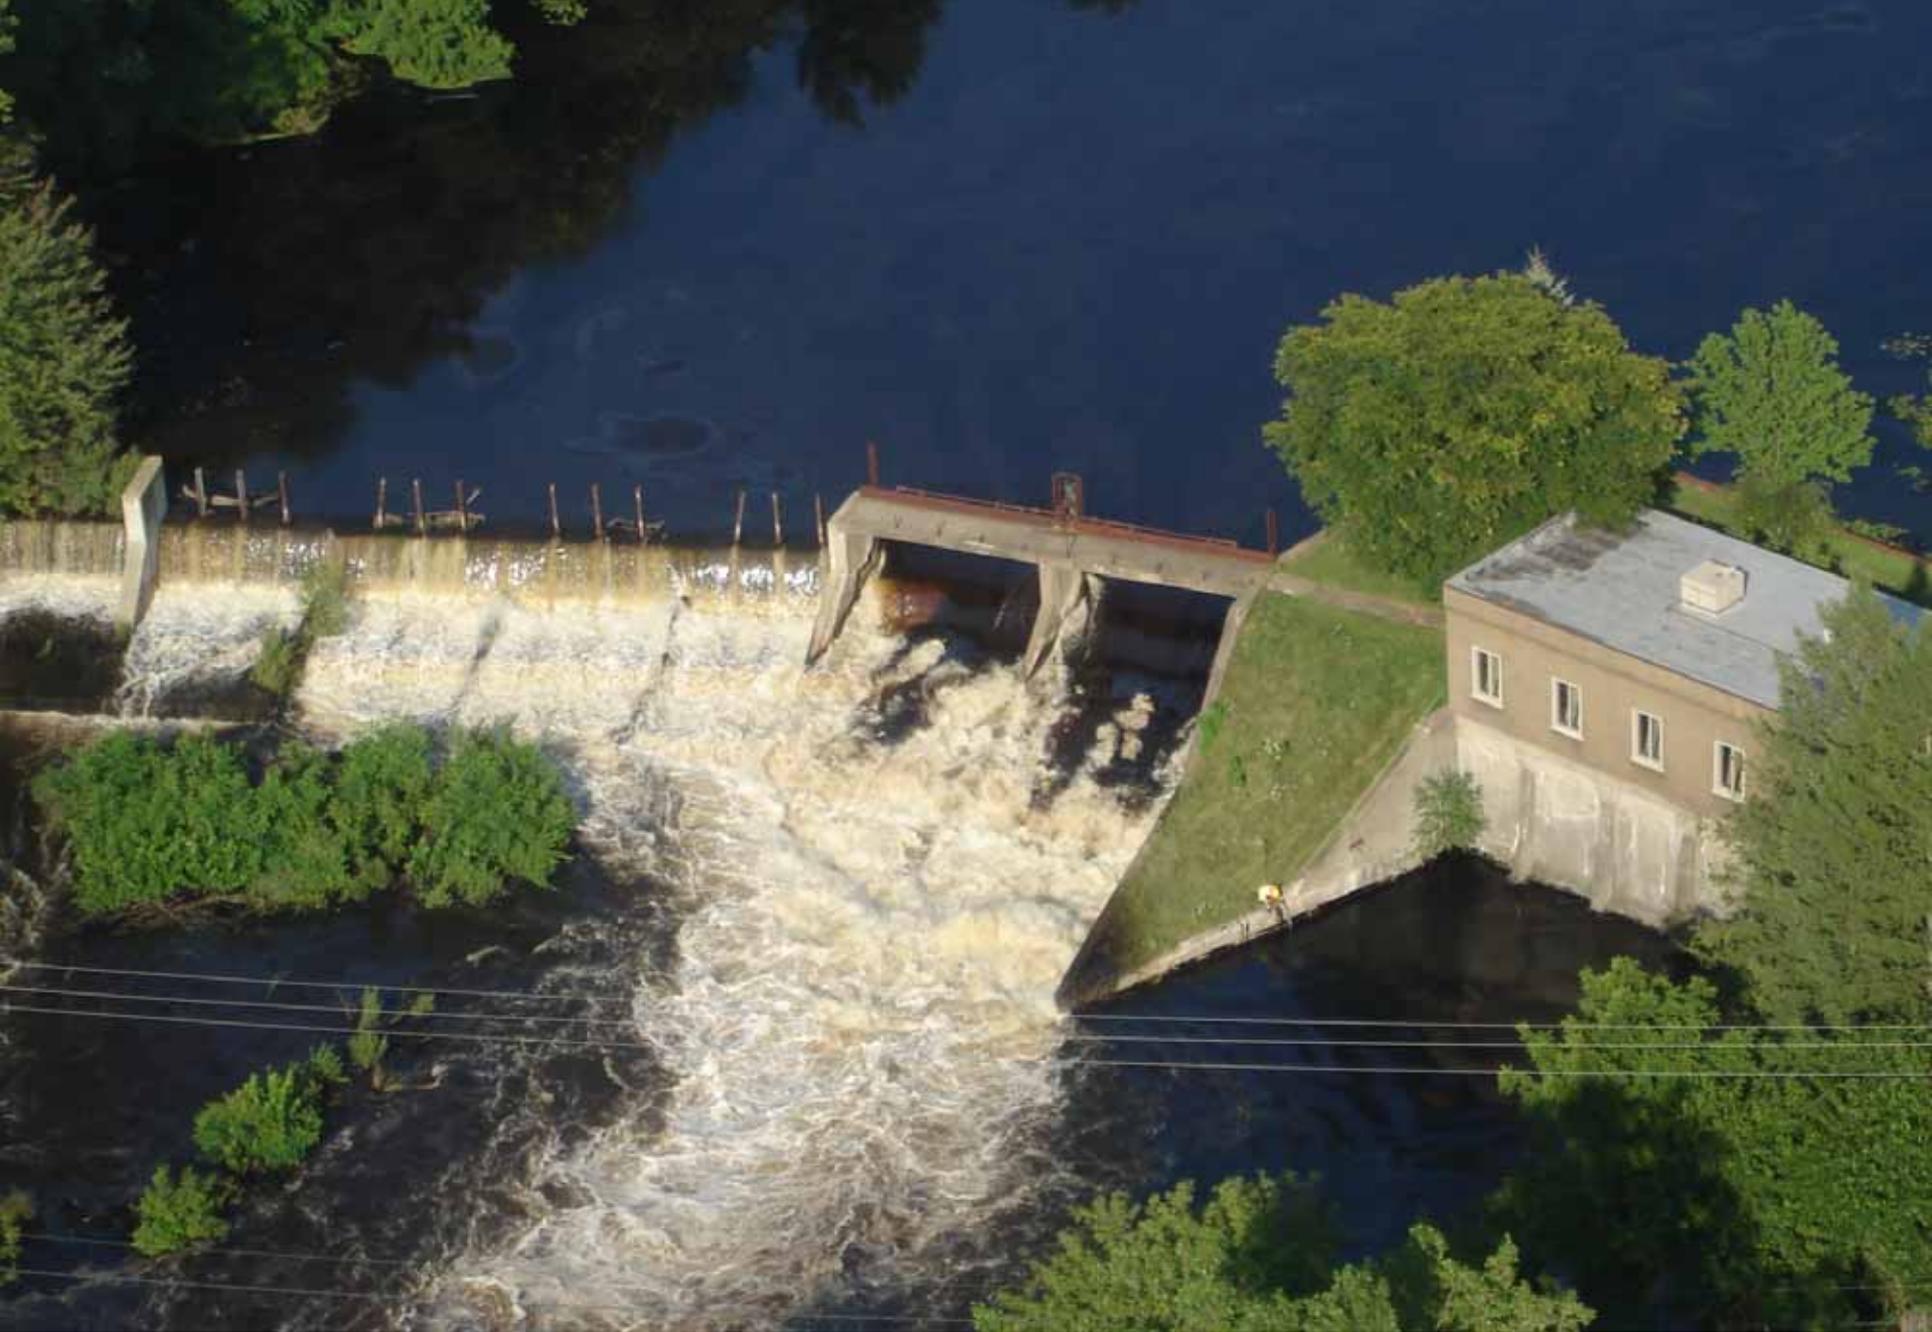
**July 26, 2010, Ceresco Dam: note the oil flowing over the dam.**
