Appendix A: Photographs of the Areas Impacted by the Enbridge Line 6B Oil  
Discharges and of Response Actions  
from U.S. EPA presentations in 2010 and 2015

# Enbridge Line 6B Incident

## Public Update and Availability Session

October 14, 2010  
(Day 81)

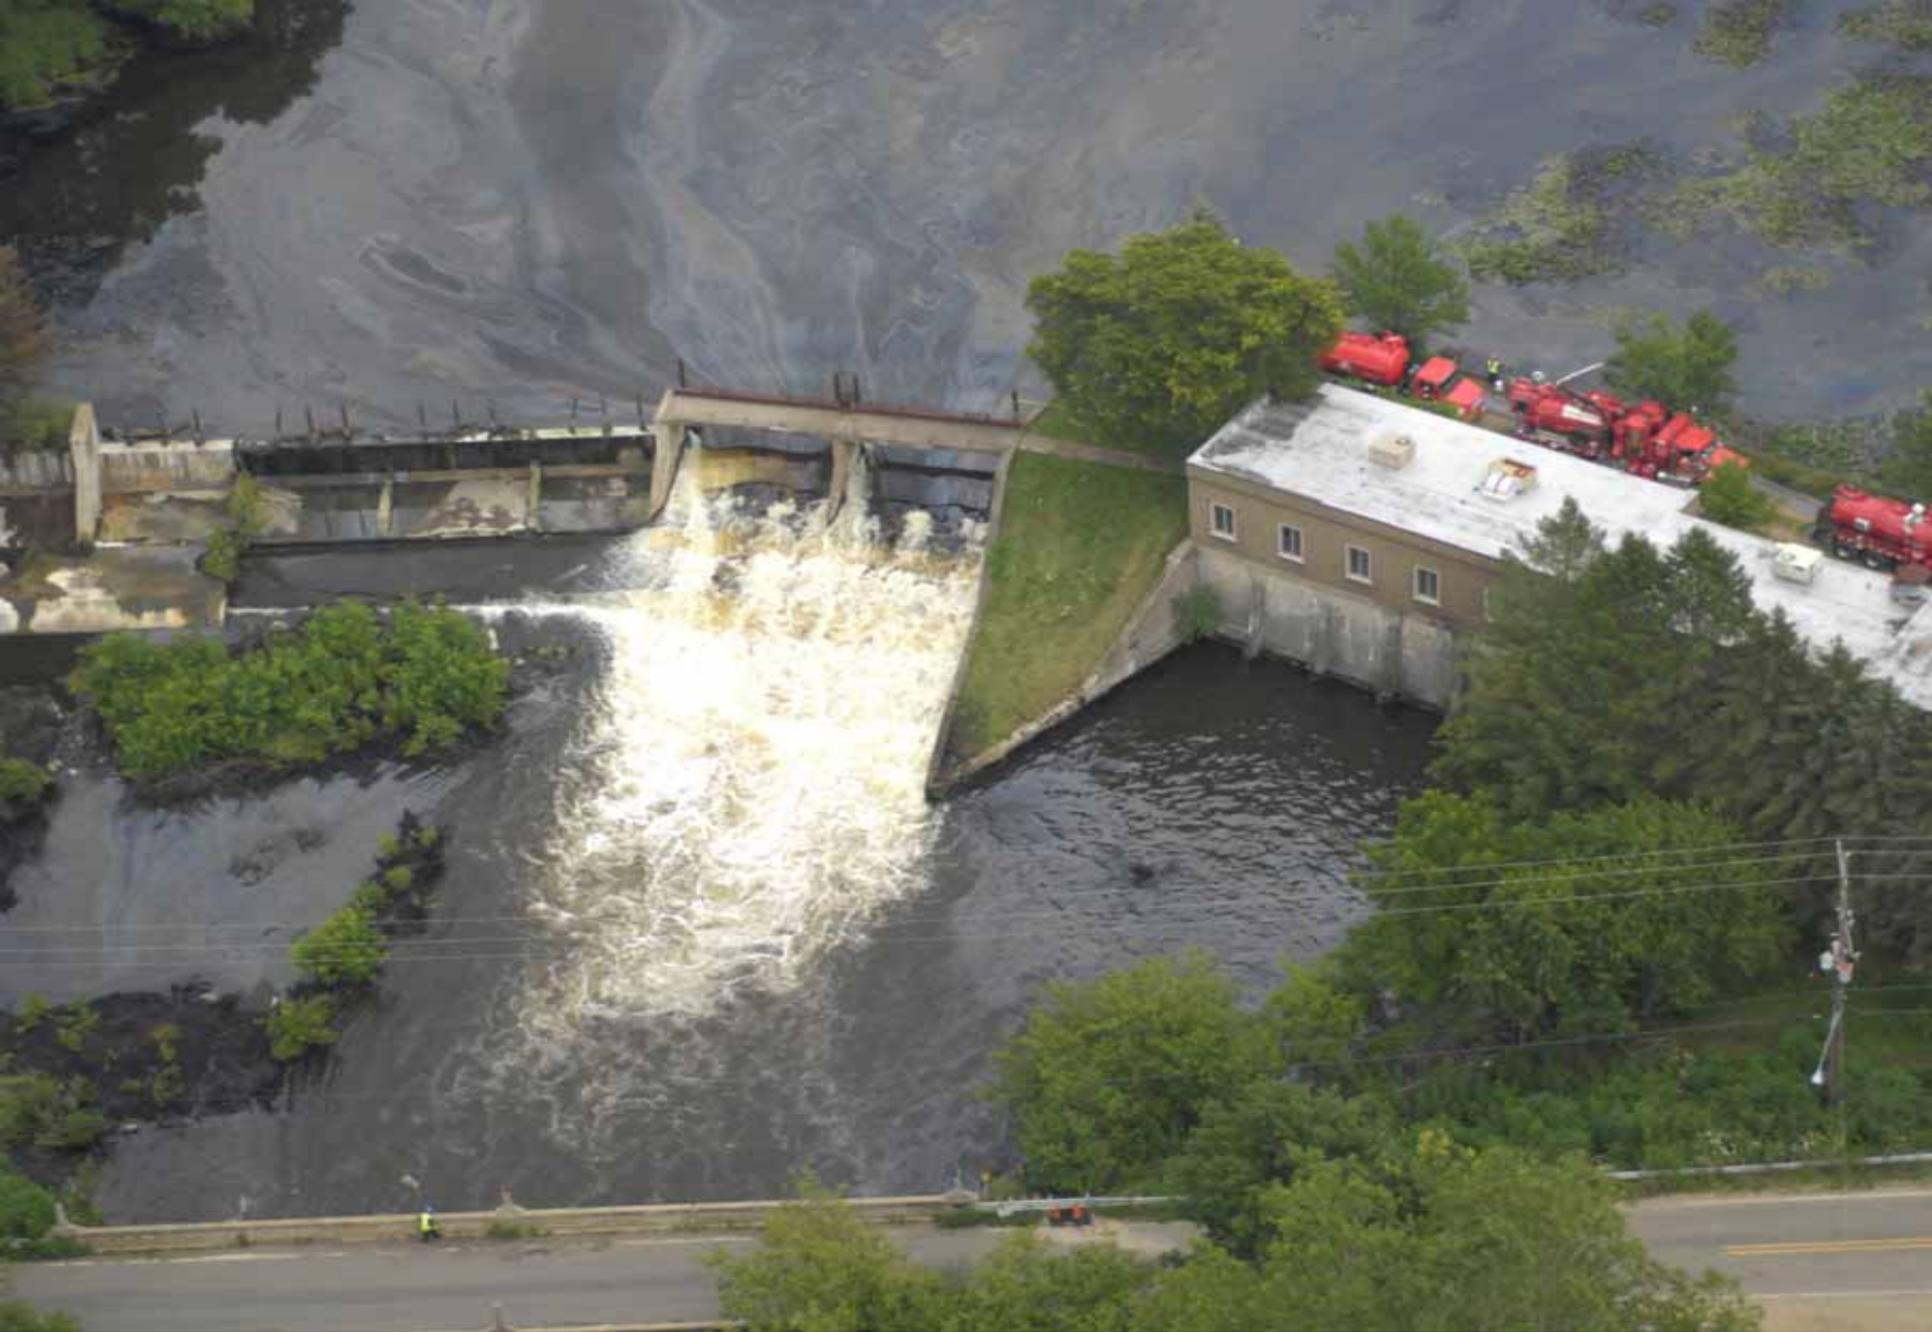
**By the end of the first week, oil reduced to a heavy sheen.**

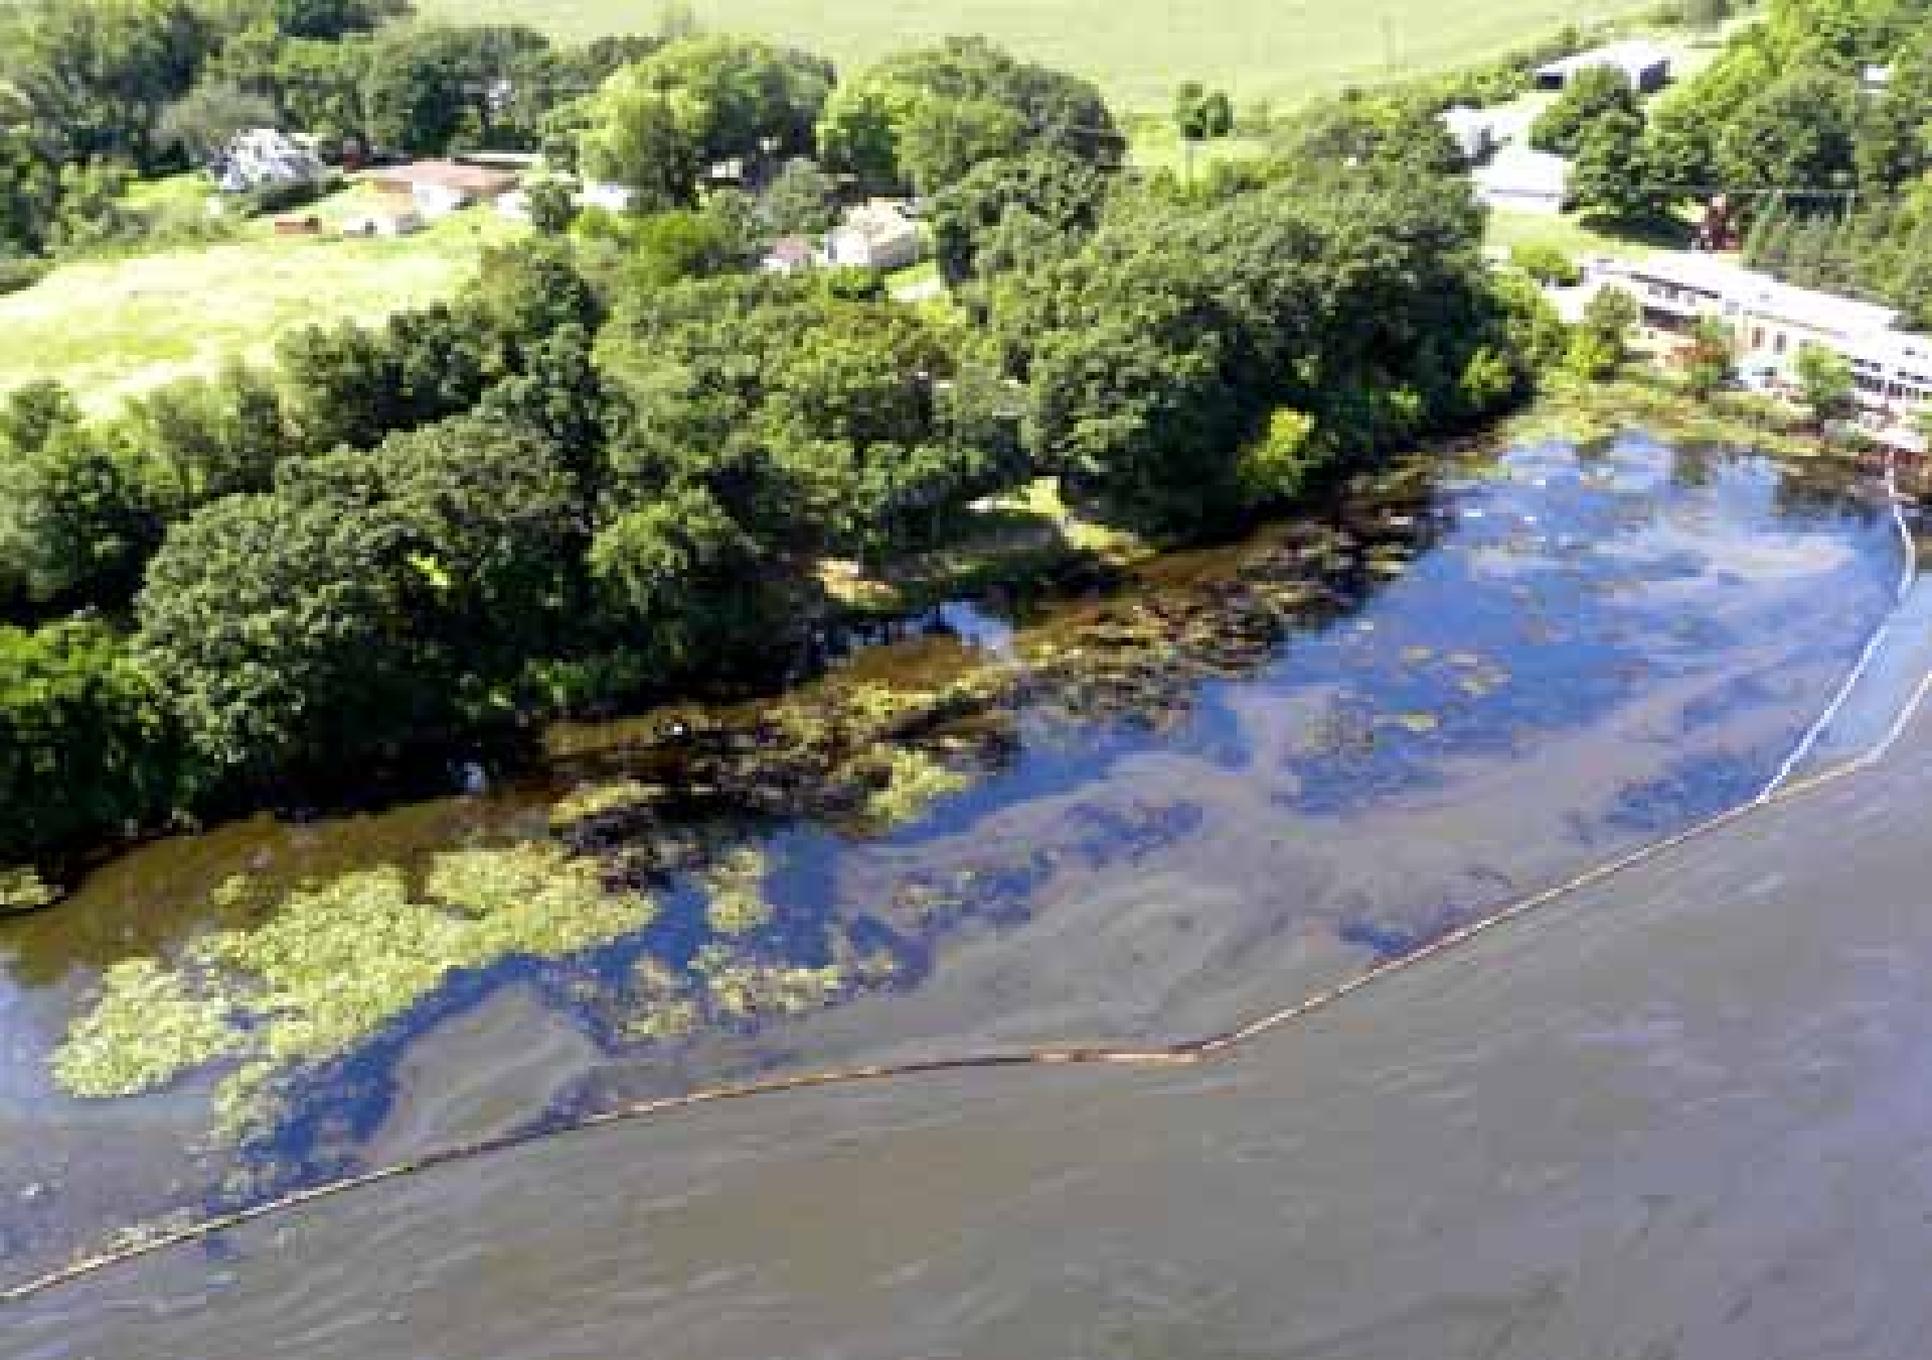
**Oil caught in backwater vegetation just upstream from Ceresco Dam.**

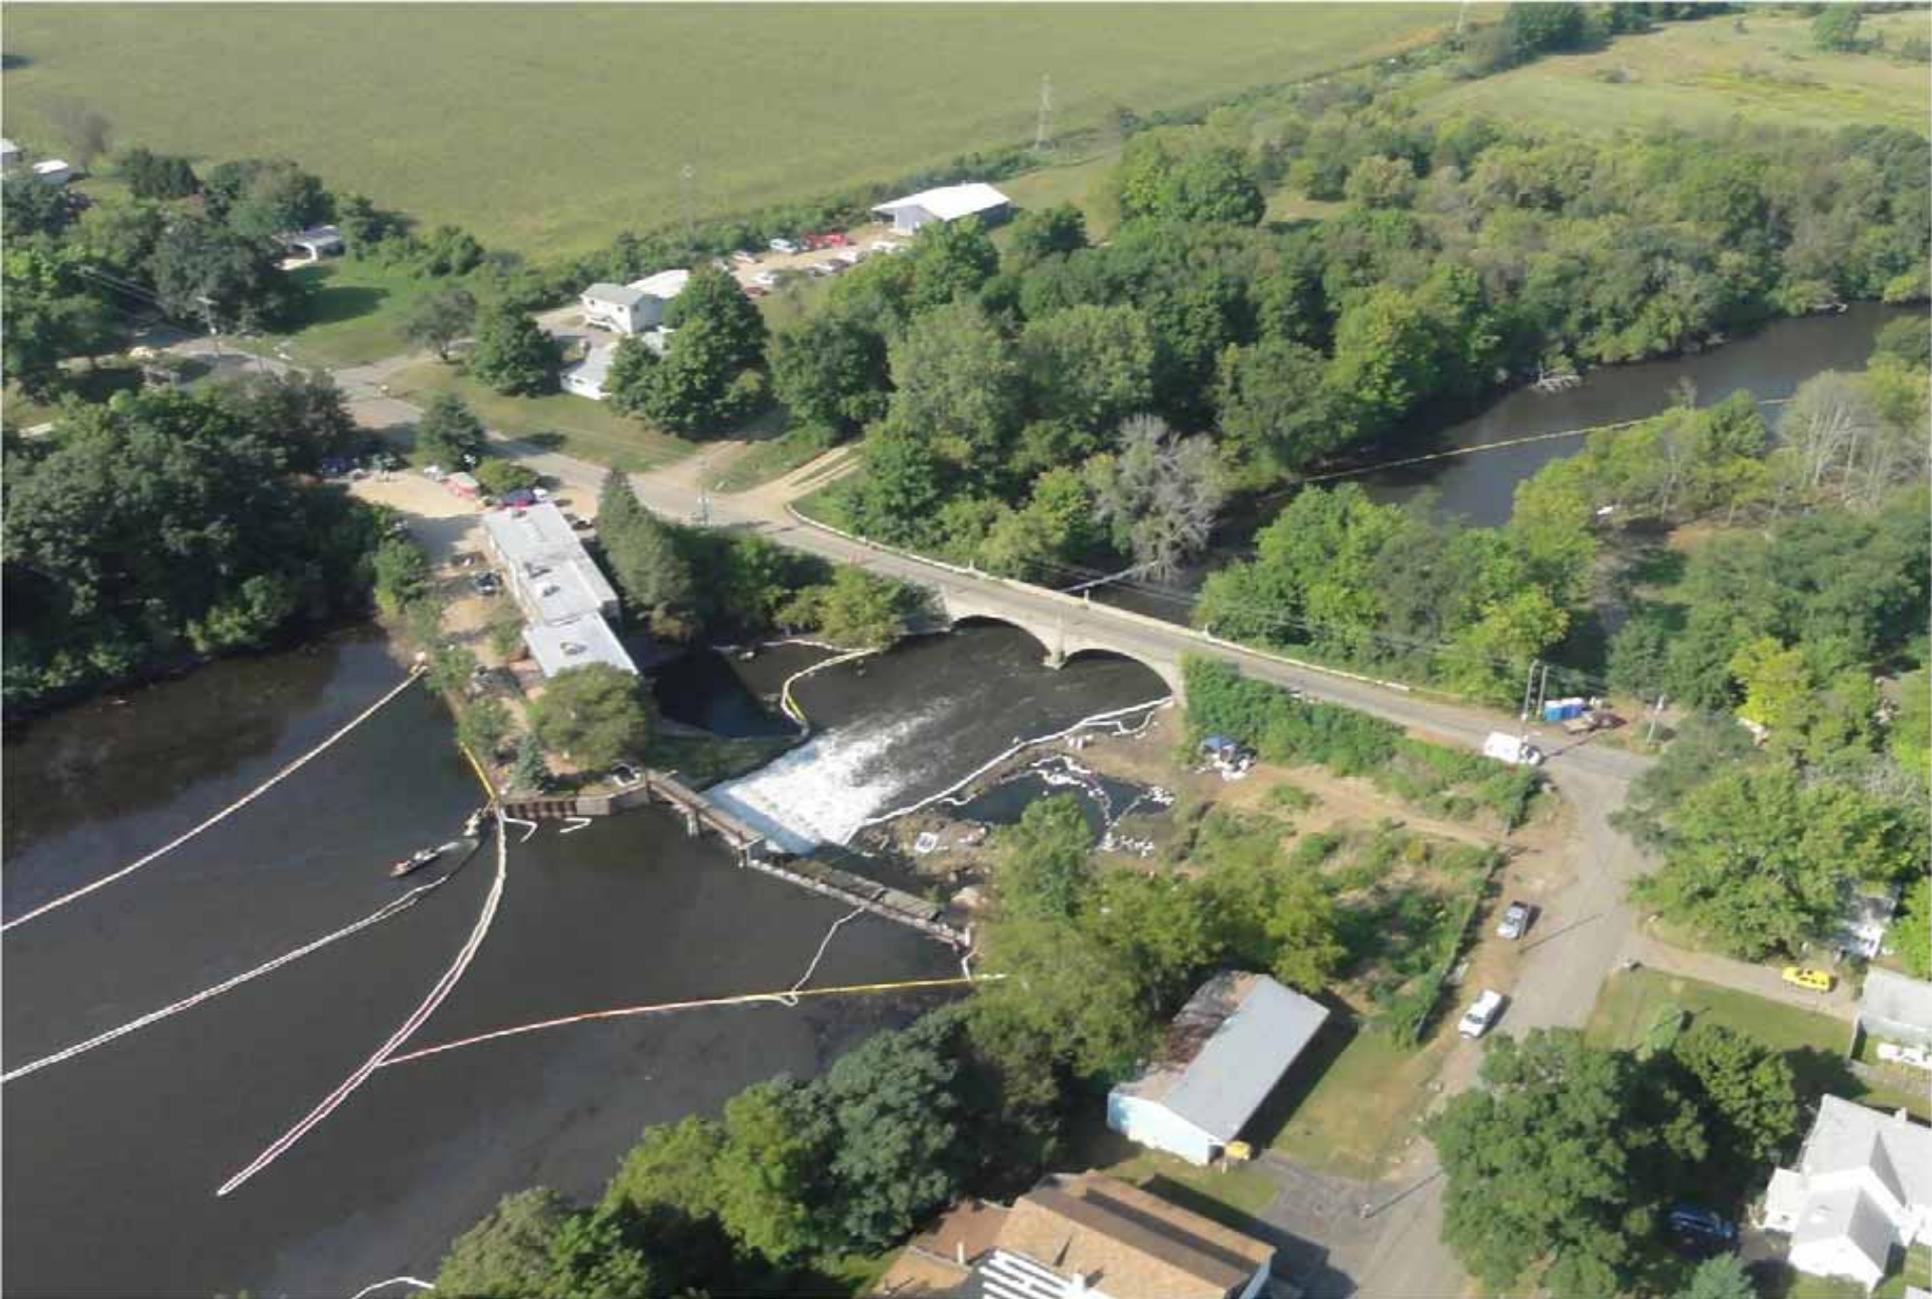
**Containment booming established to control vegetation sheening upstream of Ceresco Dam.**

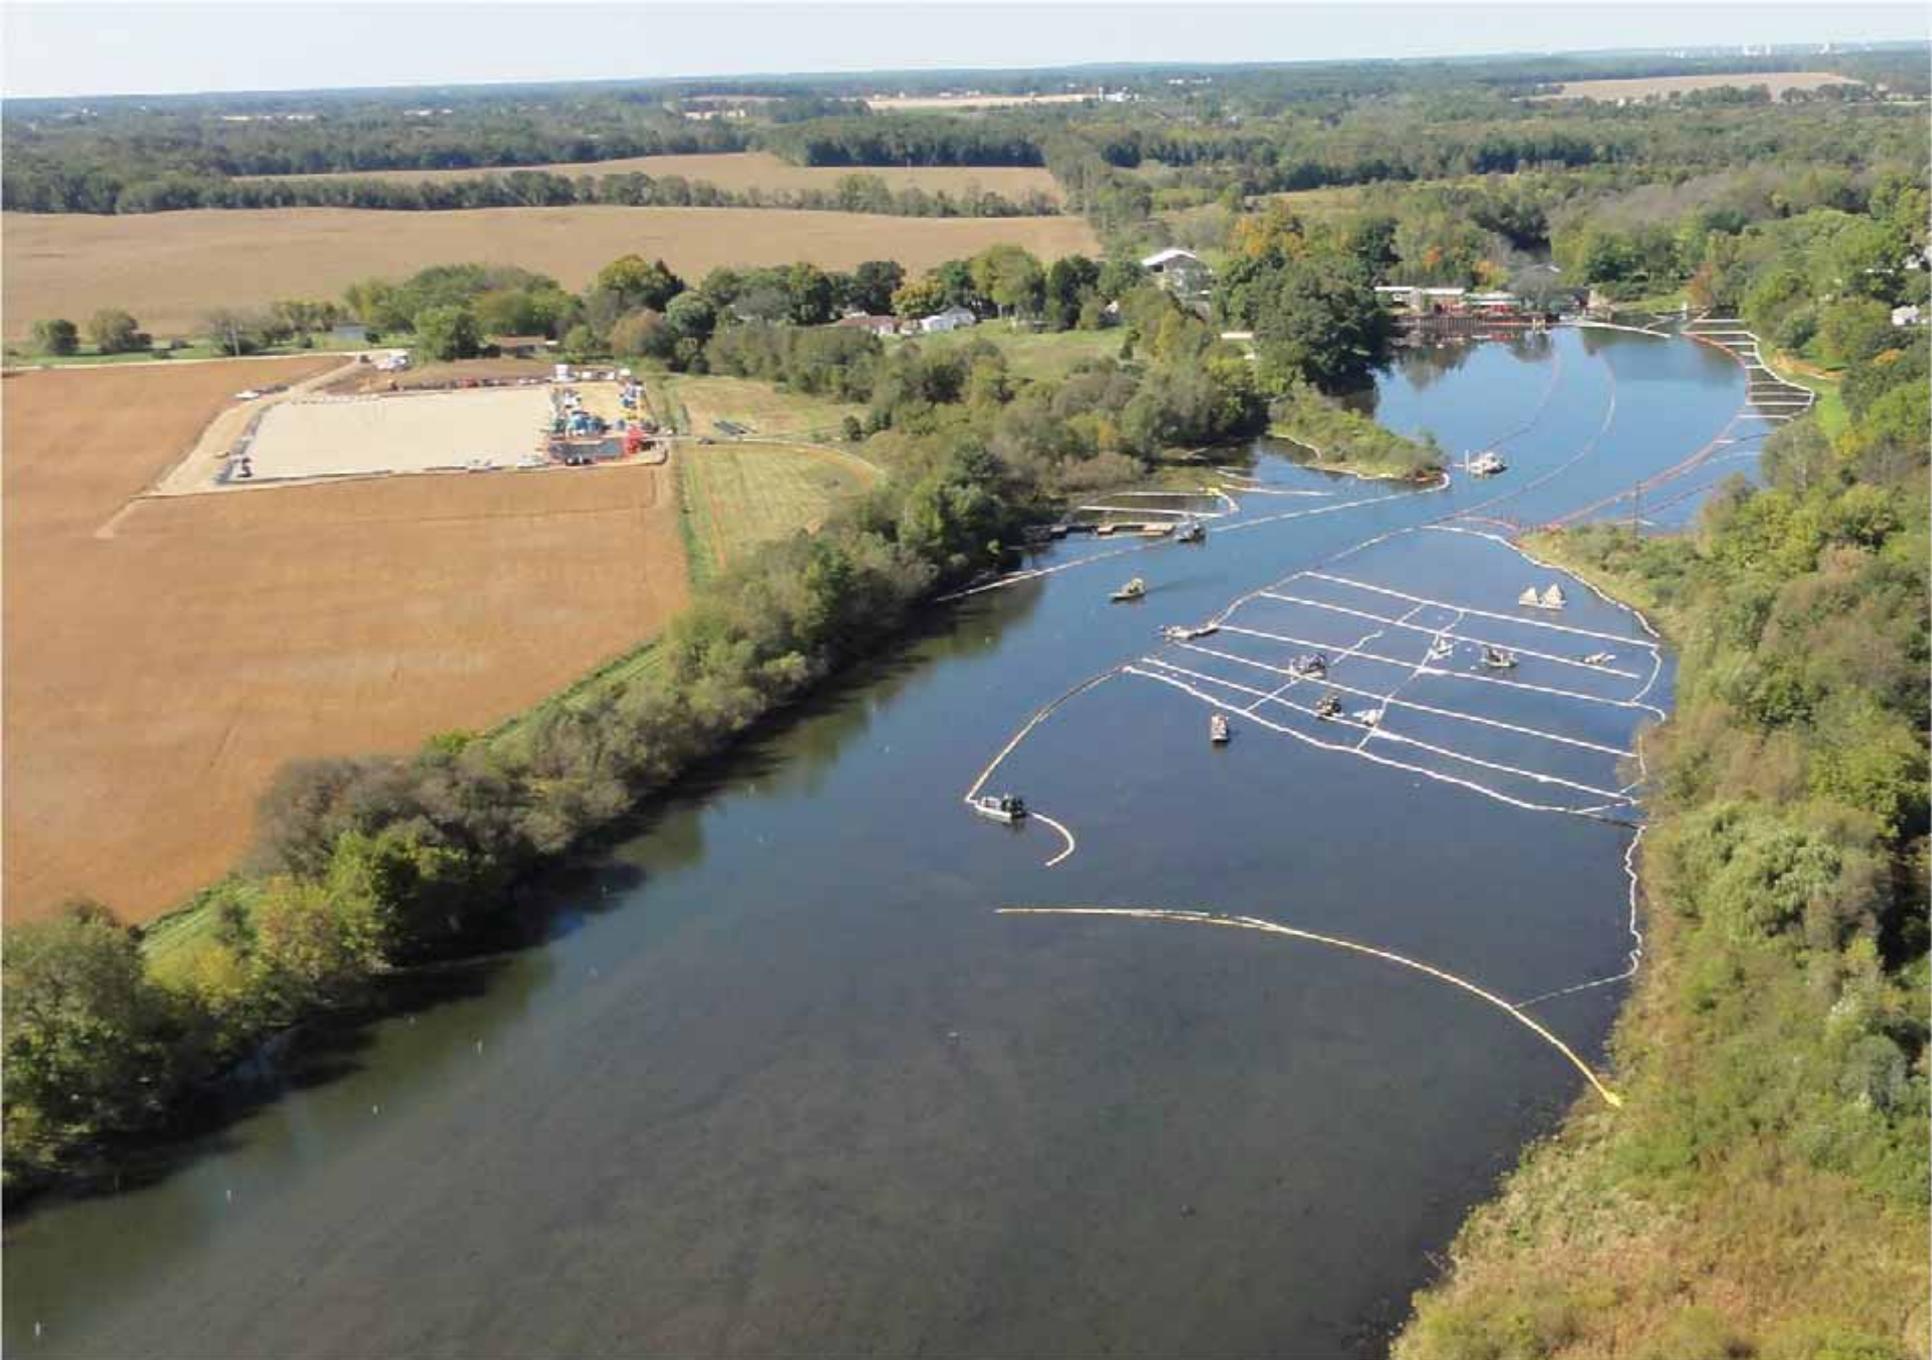
**October 2010: submerged oil cleanup started upstream of Ceresco Dam.**

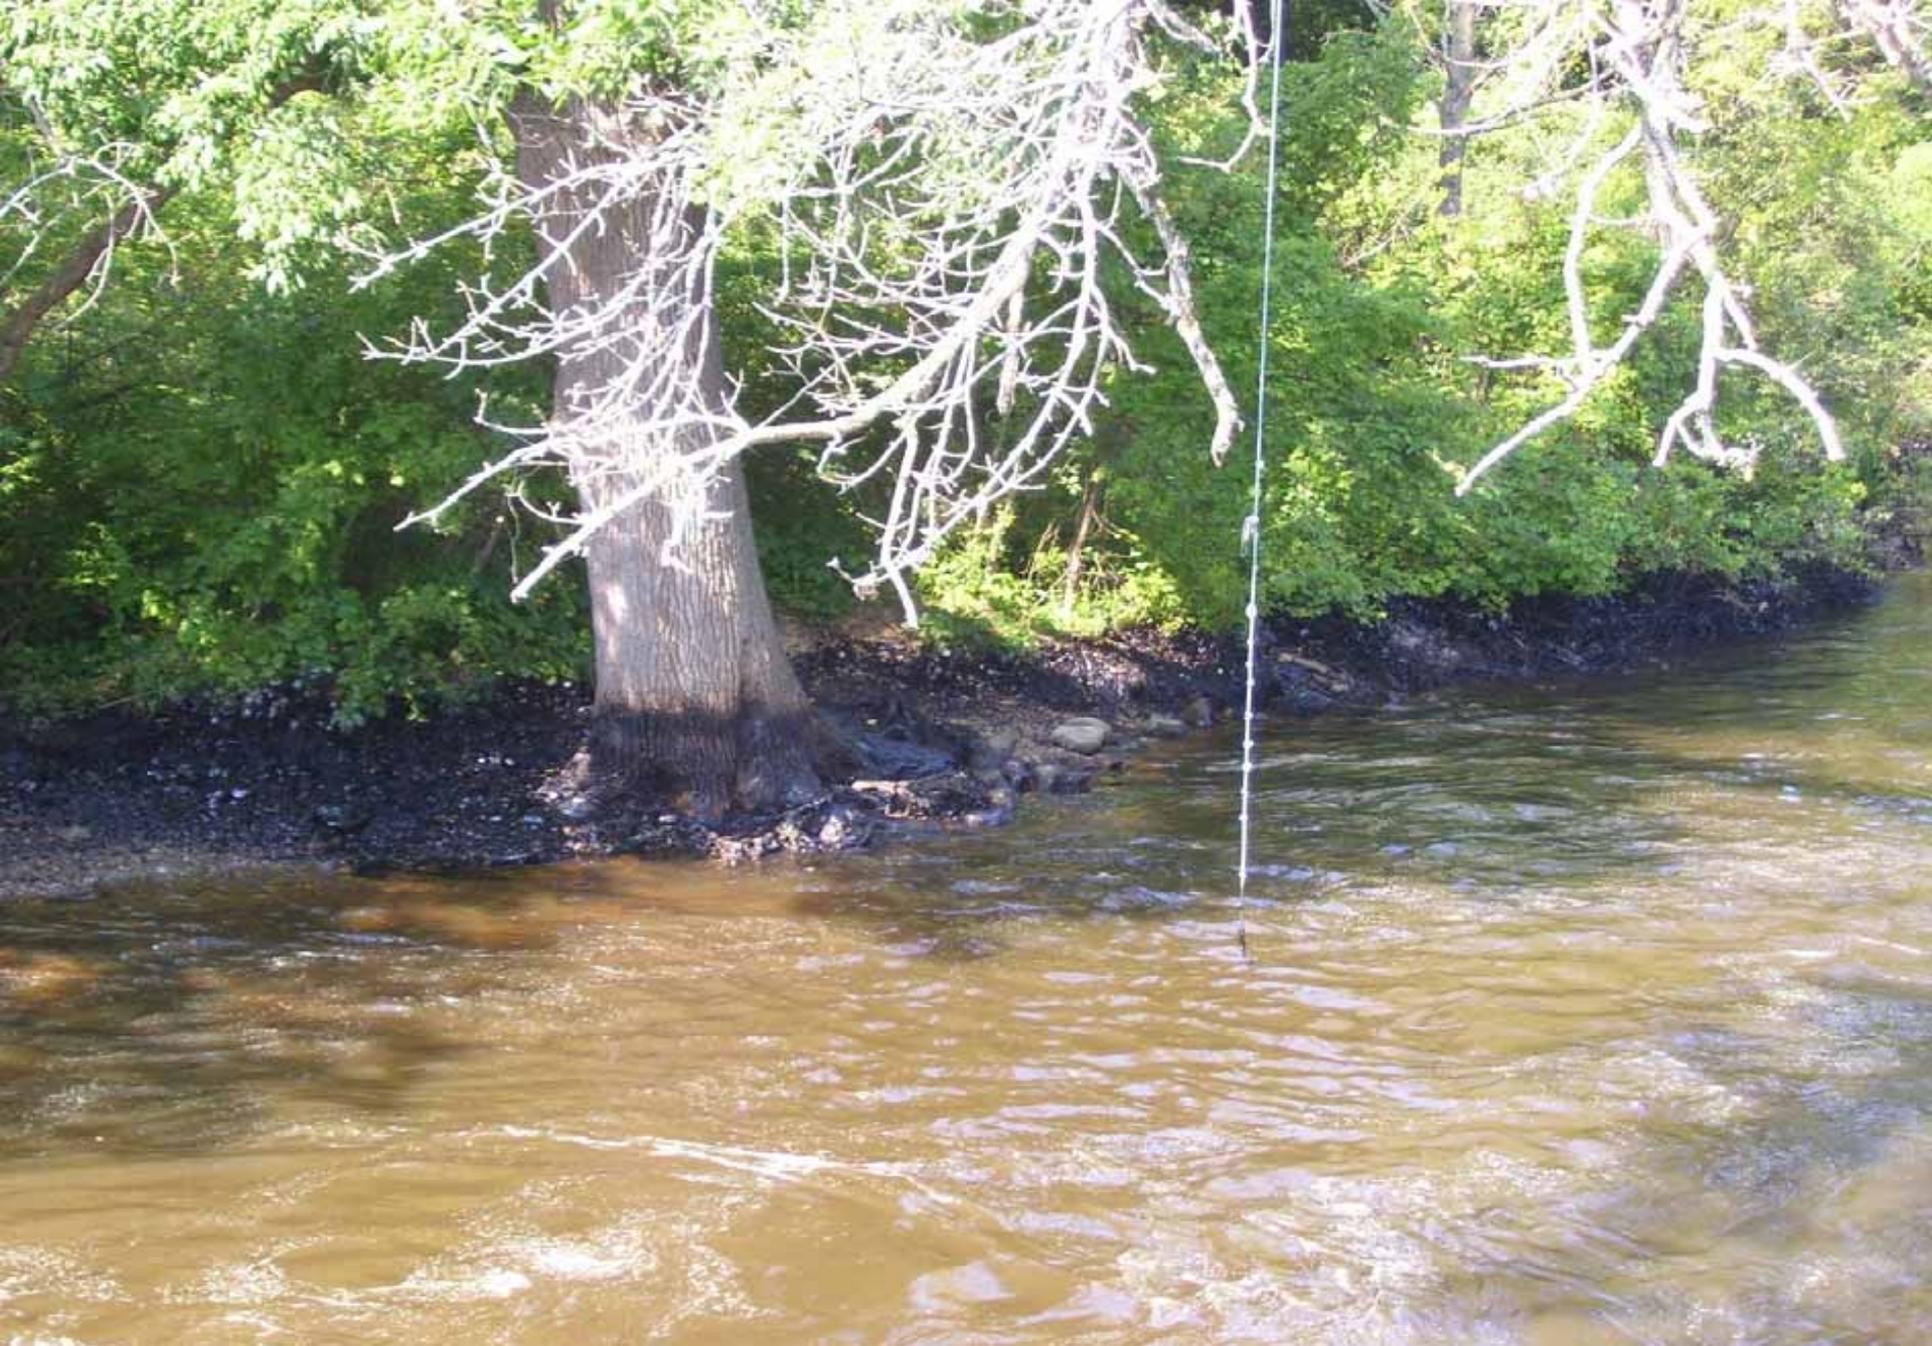
**Condition of stream bank just downstream of Ceresco Dam in late July 2010.**

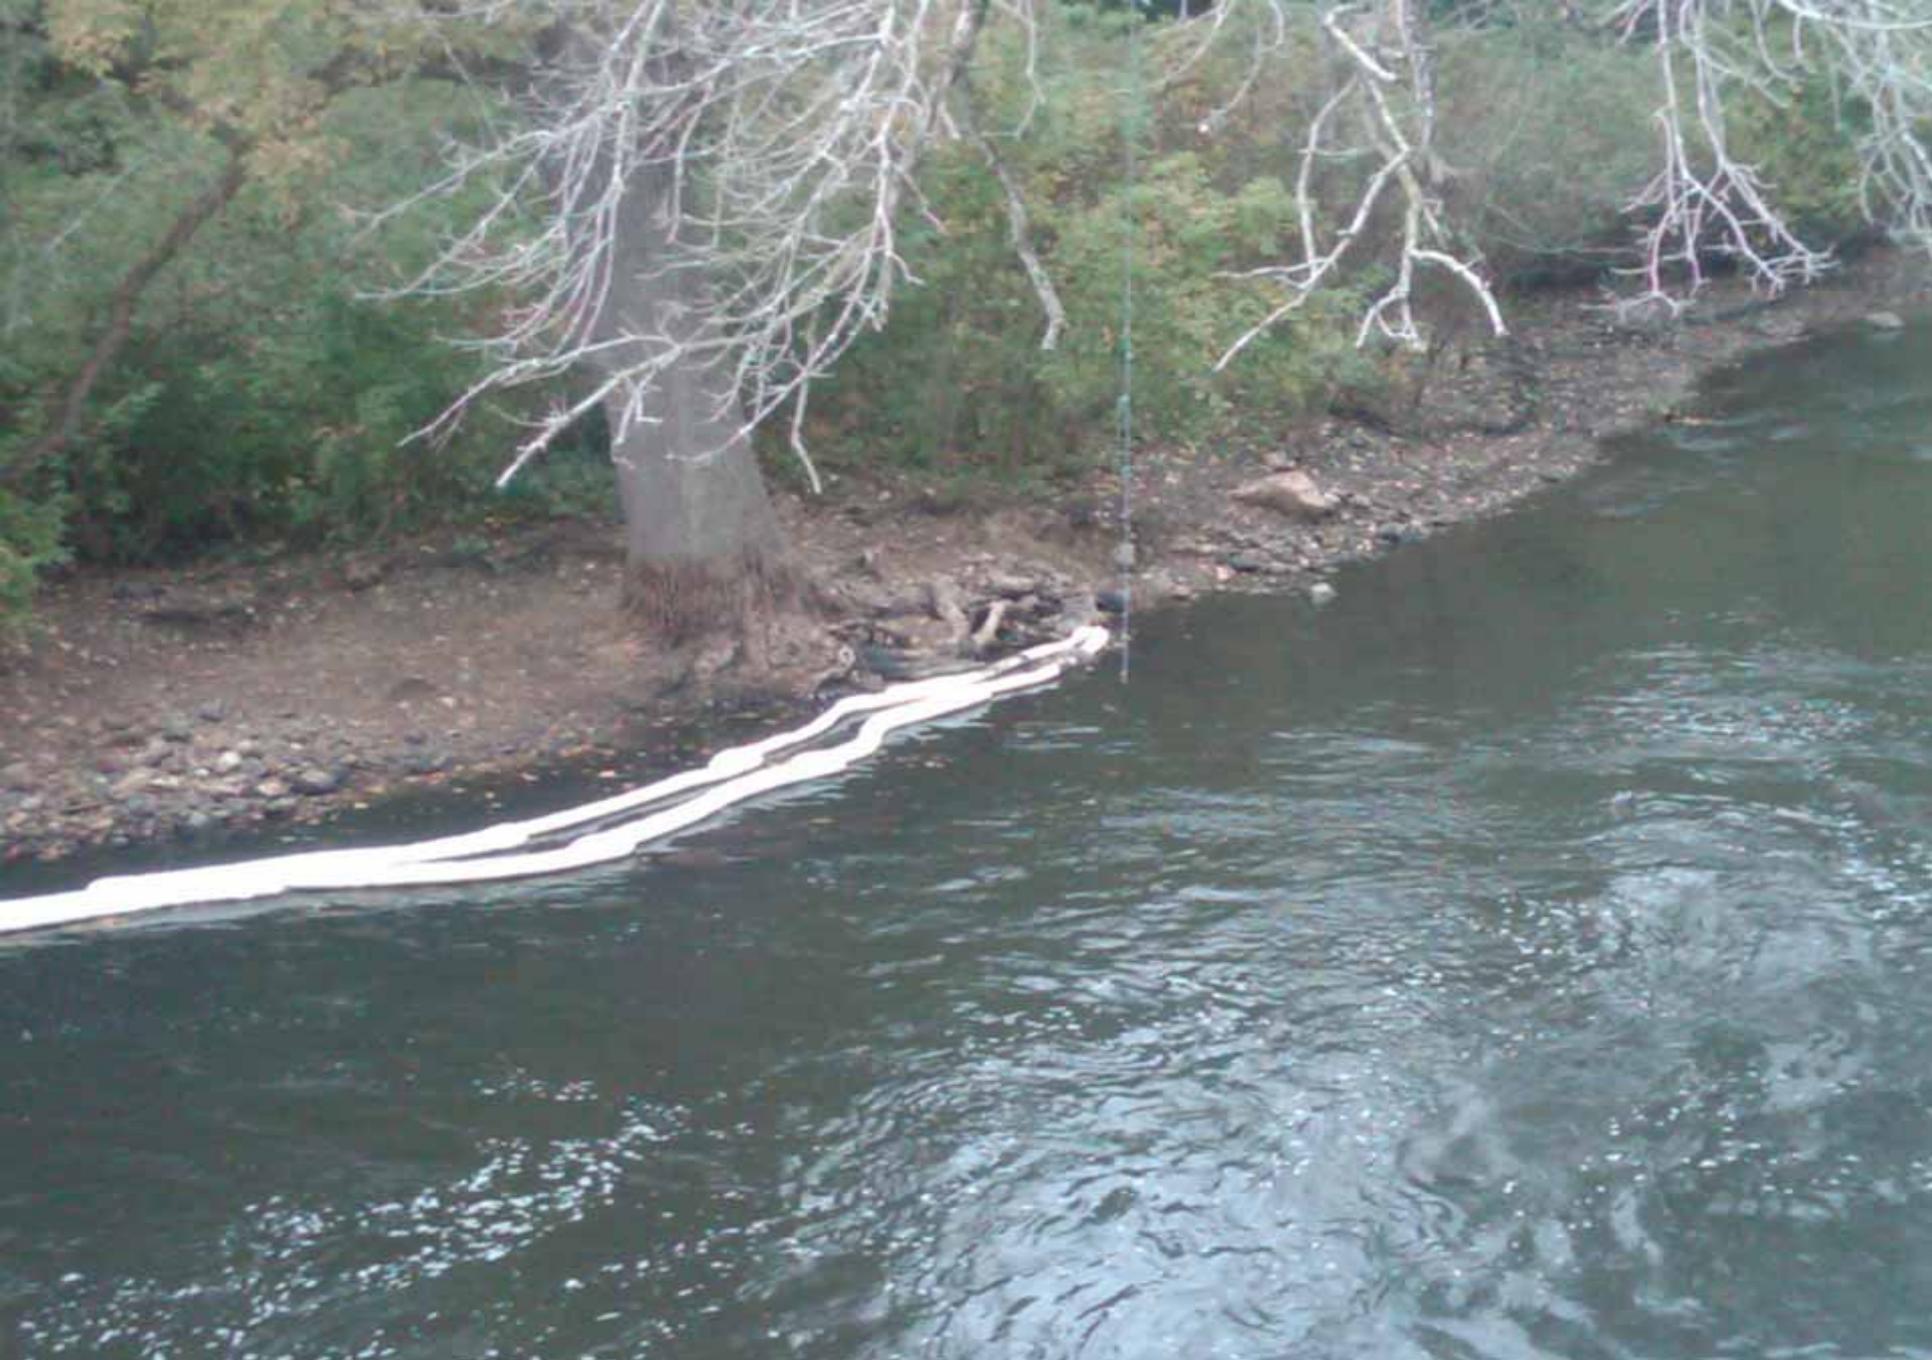
**Same location, late September 2010.**

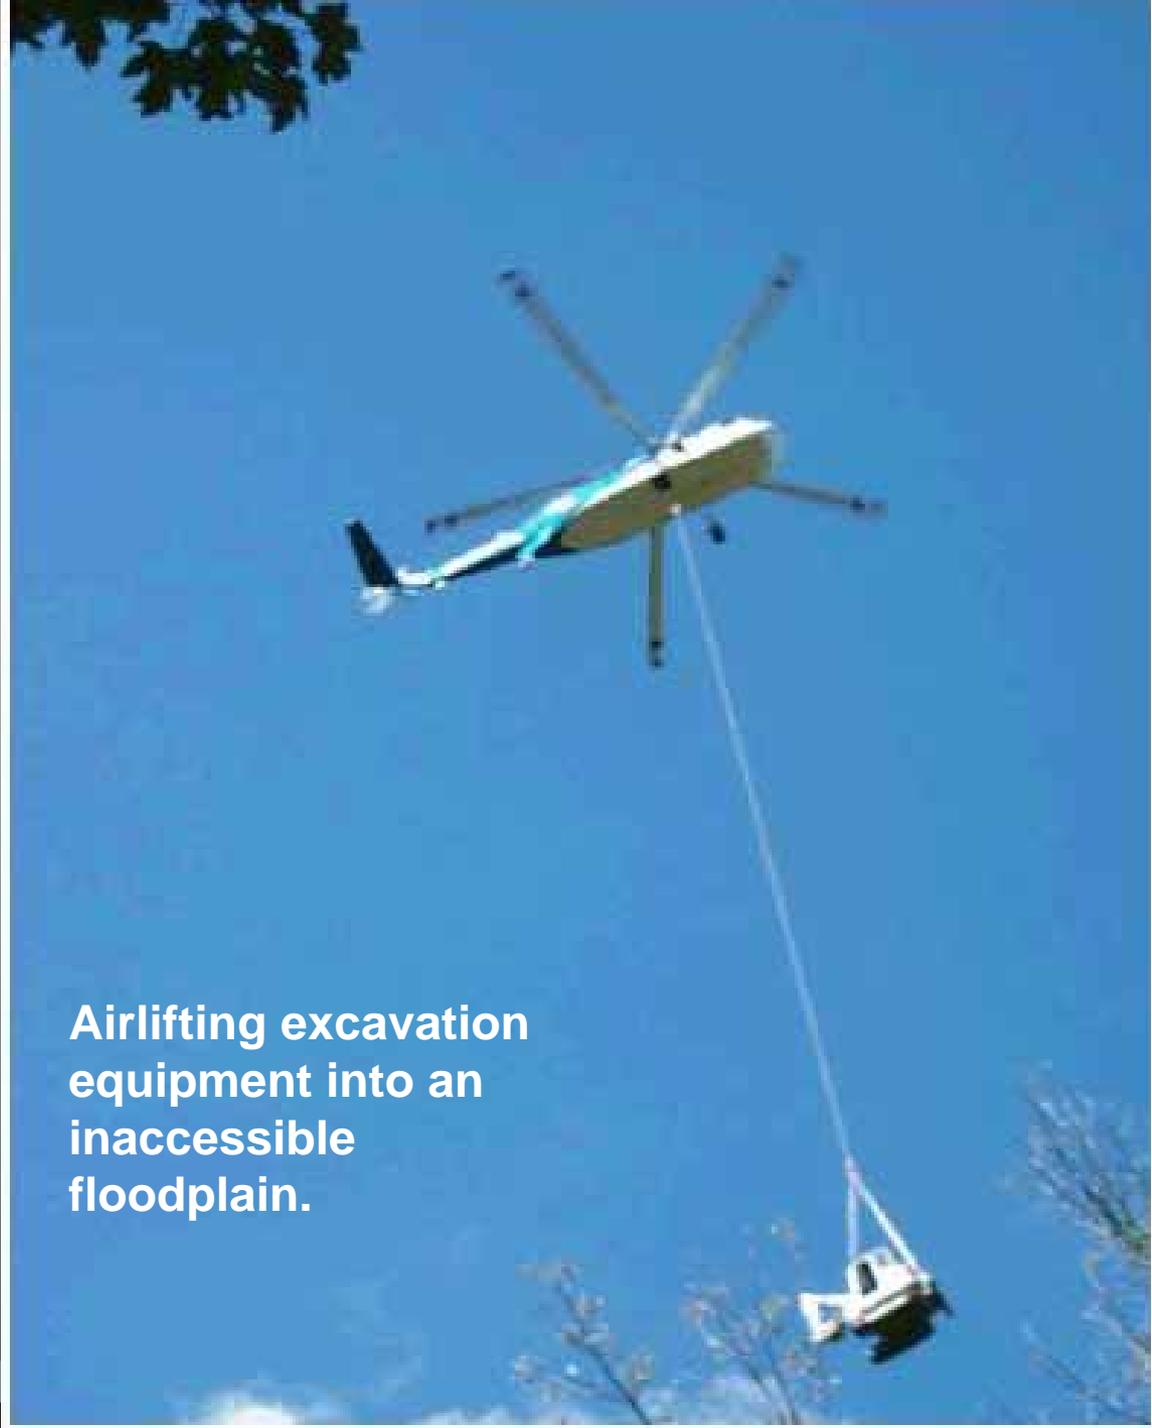
**Airlifting excavation  
equipment into an  
inaccessible  
floodplain.**

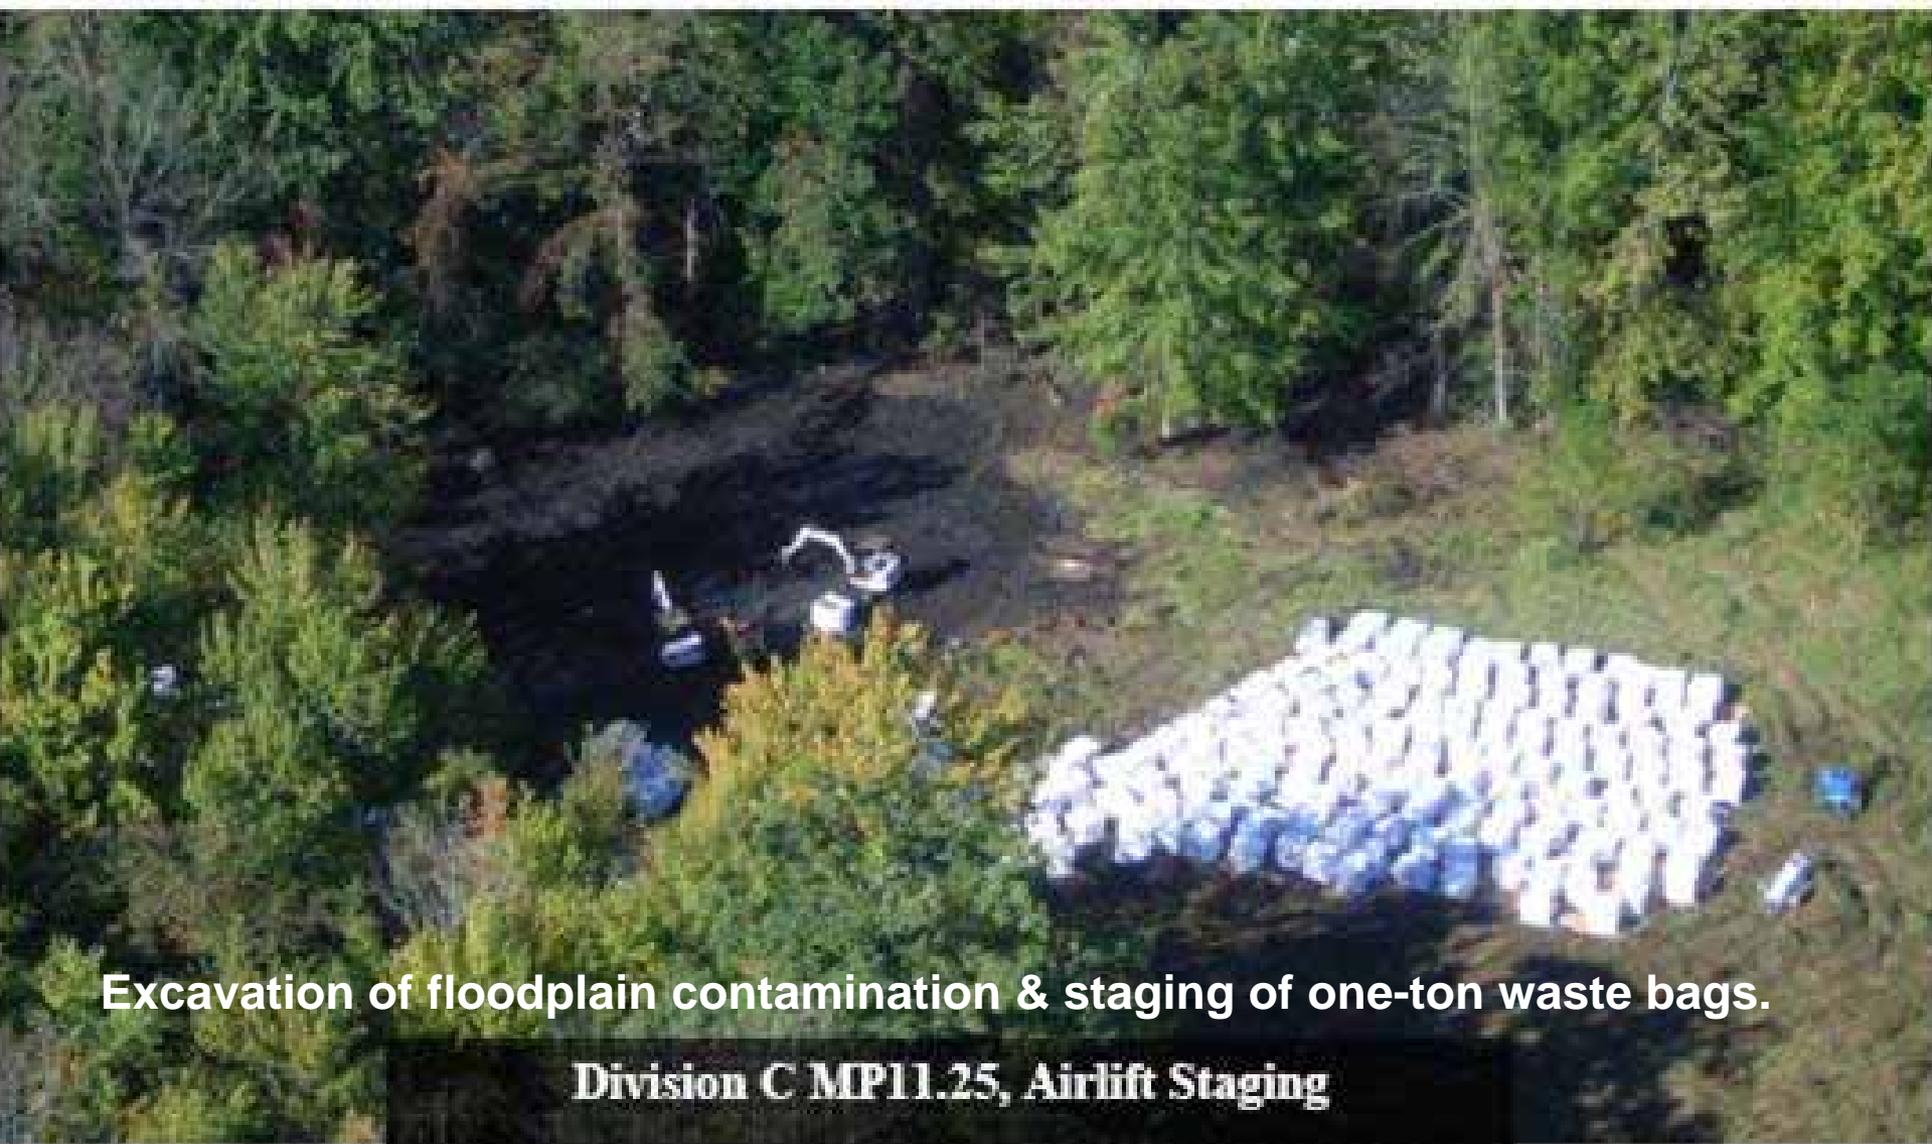
**Division C MP11.25, Airlift Staging**

**Excavation of floodplain contamination & staging of one-ton waste bags.**

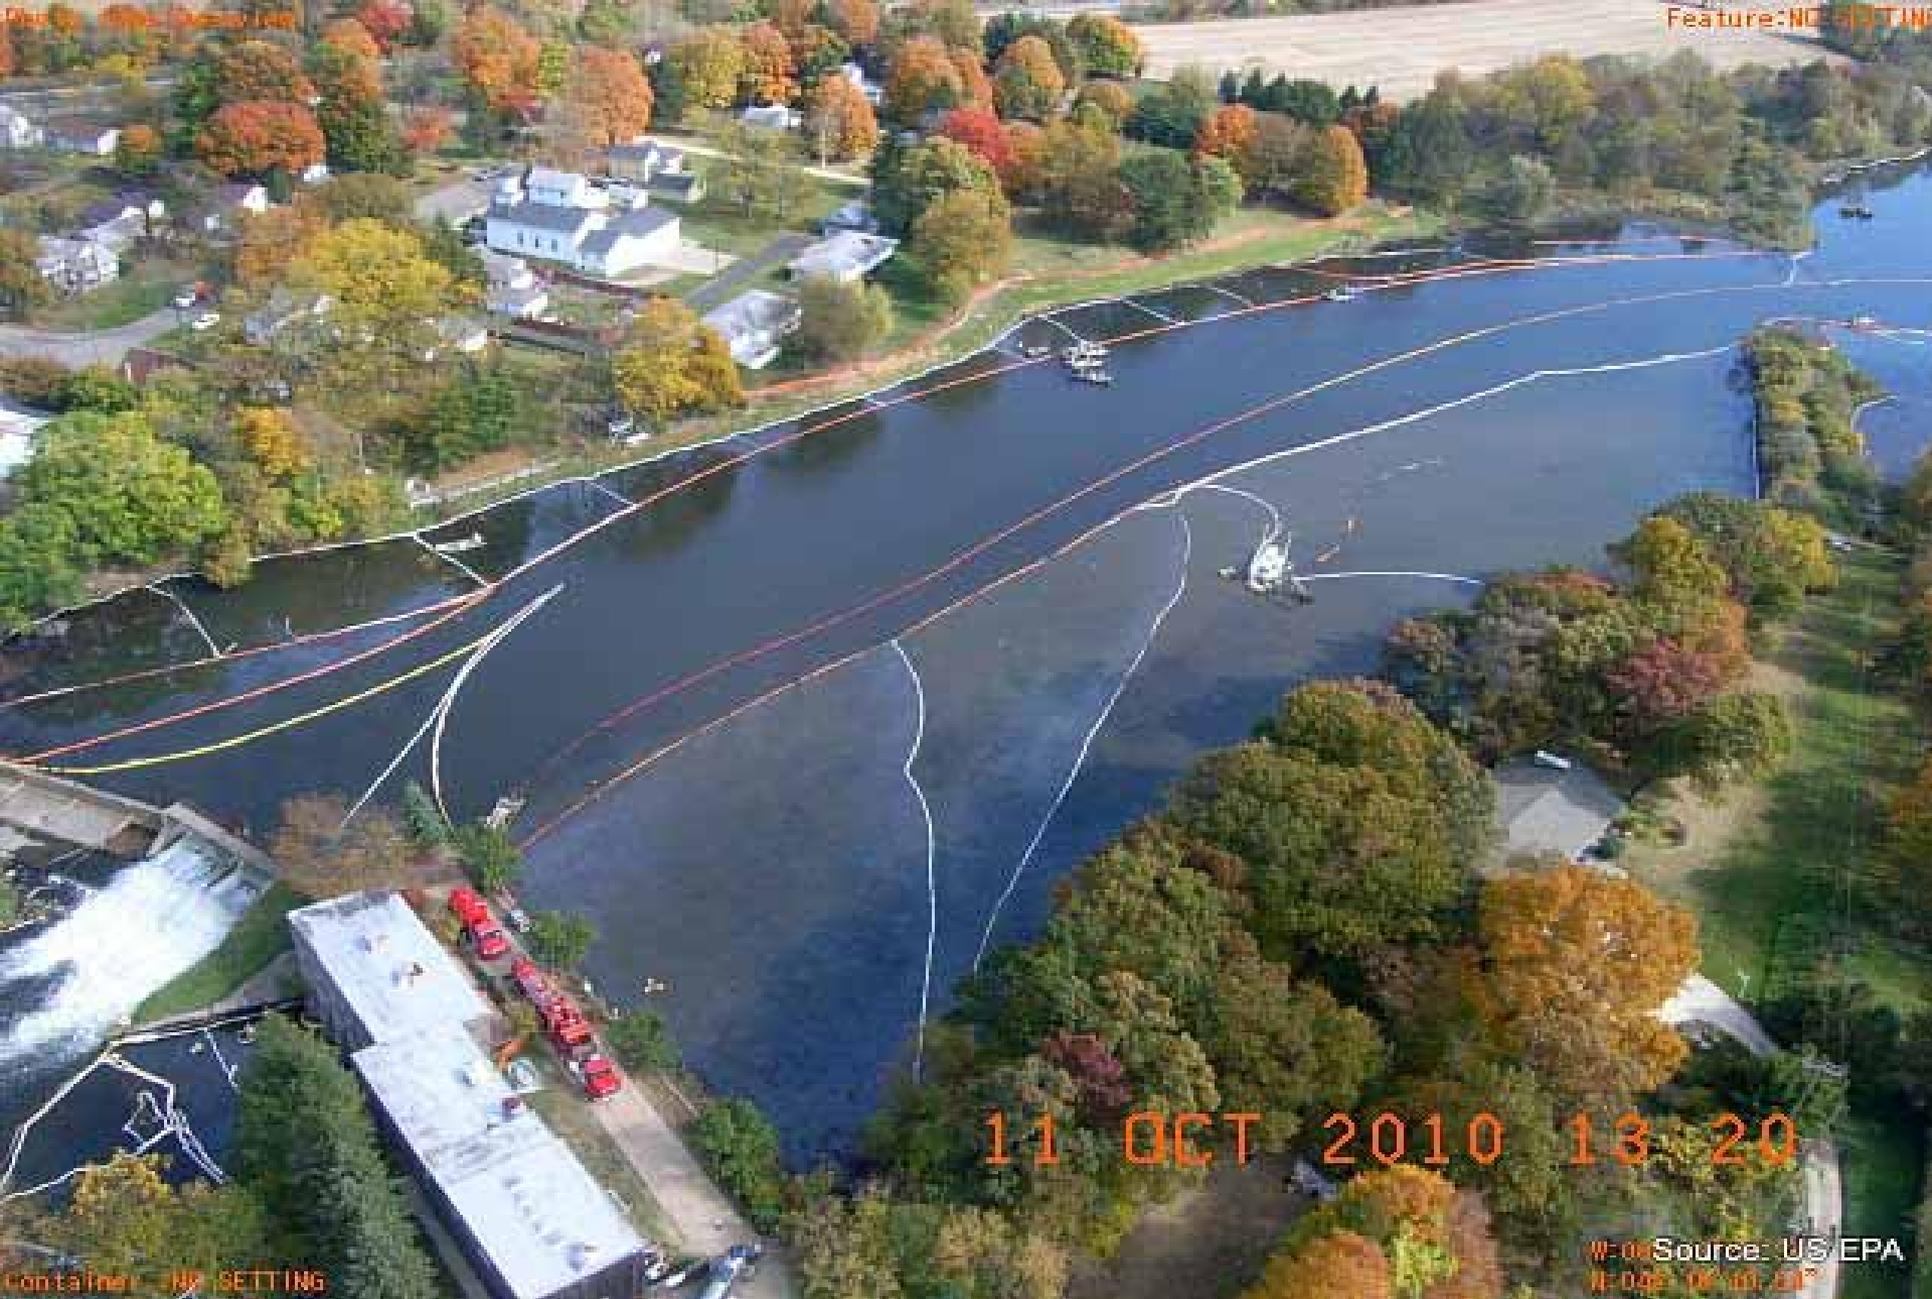
**Ceresco Dam dredging operation and submerged oil aeration cells along the north bank.**
