Appendix A: Photographs of the Areas Impacted by the Enbridge Line 6B Oil  
Discharges and of Response Actions  
from U.S. EPA presentations in 2010 and 2015

# Enbridge Line 6B Incident

## Public Update and Availability Session

October 14, 2010  
(Day 81)

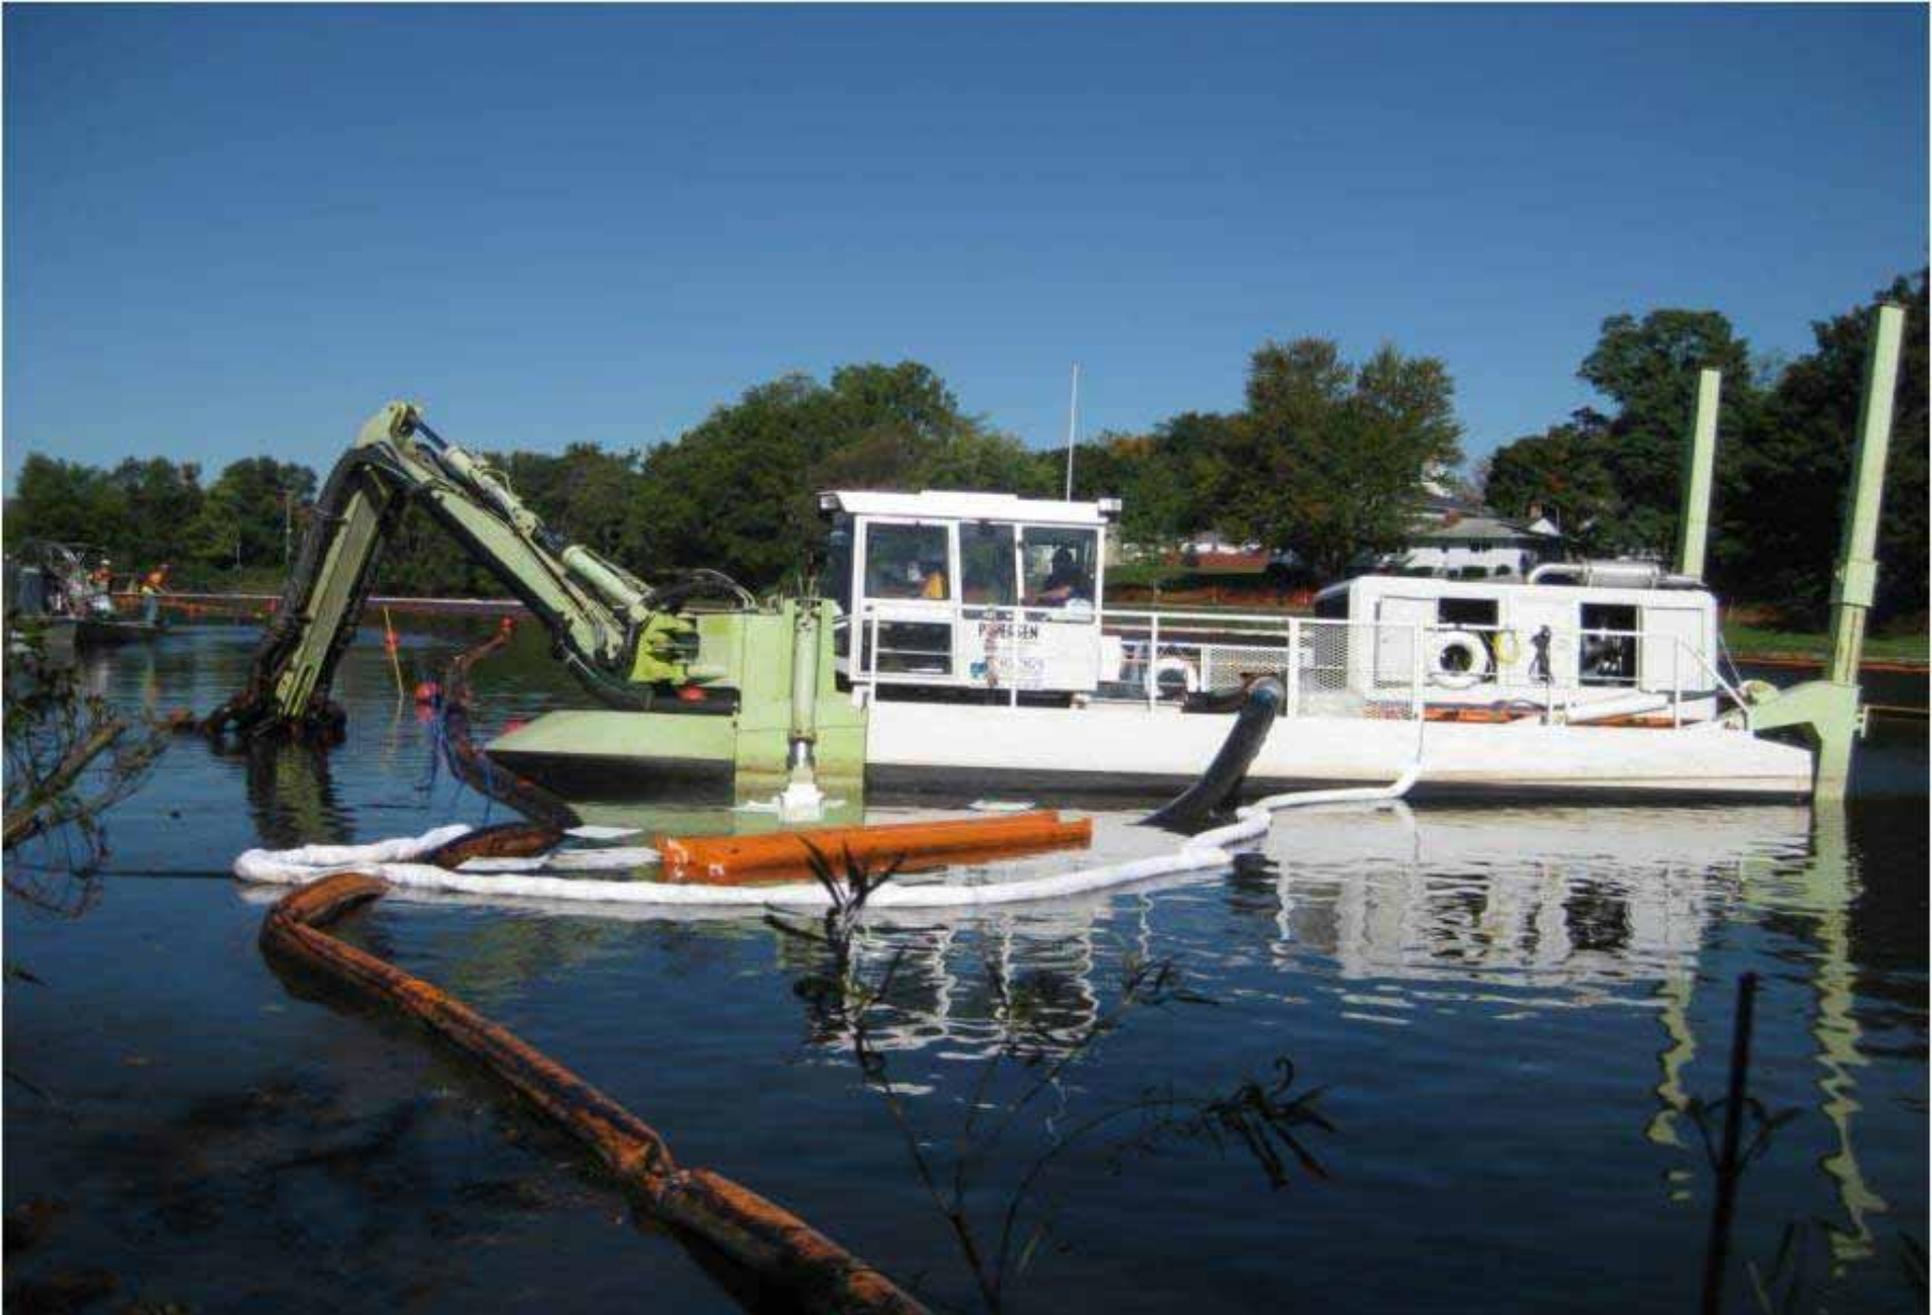
**Amphibex dredge used to remove approximately 18 inches of sediment from upstream of Ceresco Dam.**

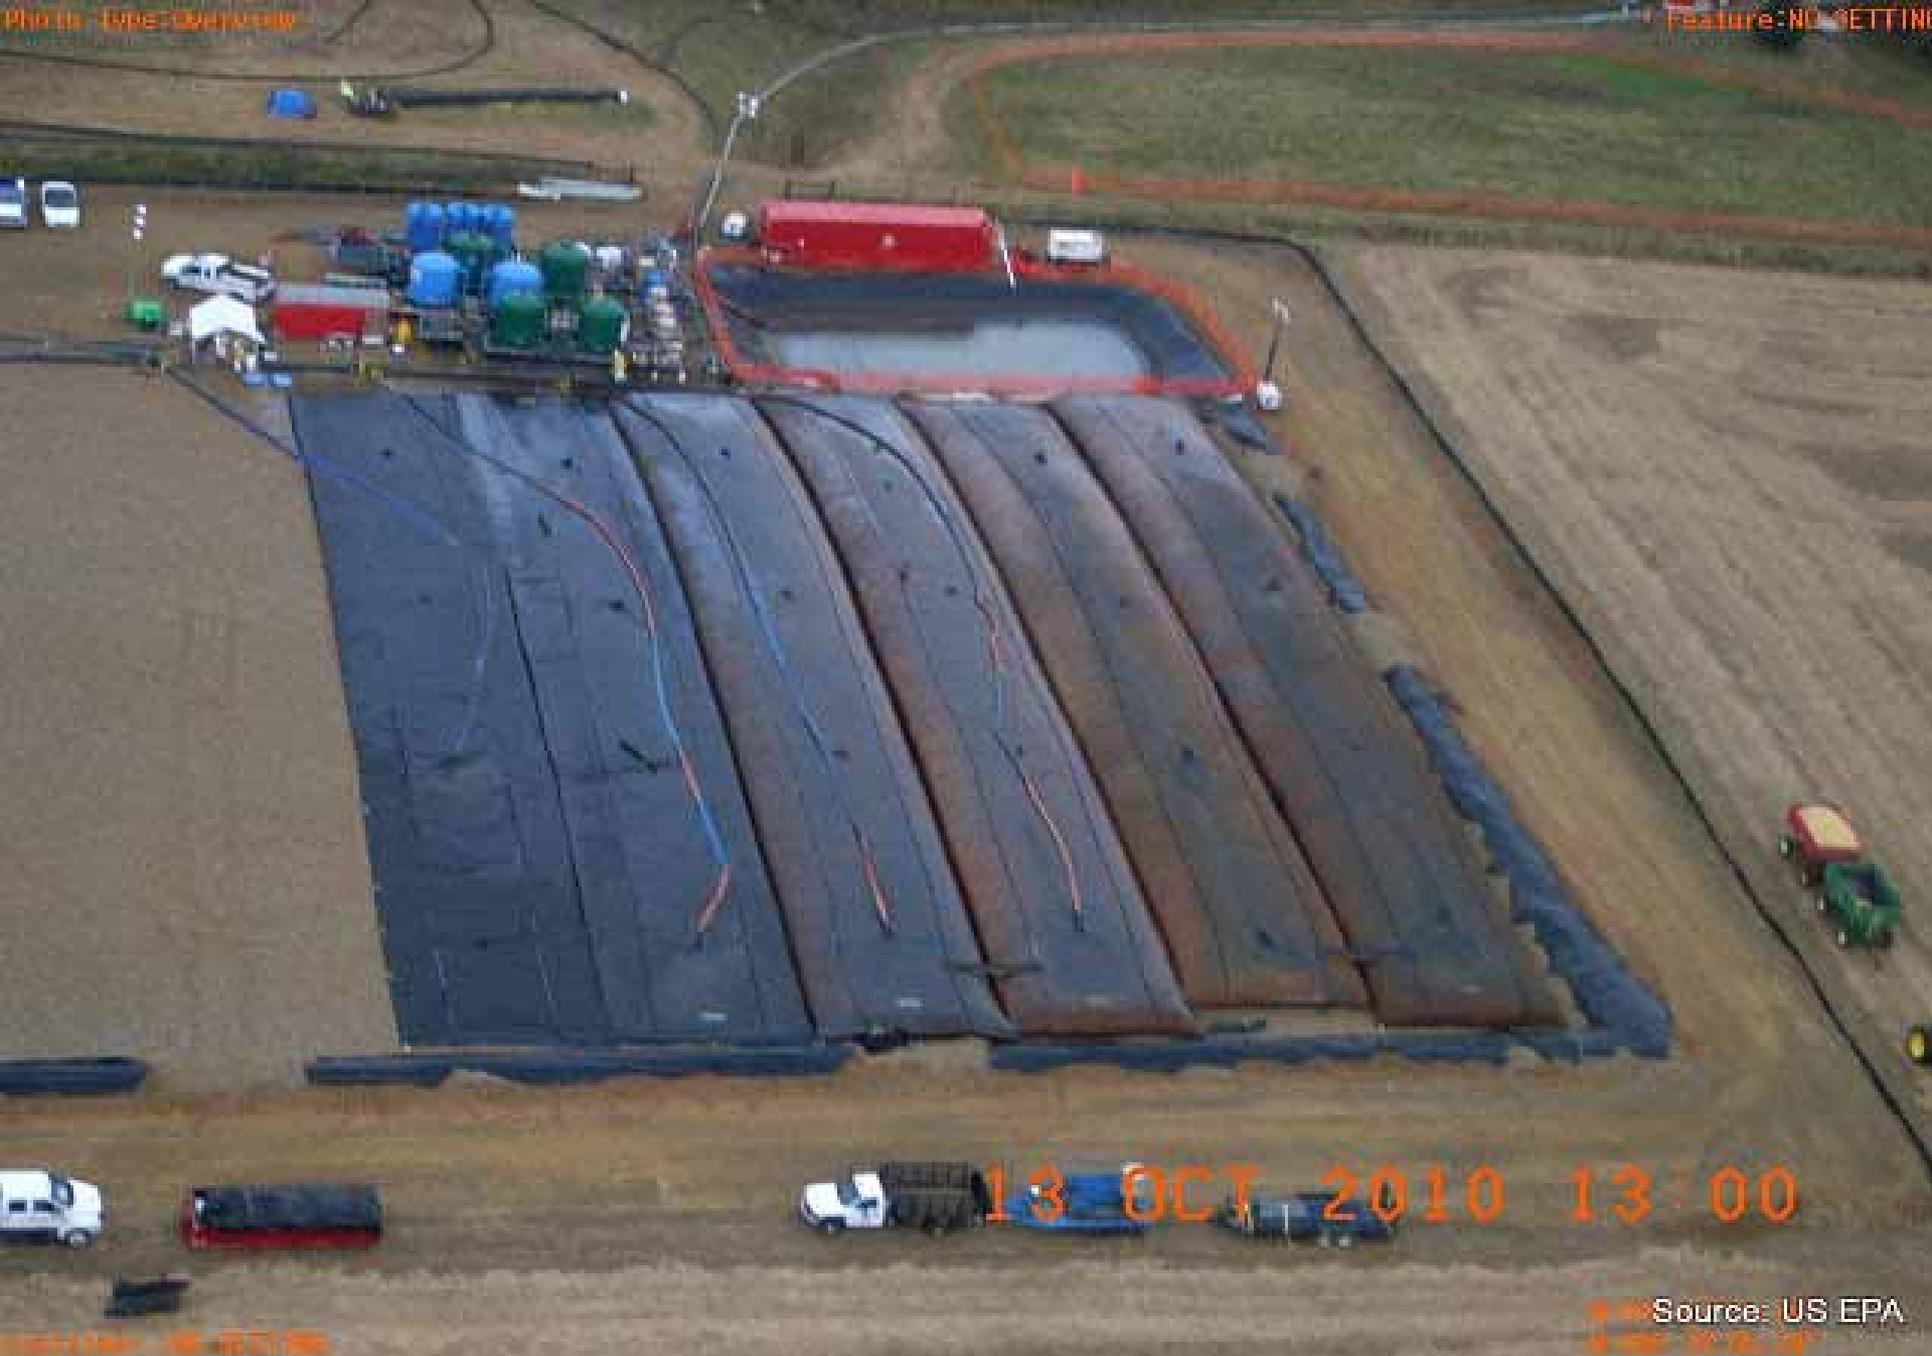
**Geotube filter system used to capture contaminated sediment.**

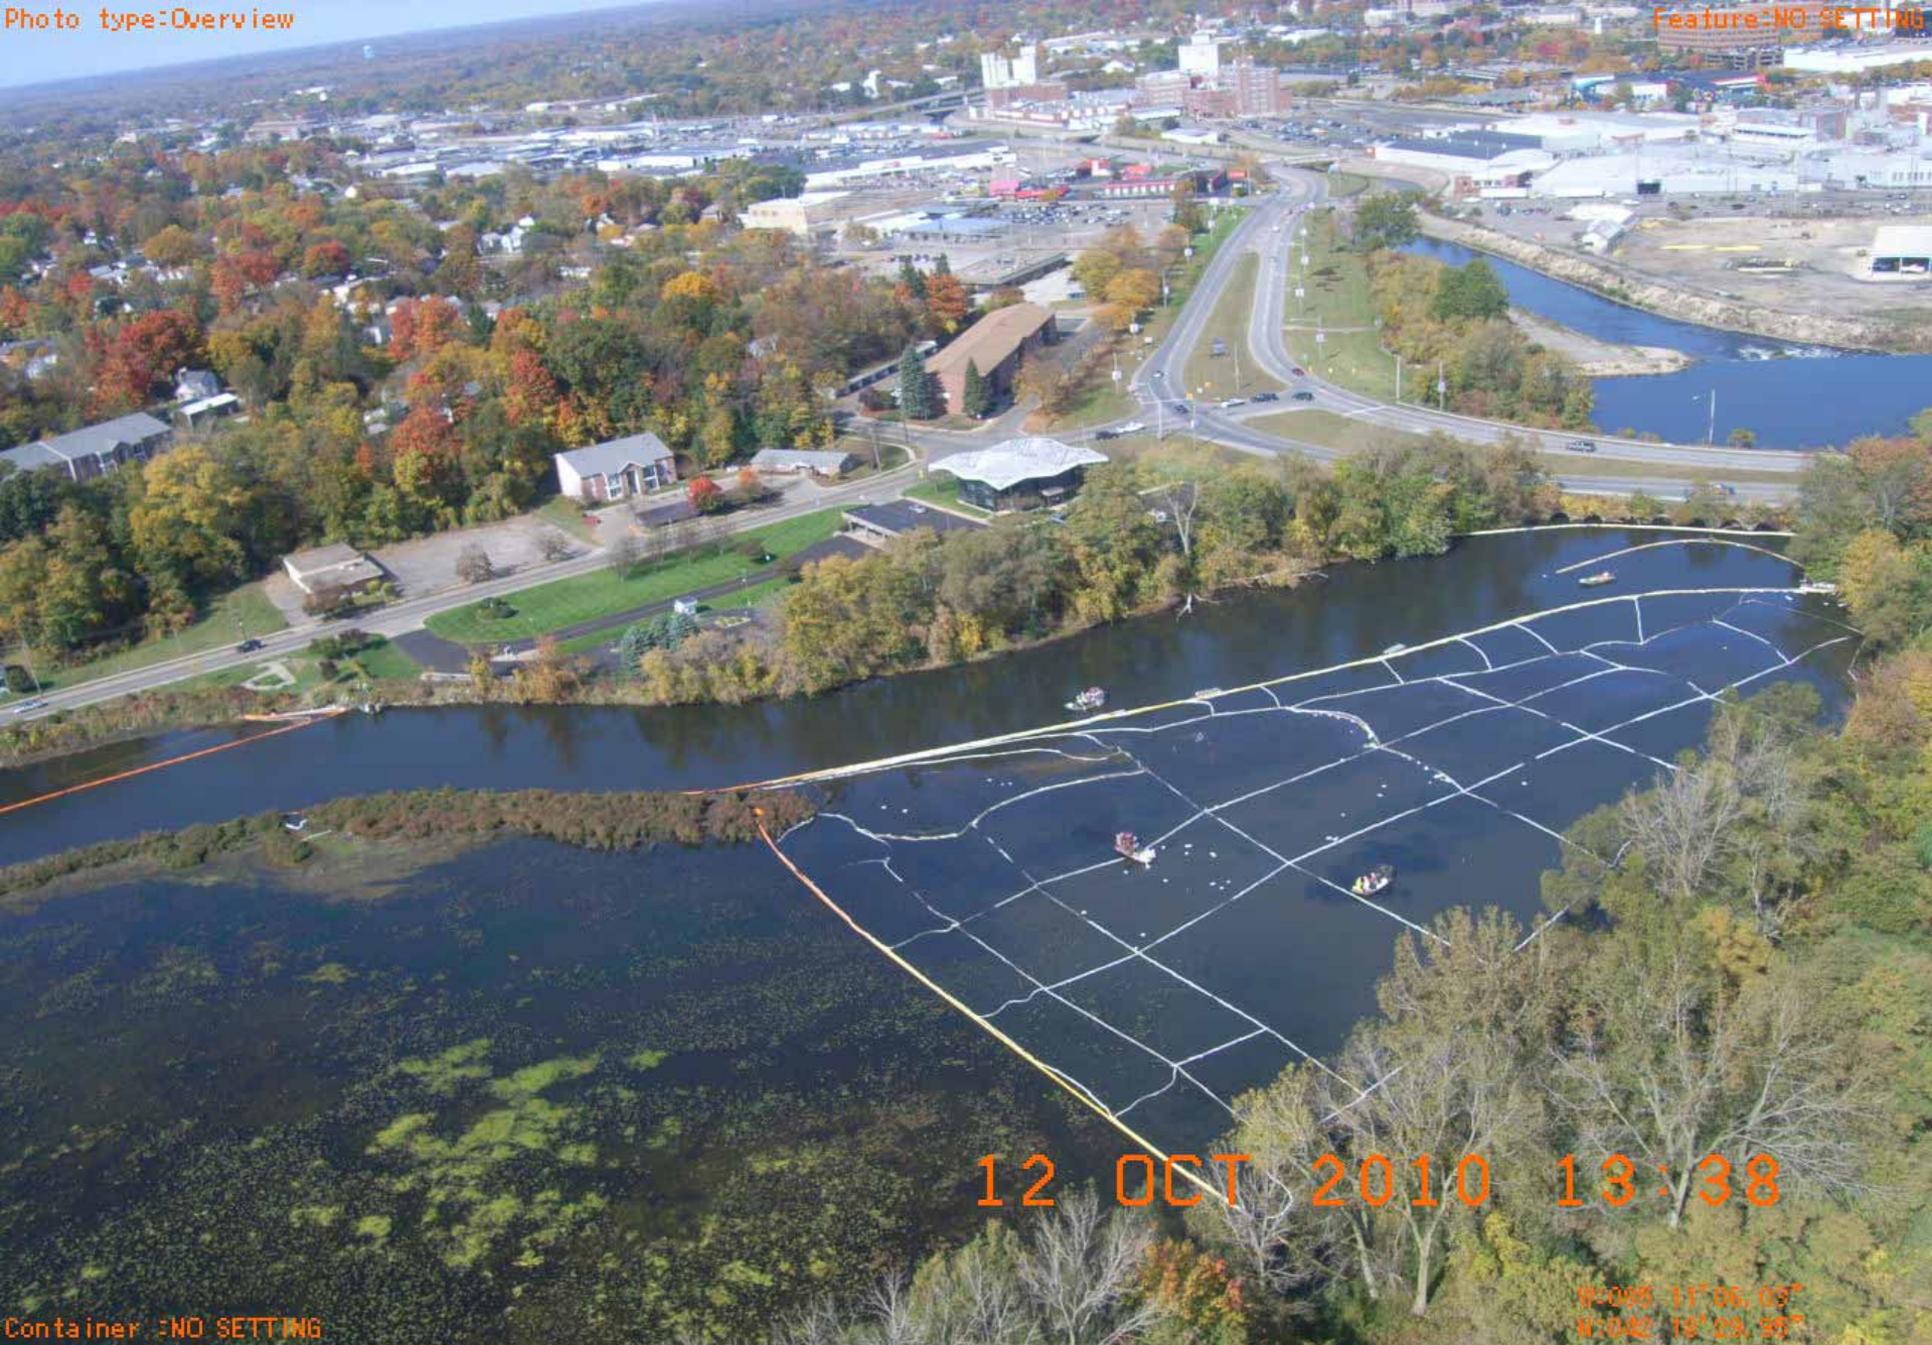
**Submerged oil recovery at "Mill Pond Area" in Battle Creek.**

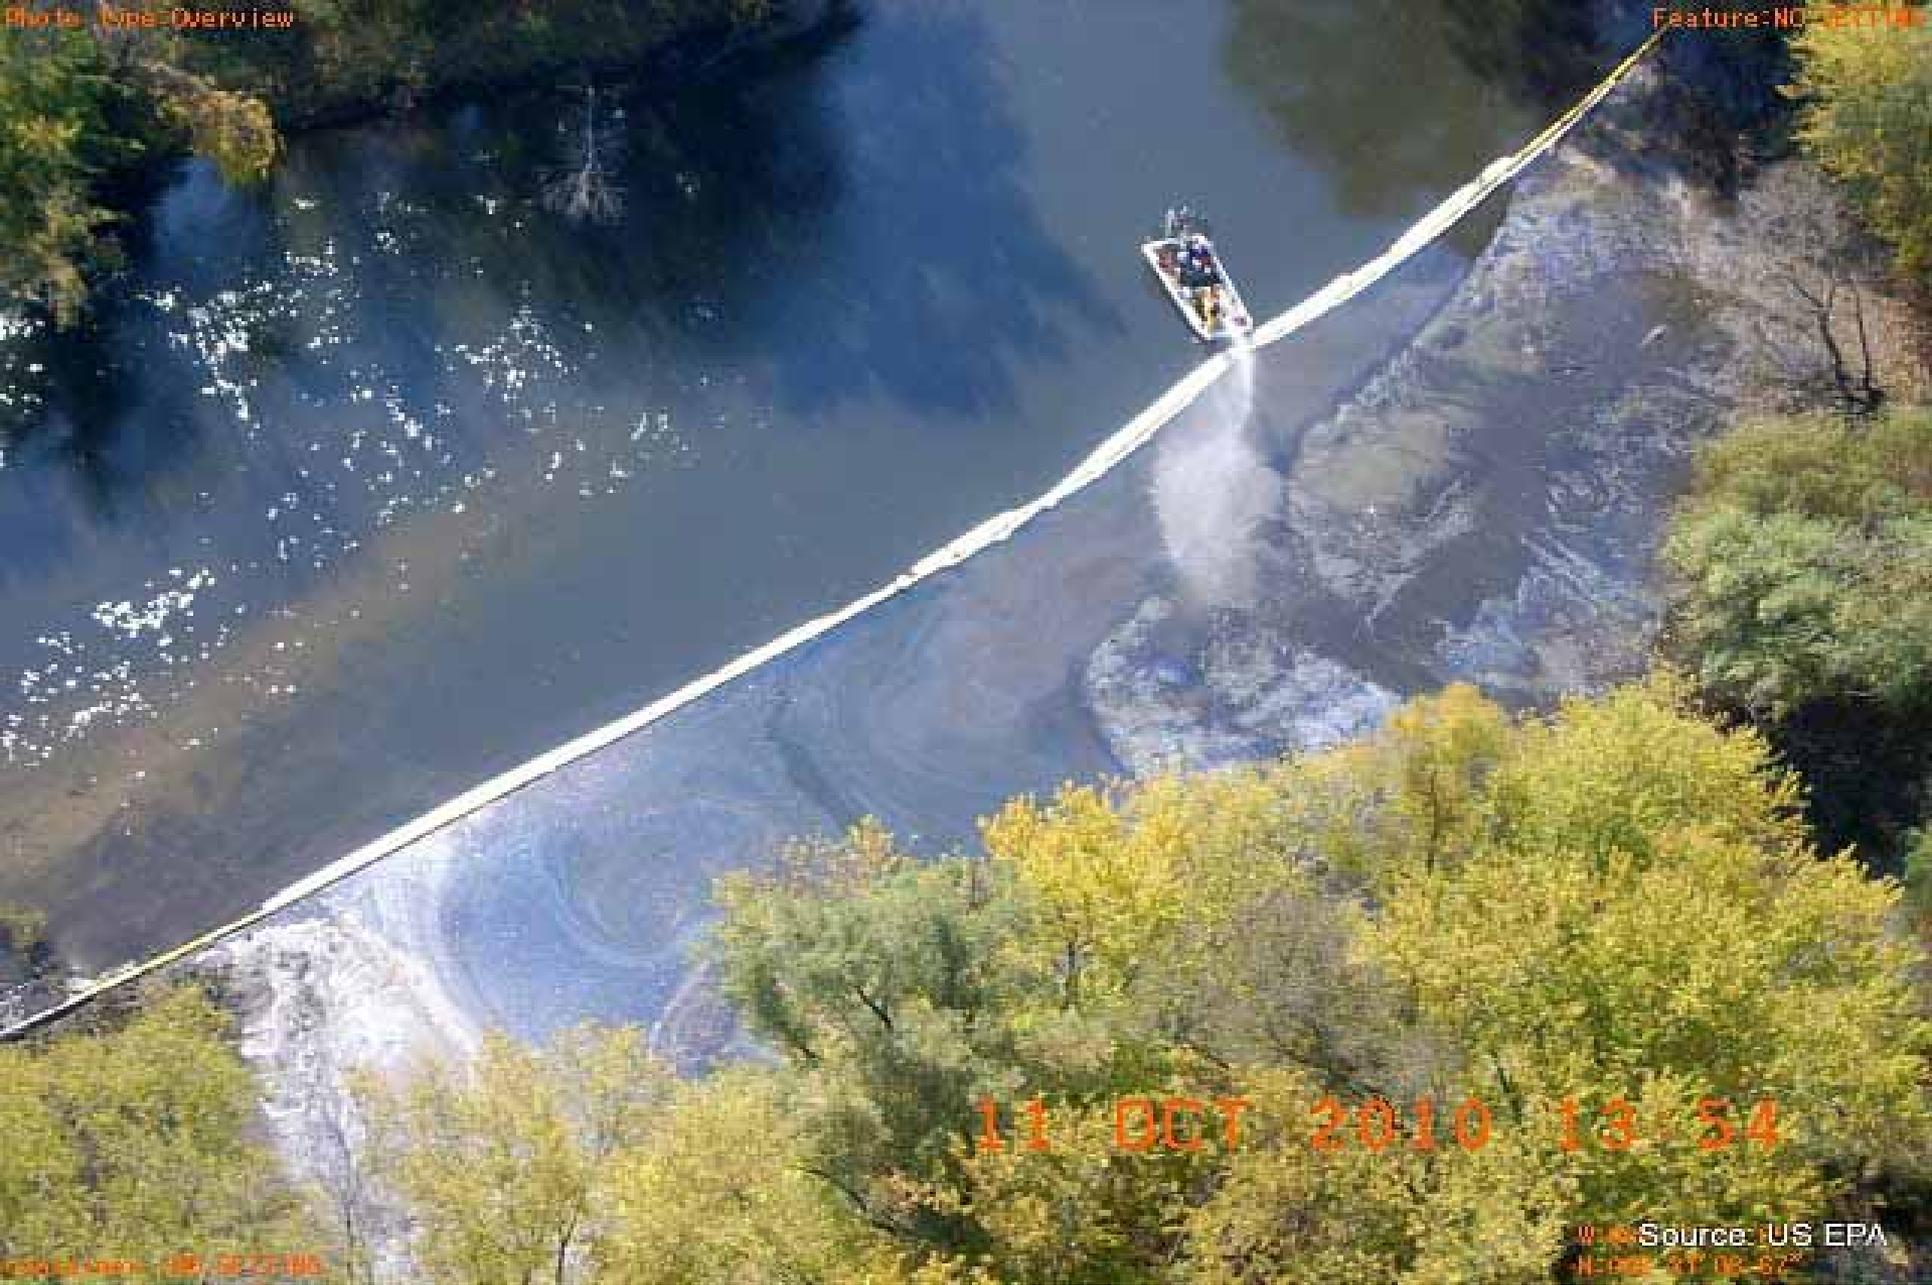
**Example of submerged oil aeration, flushing, and recovery. Sediment is agitated to reintroduce oil to the surface so it can be collected.**

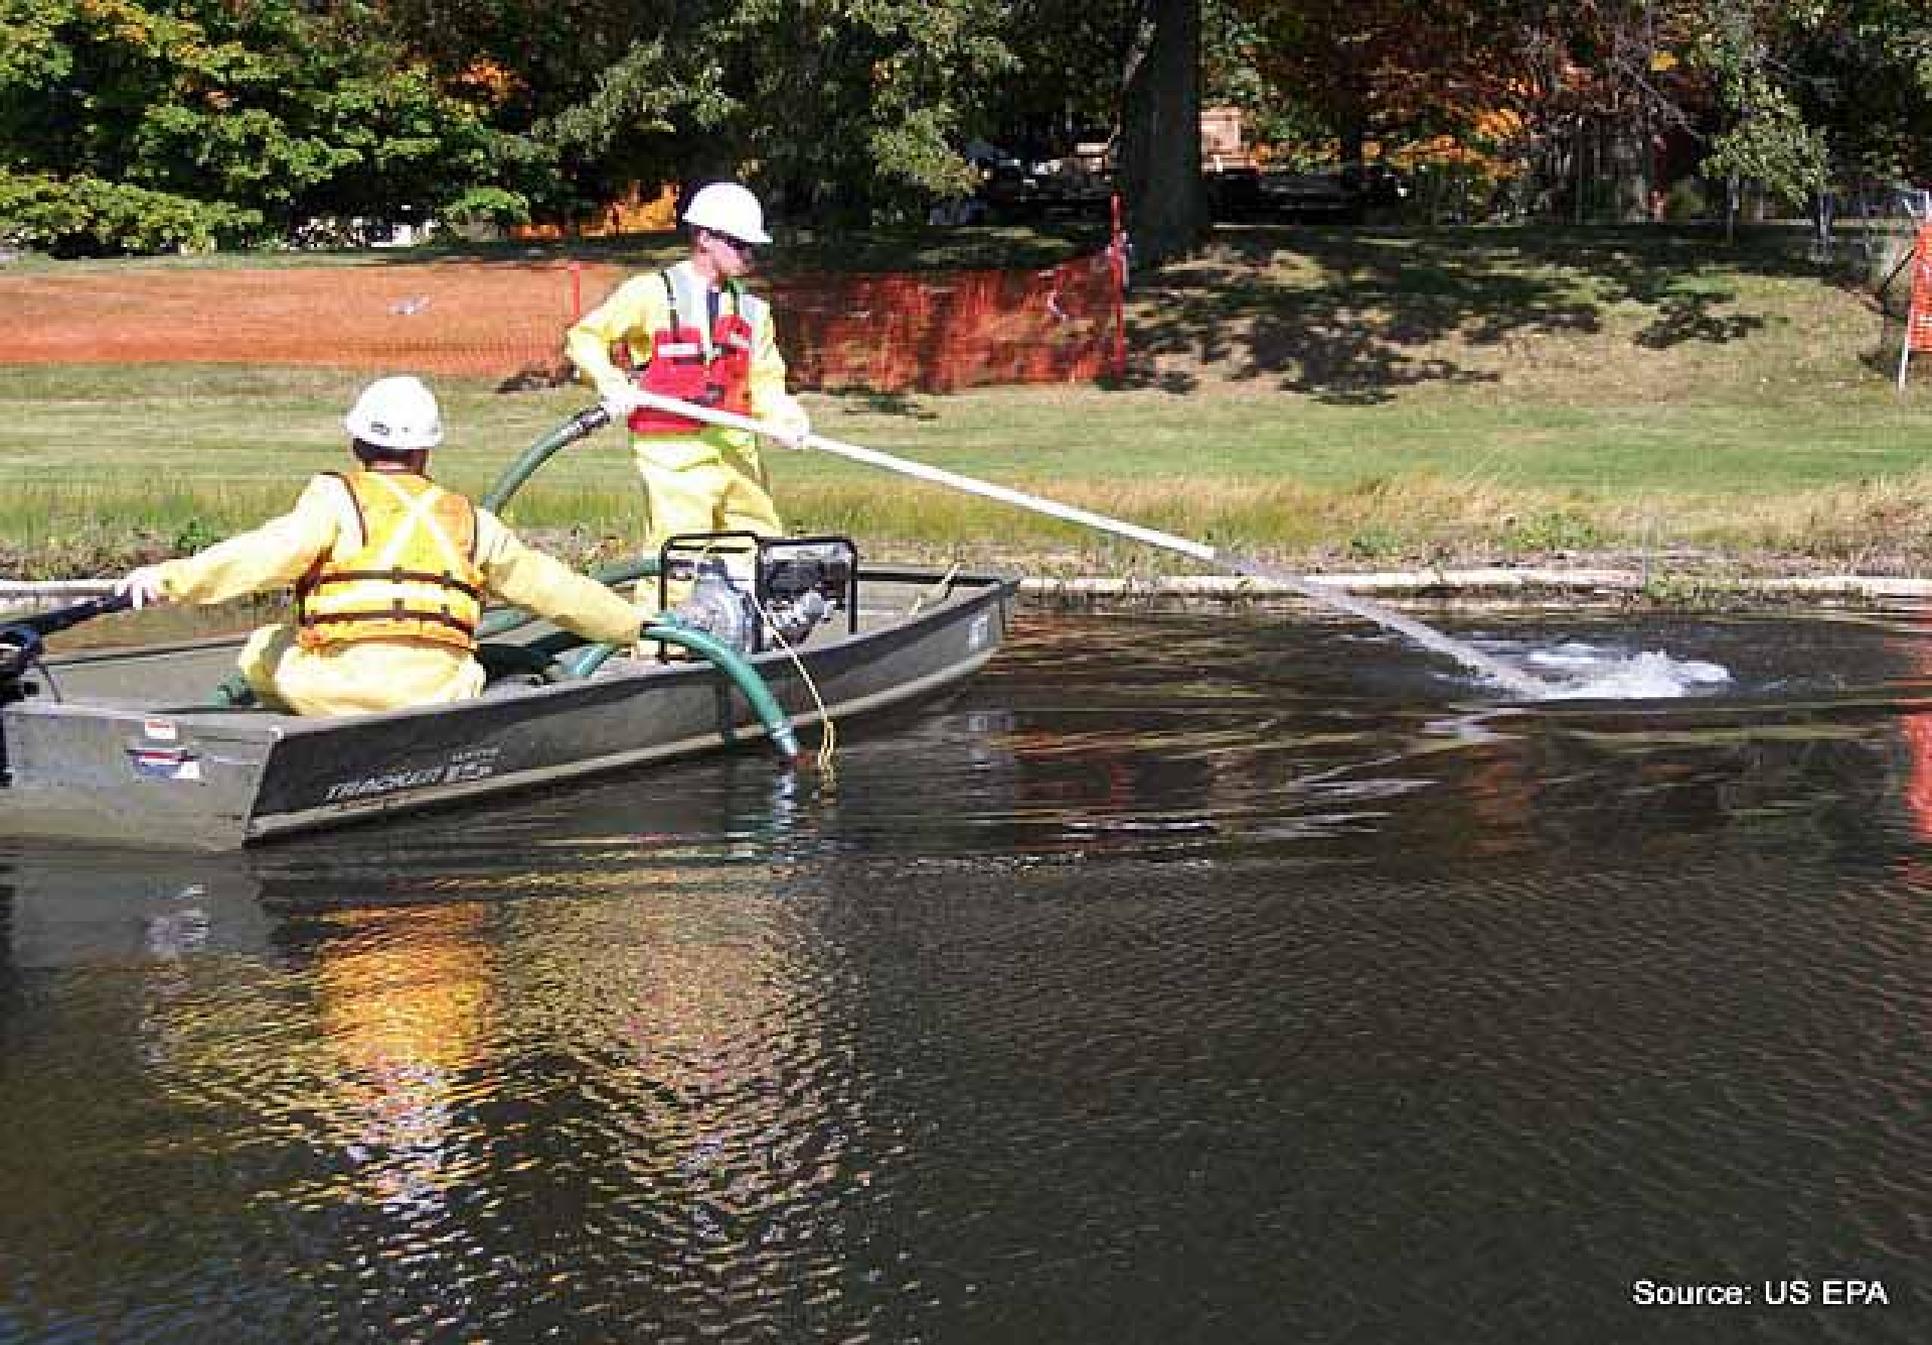
**Riverbank flushing activities.**

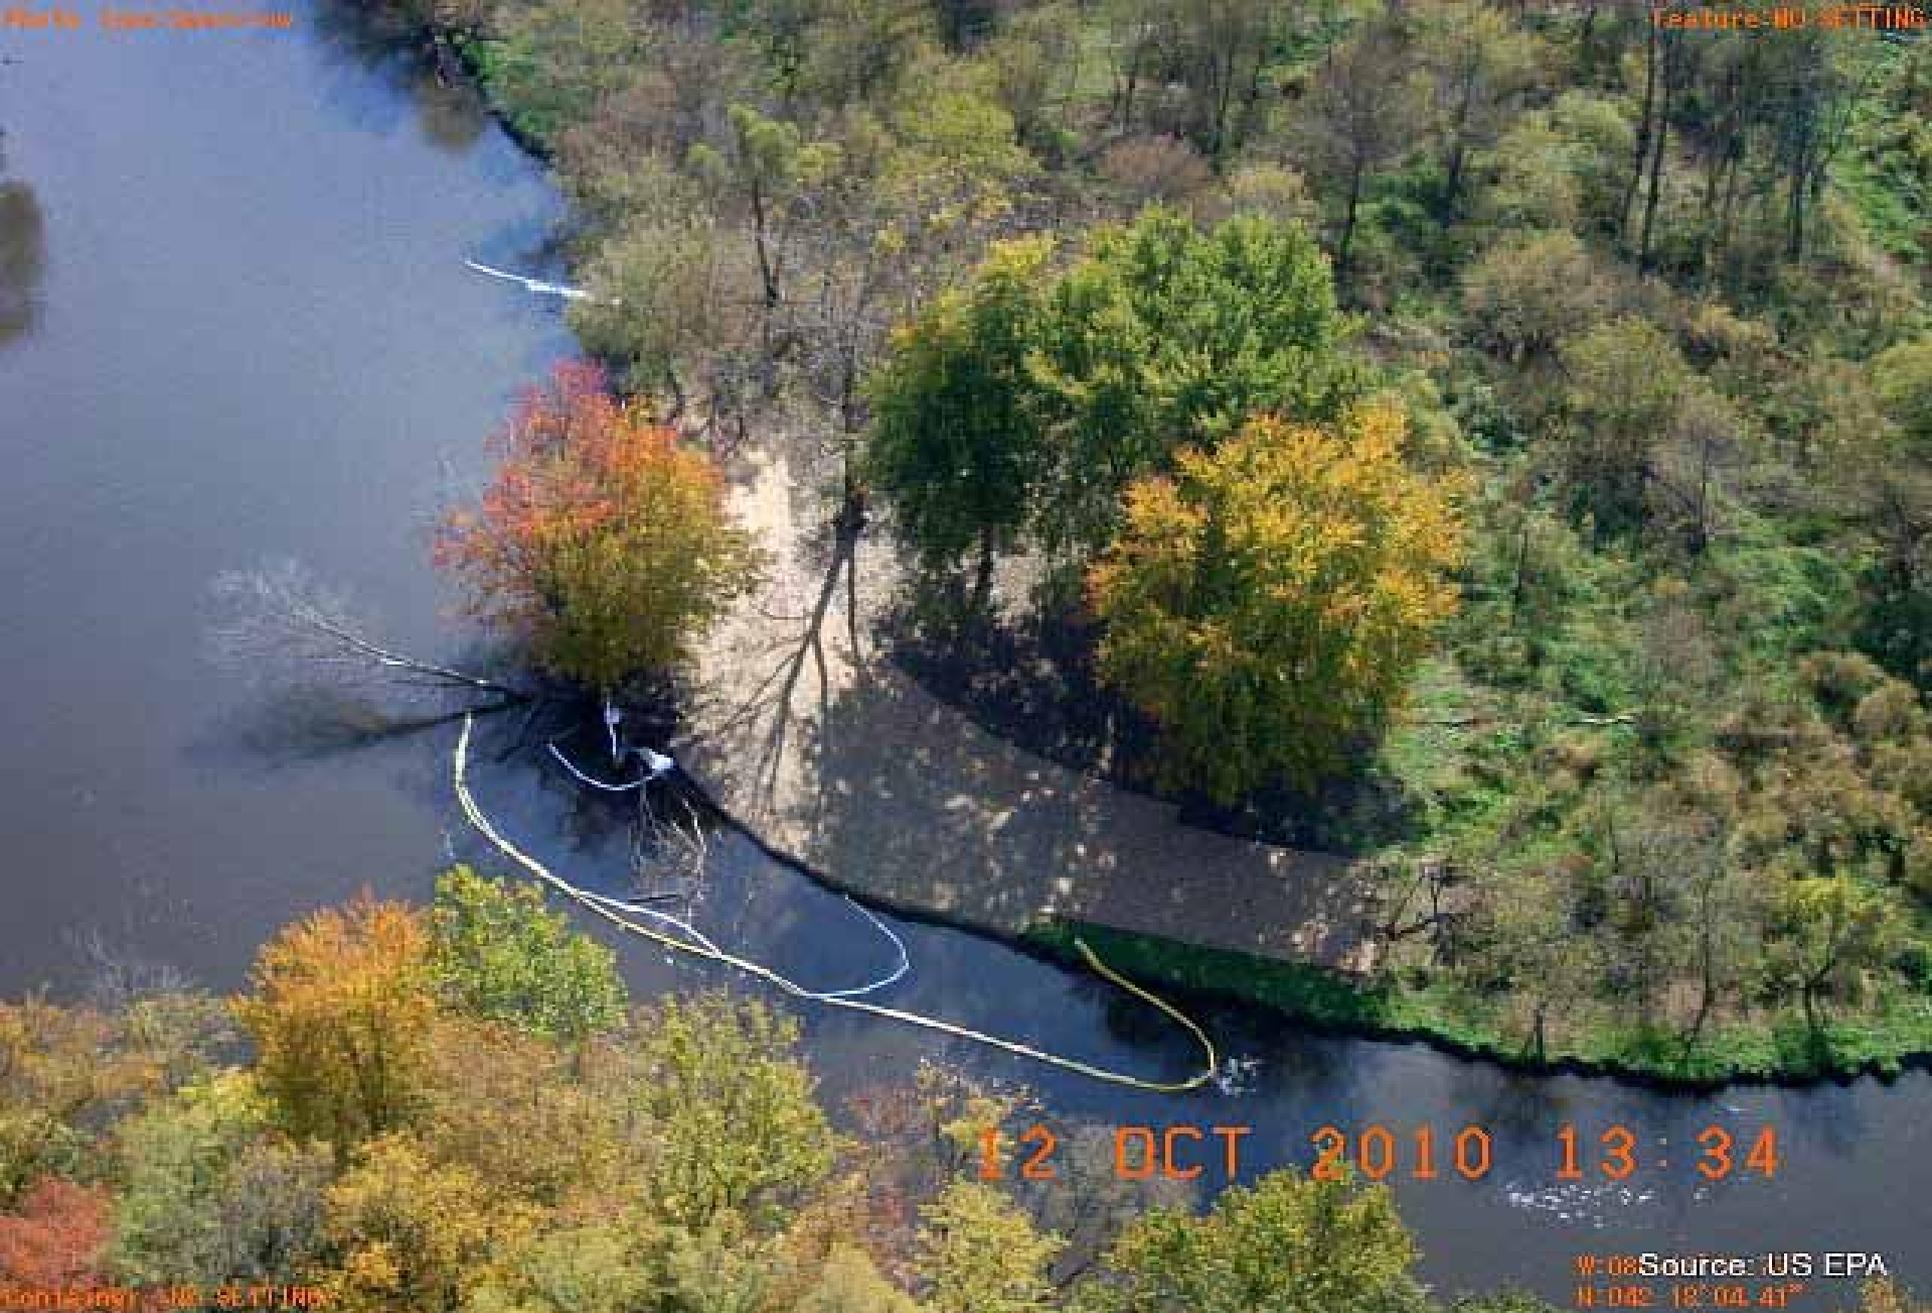
**Riverbank restoration and long-term containment . Some areas on river will be monitored over time for potential contamination.**

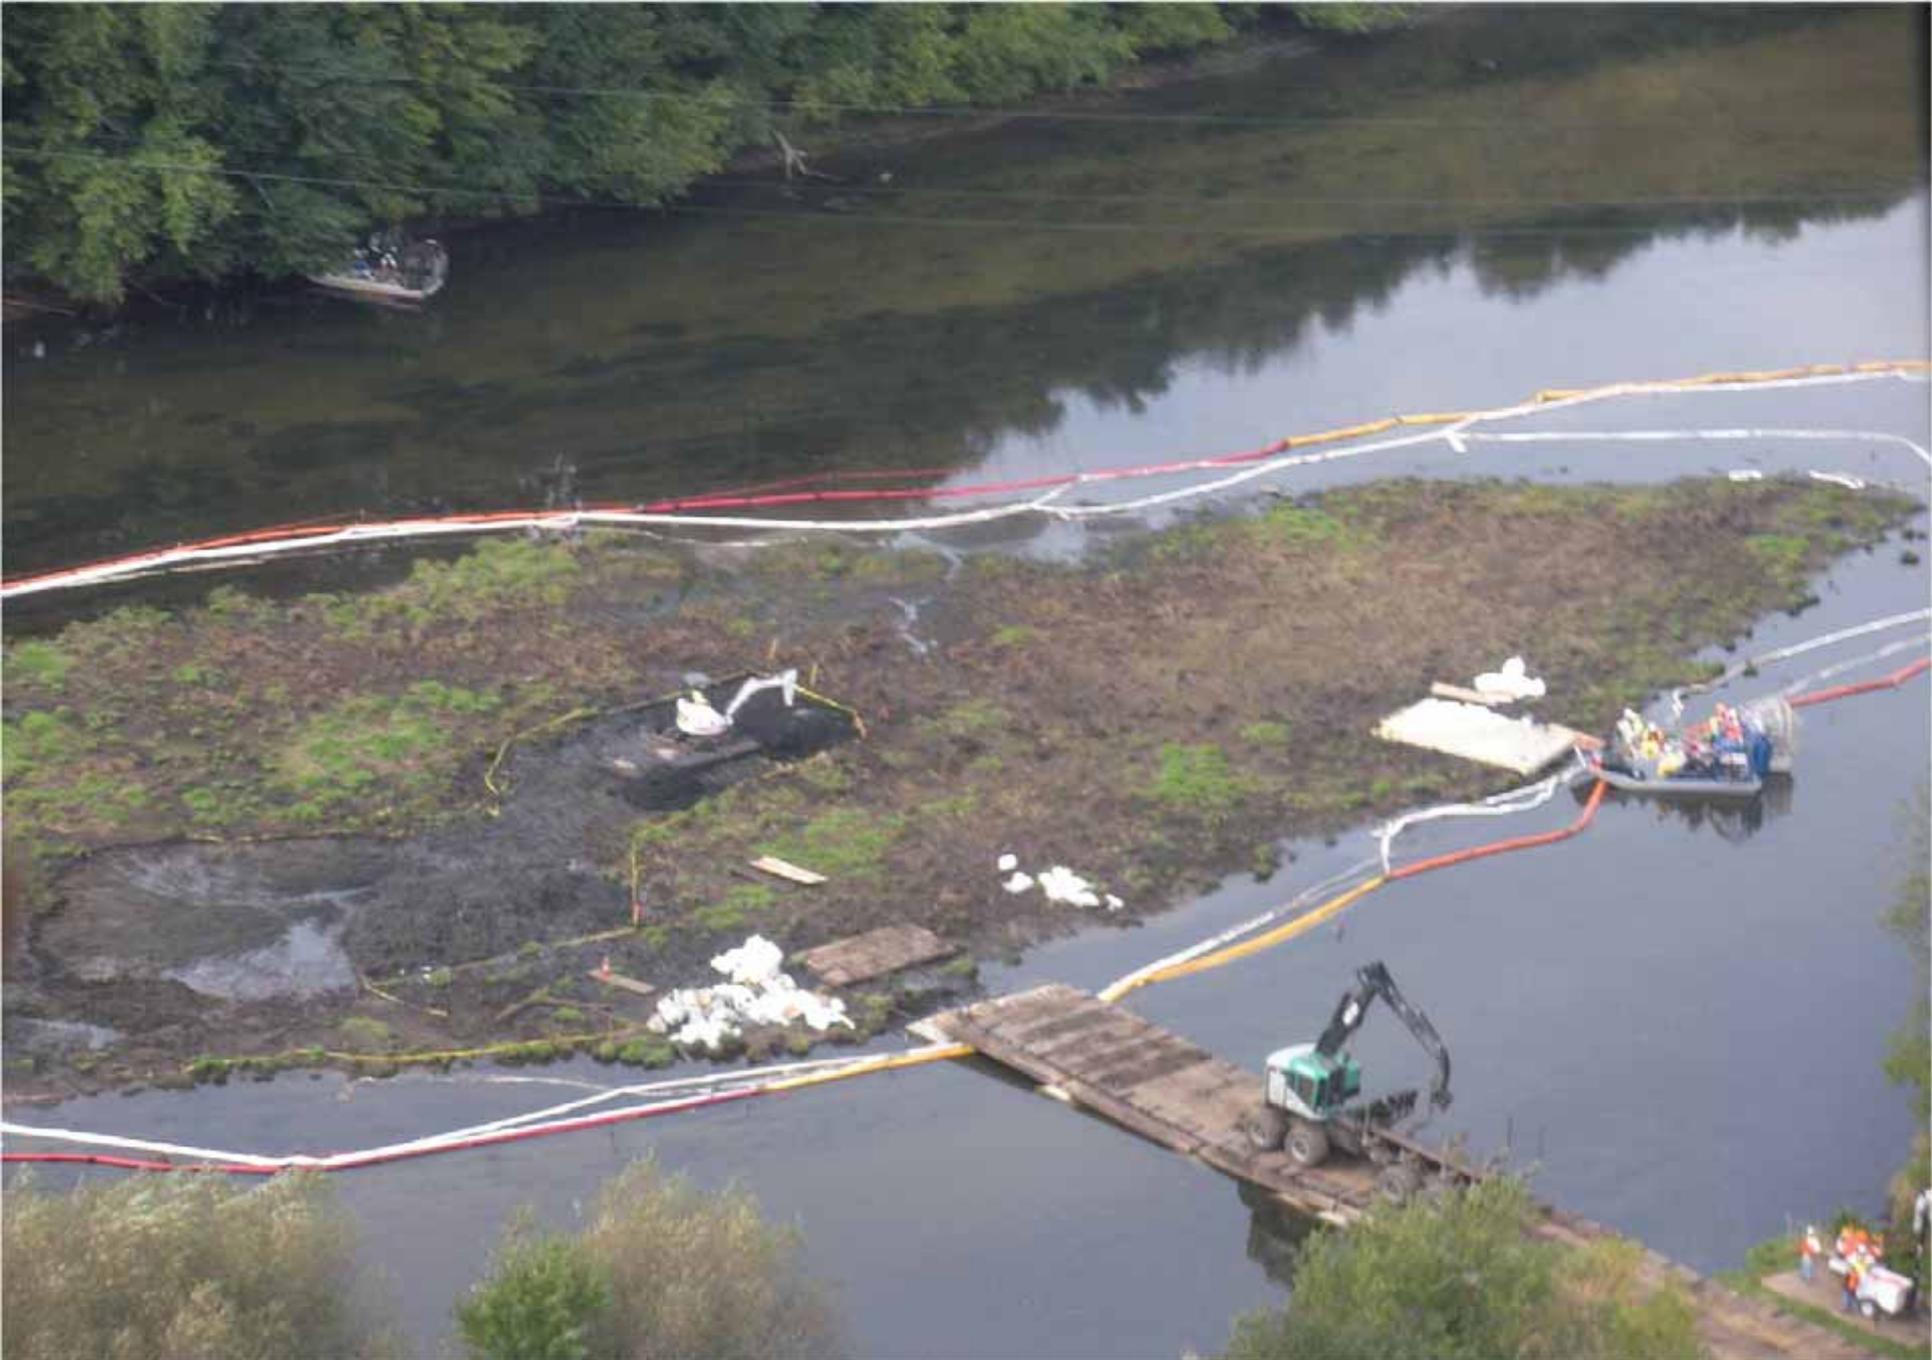
**Residual contamination on islands will be monitored over time.**

**Stains on trees and rocks will fade over time and do not present health or environmental risks.**

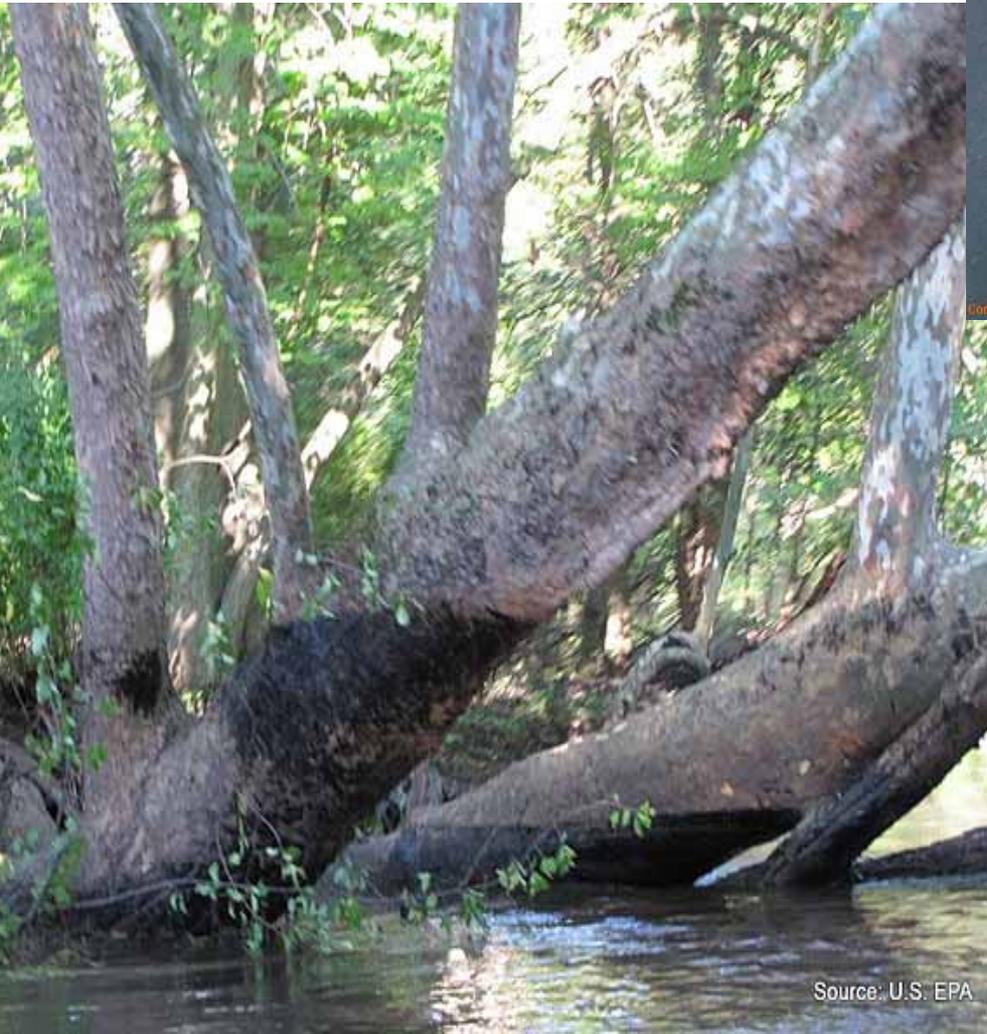
**Other areas will require long-term operation and maintenance to continue to reduce contamination levels.**
