Appendix A: Photographs of the Areas Impacted by the Enbridge Line 6B Oil  
Discharges and of Response Actions  
from U.S. EPA presentations in 2010 and 2015

# Enbridge Line 6B Incident

## Public Update and Availability Session

October 14, 2010  
(Day 81)

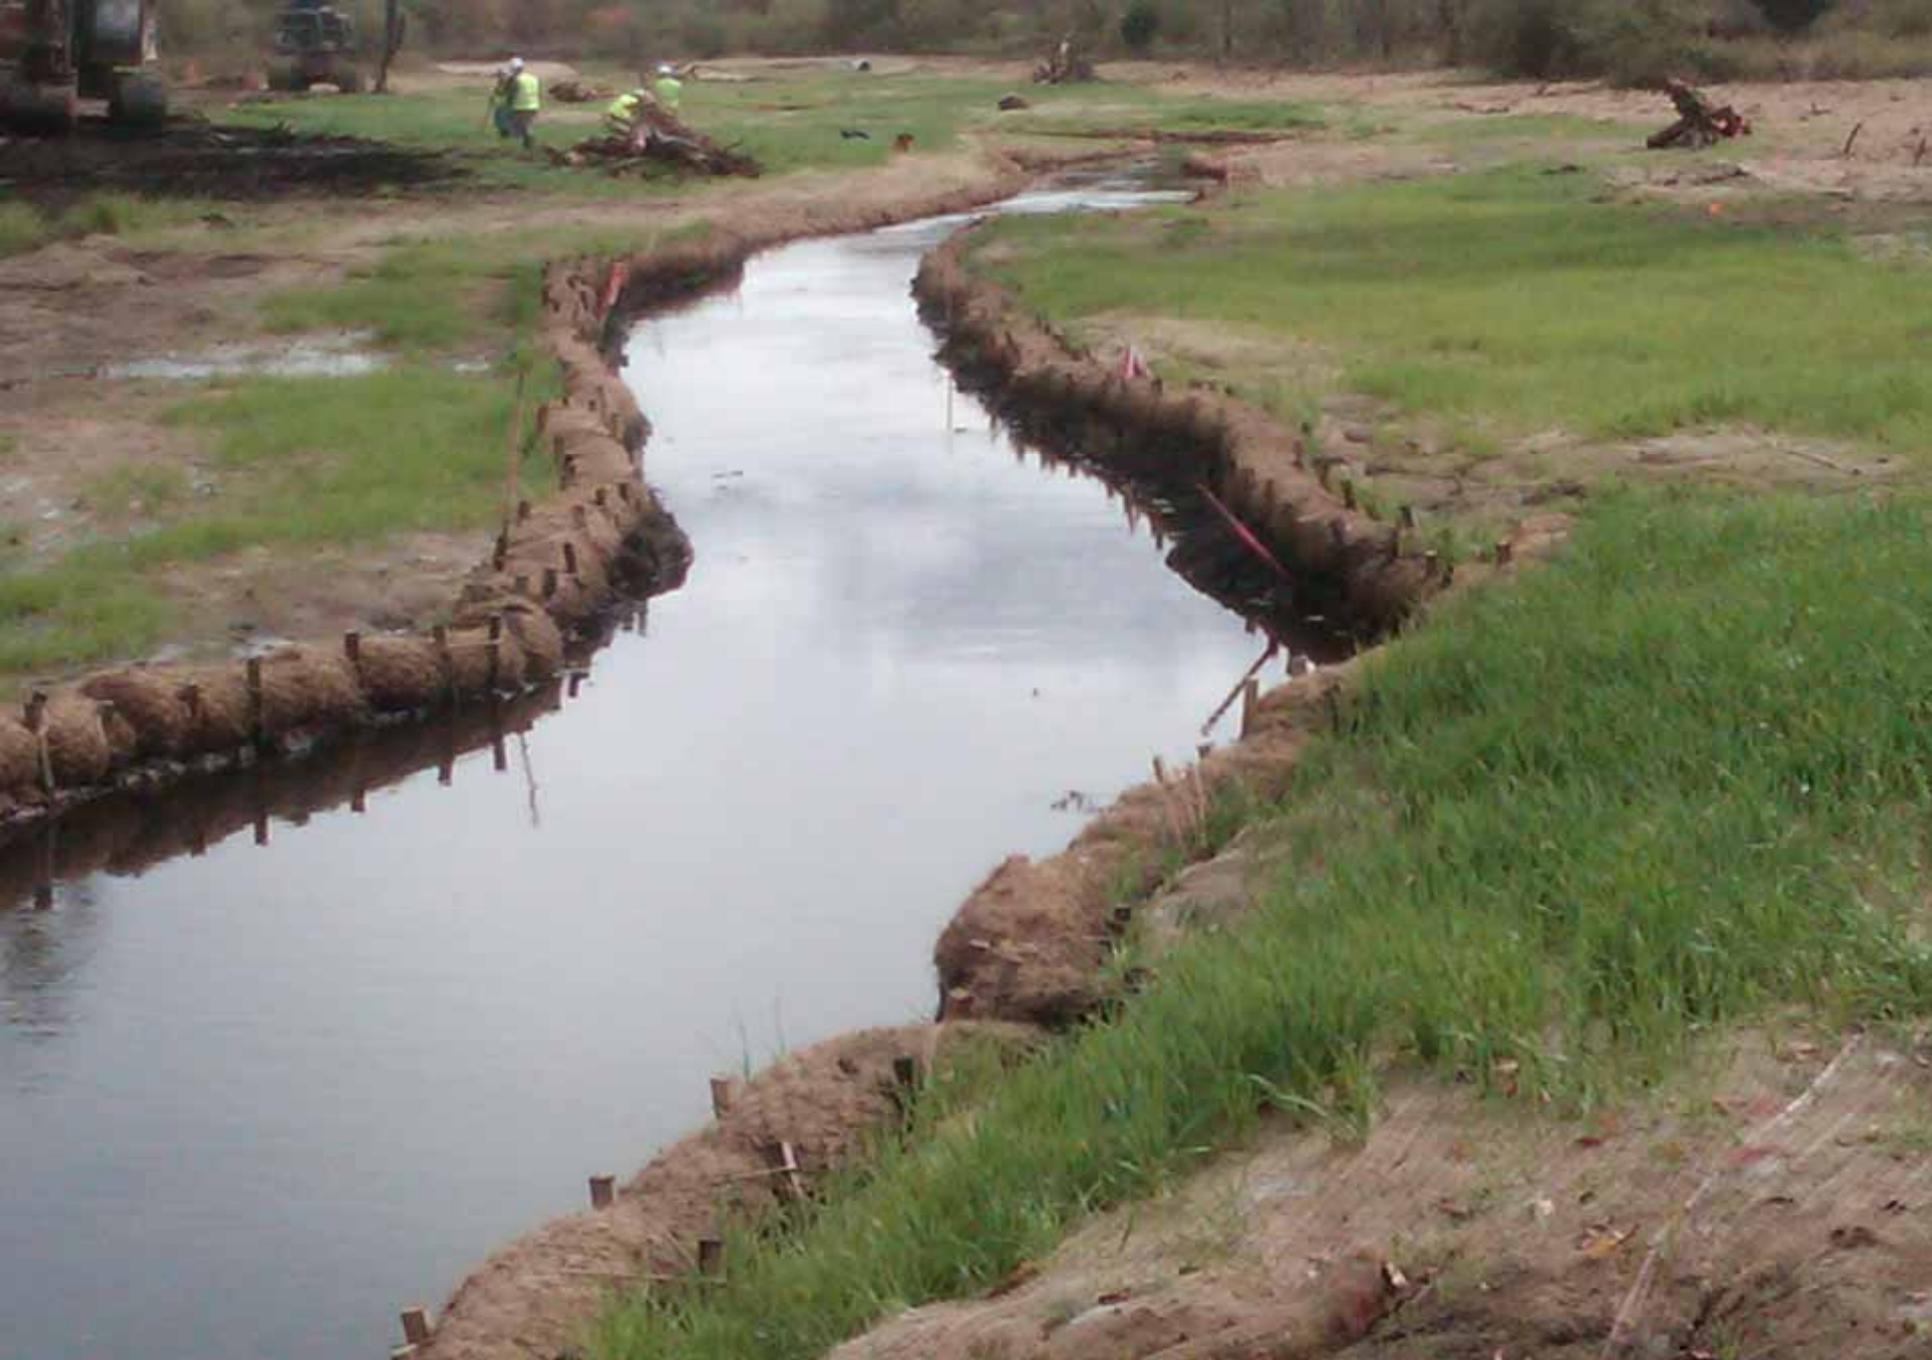
**View of Talmadge Creek on Oct. 14, 2010.**

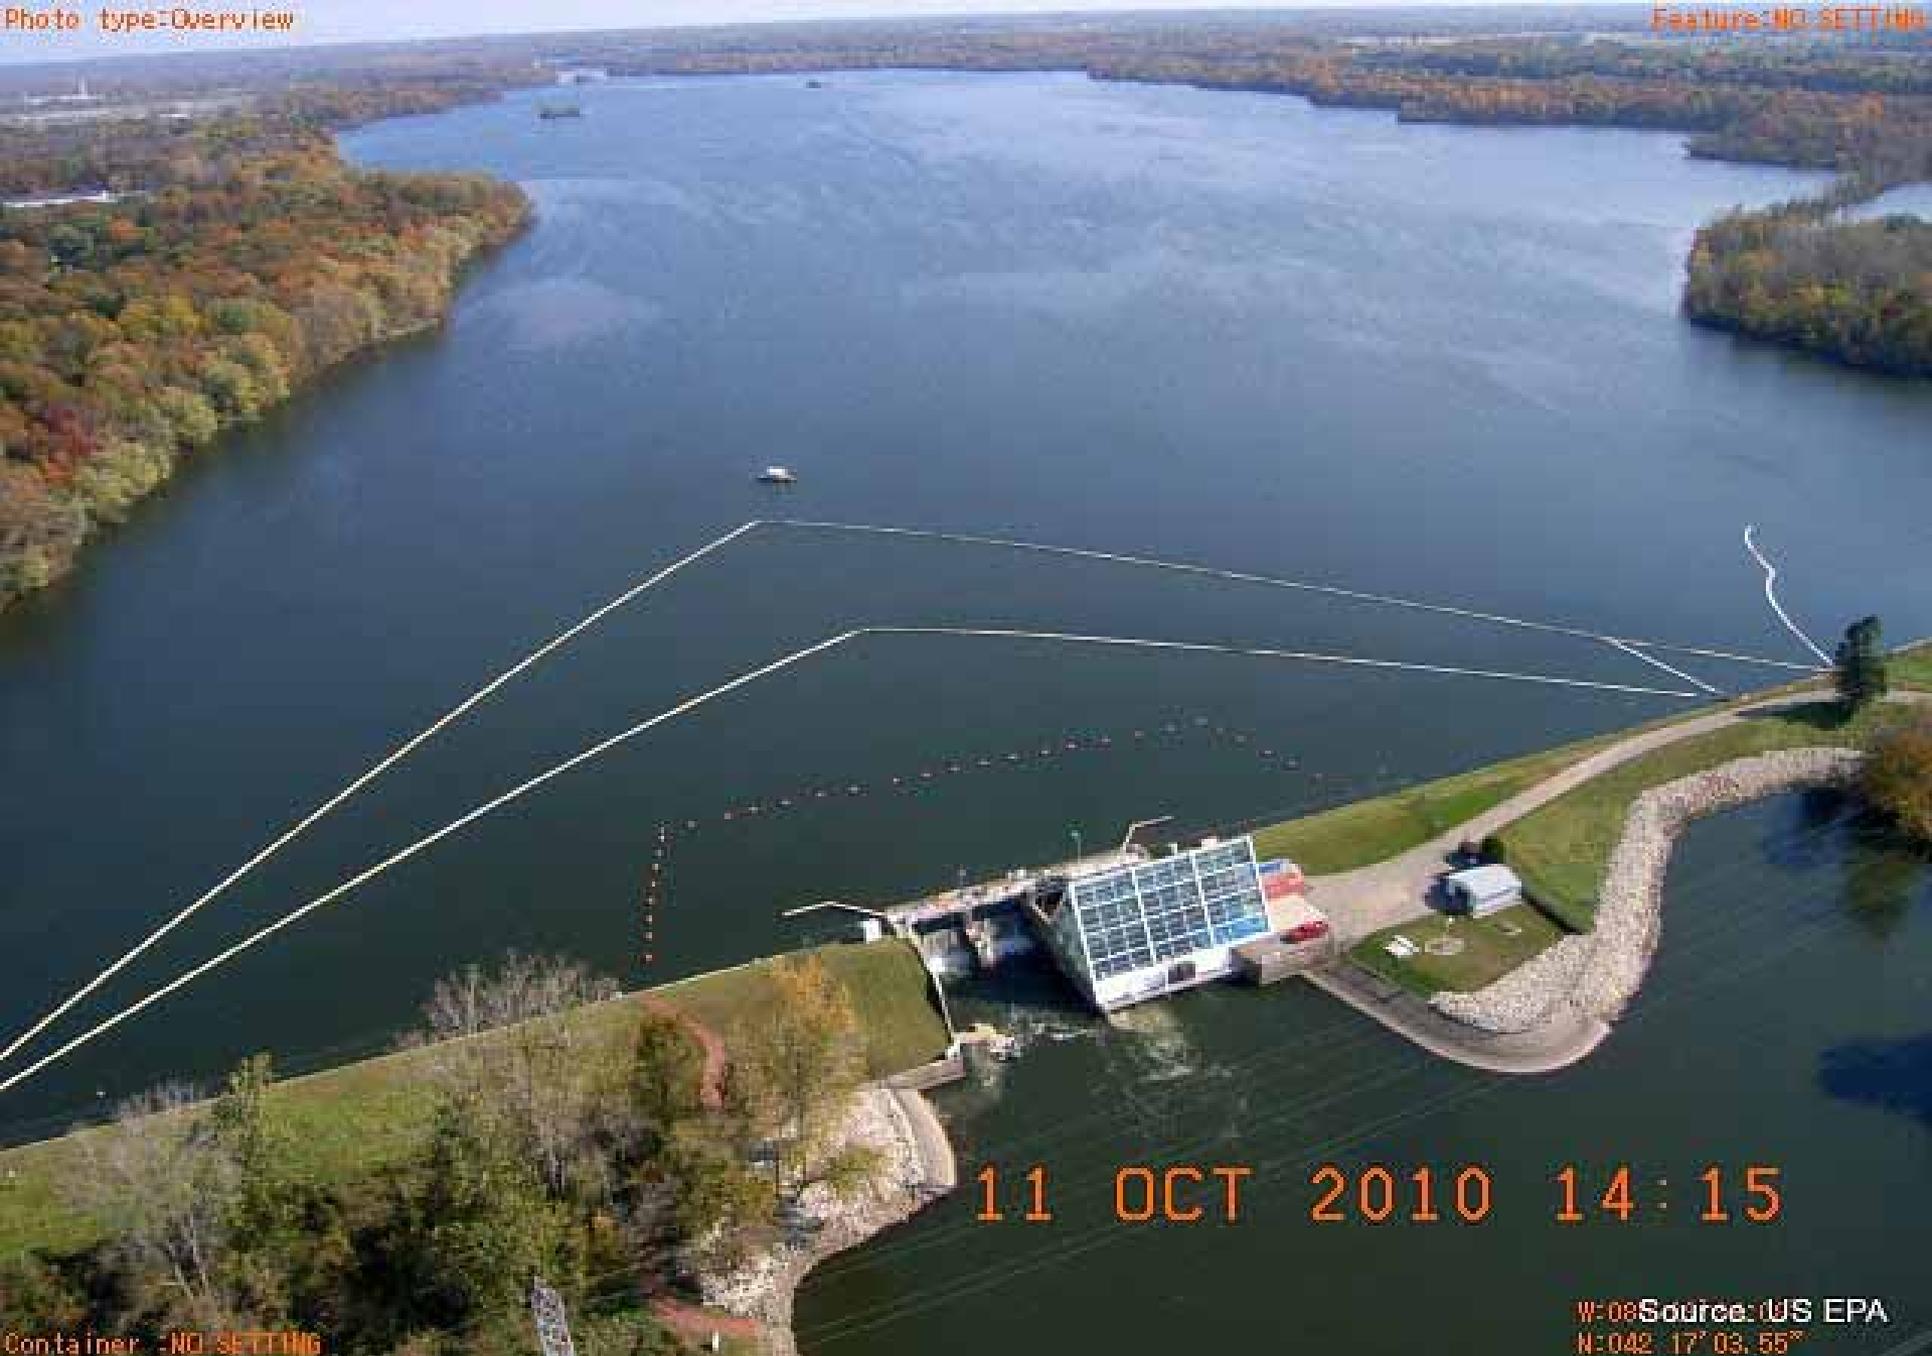
Morrow Lake, October 11, 2010.

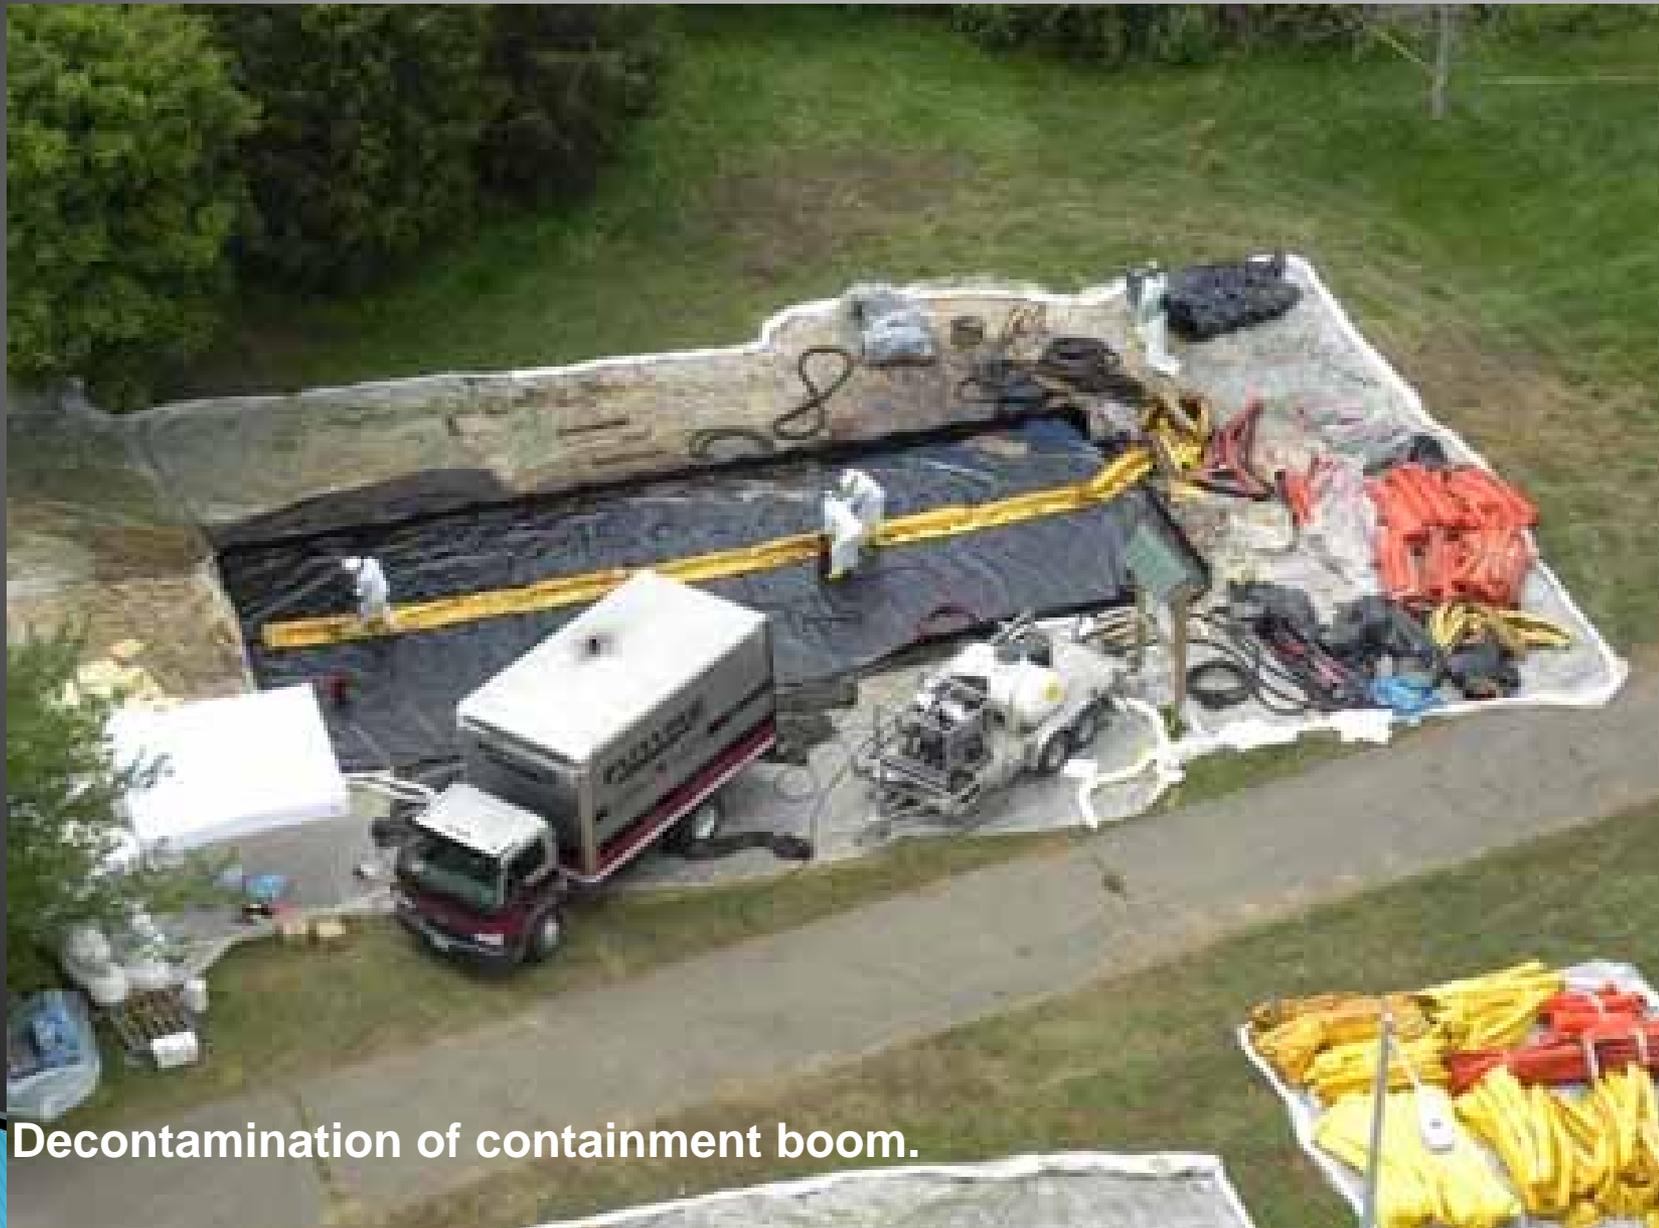
Decontamination of containment boom.

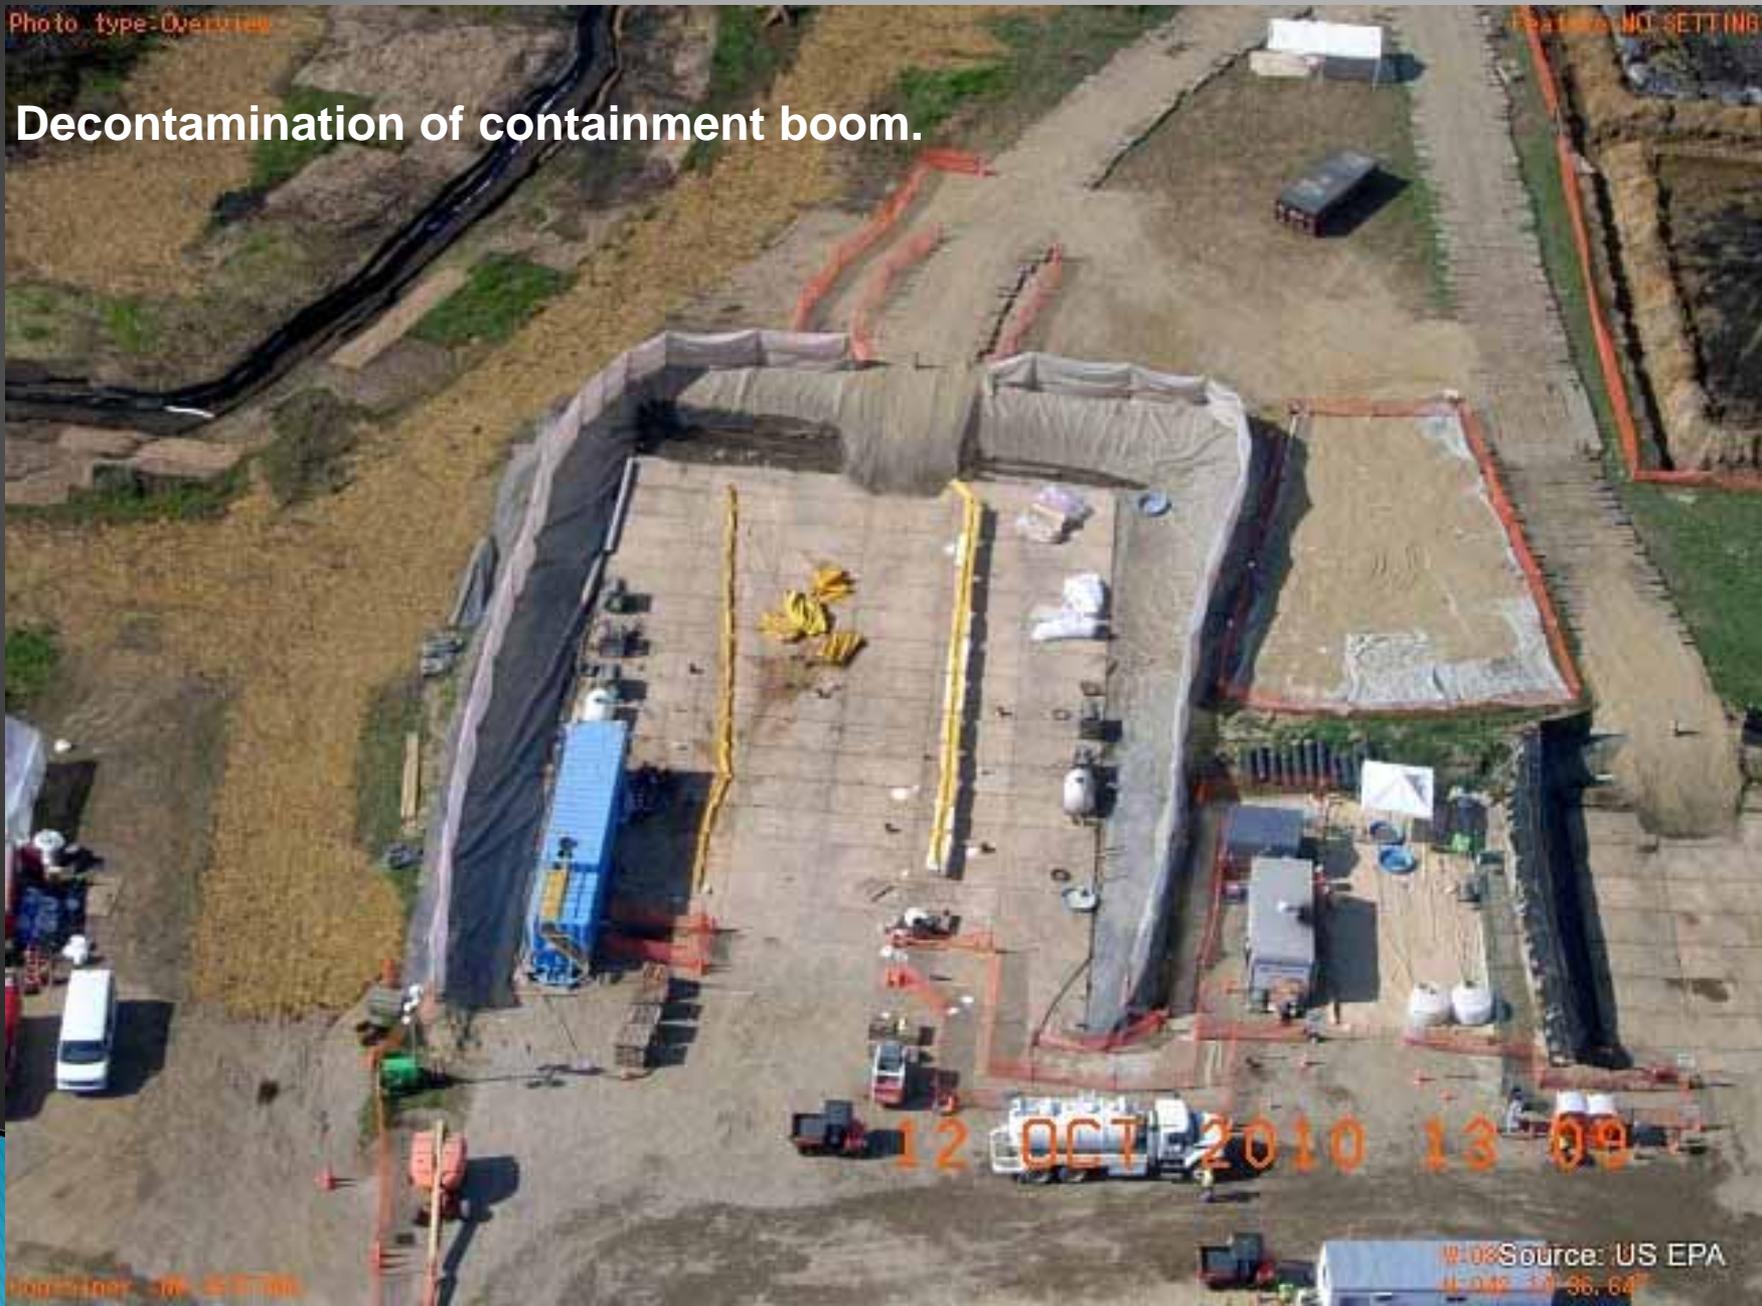
Decontamination of containment boom.

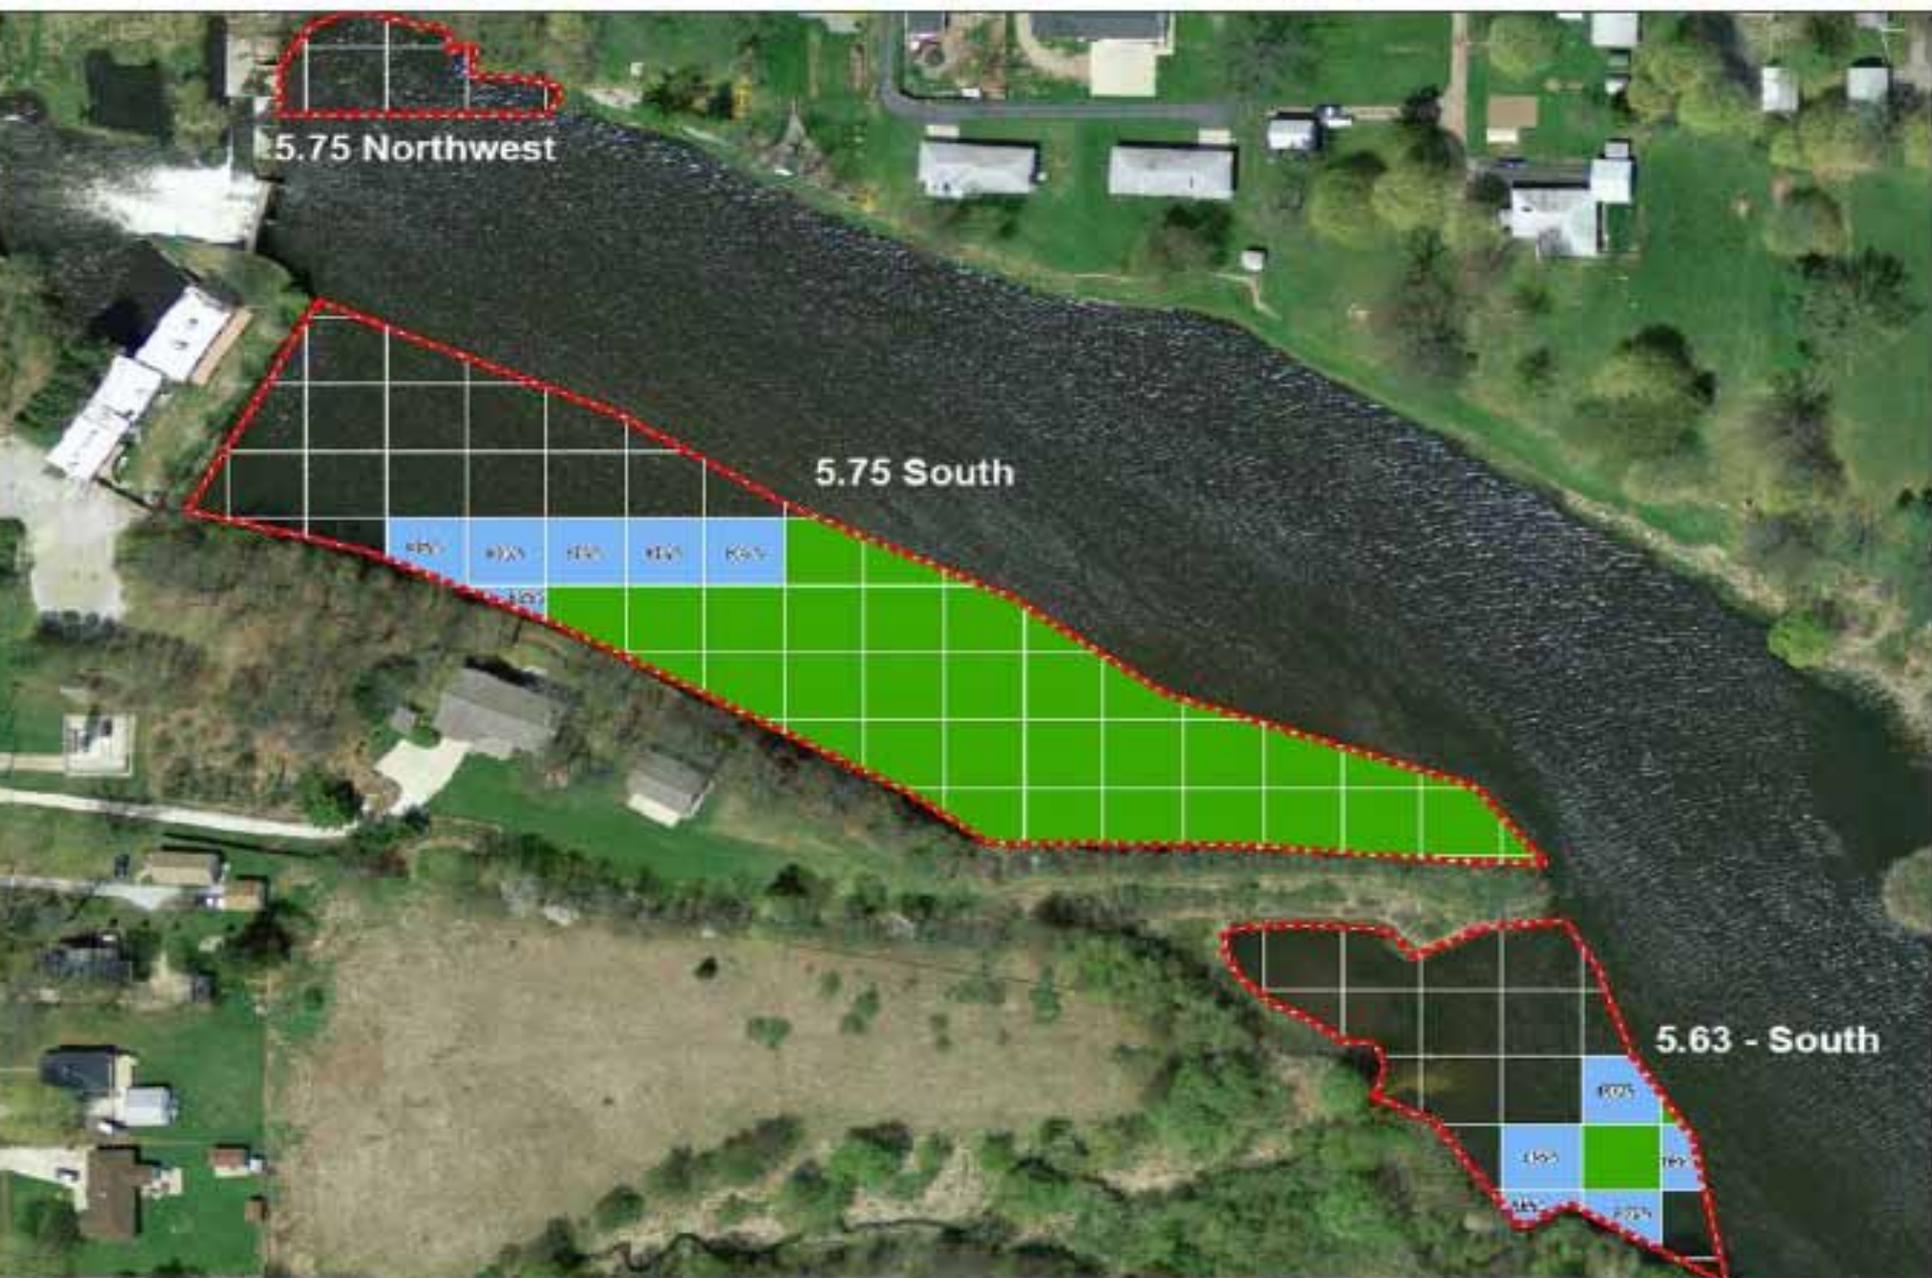
**Ceresco Dam dredging progress as of Oct. 12, 2010: green indicates completed areas and blue shows areas in progress.**

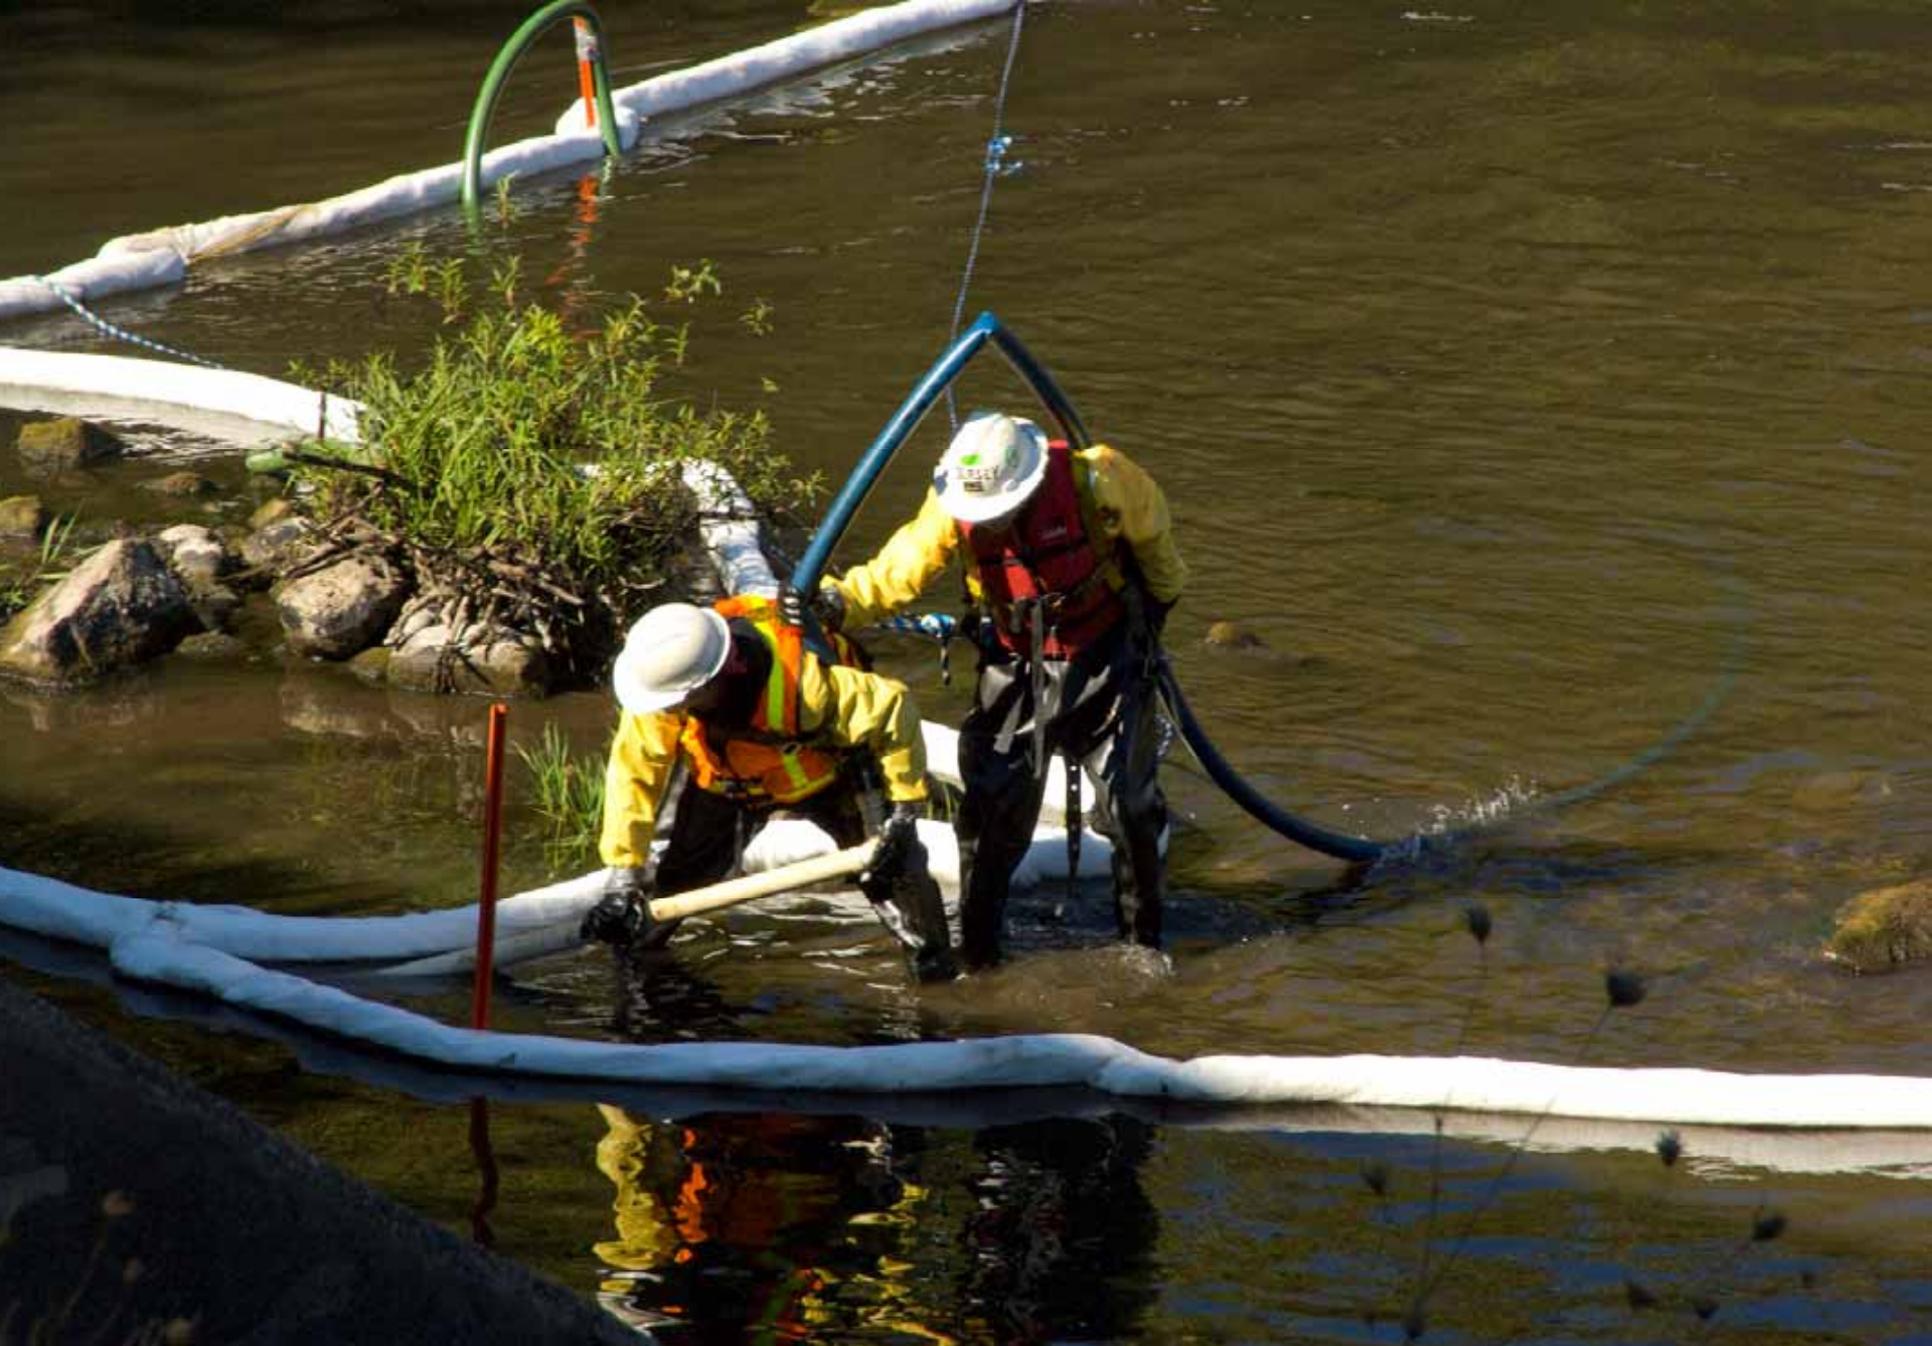
**Close-up shot of aeration activities.**

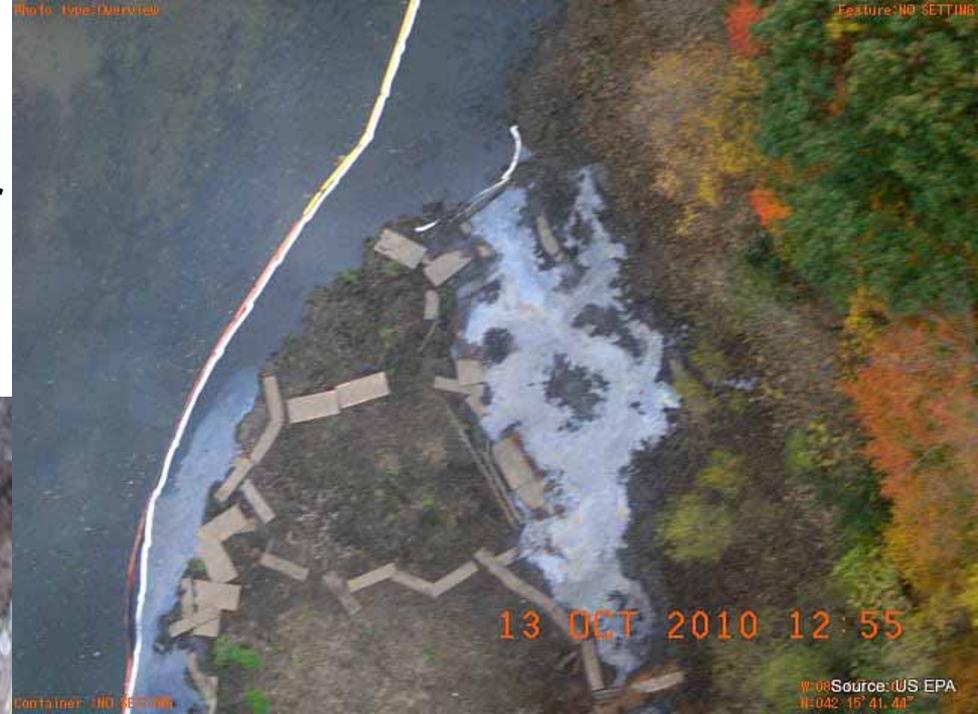
**Other areas will require long-term operation and maintenance to continue to reduce contamination levels.**
